CITY OF SASKATOON

# Asbestos-Containing Building Materials Assessment Report - Waste Water Inlet Building

**Report Number: 1667963**

**ASBESTOS ASSESSMENT  
 WASTE WATER INLET BUILDING  
 470 WHITESWAN DRIVE**

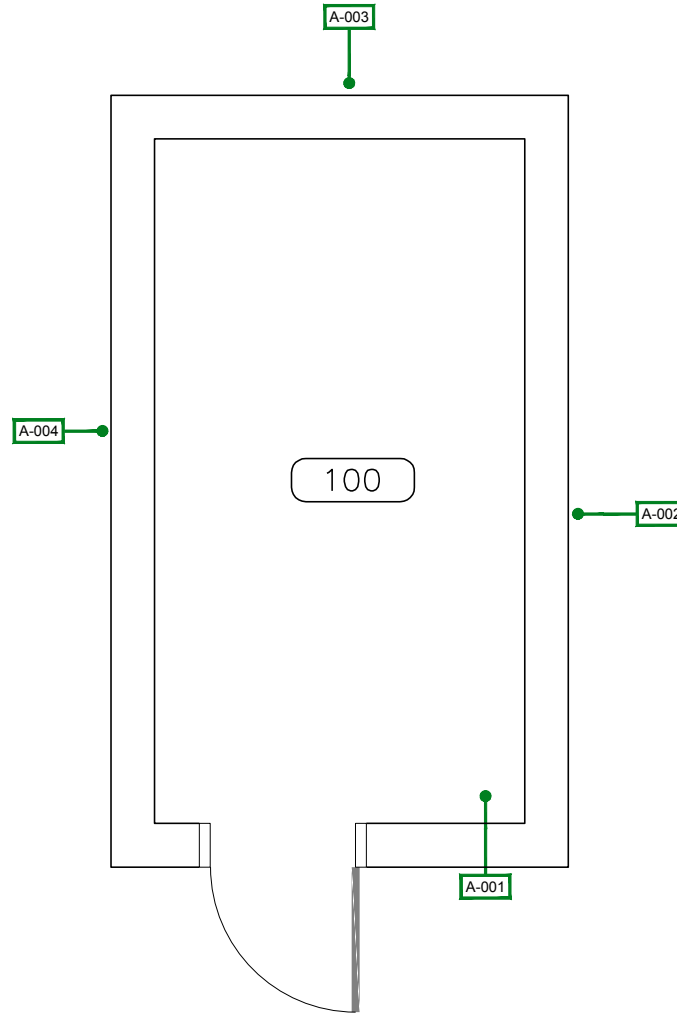
FIGURE  
**1**

SCHEMATIC ONLY, NOT TO SCALE

1. ASBESTOS IS A CARCINOGEN. DO NOT BREATHE ASBESTOS DUST.
2. ASBESTOS-CONTAINING MATERIALS WERE NOT OBSERVED ON SITE DURING THE ASSESSMENT.

**MAIN FLOOR**
