CITY OF SASKATOON

Asbestos-Containing Building Materials Assessment Report - Budz-Guenter Memorial House

Report Number: 1667963

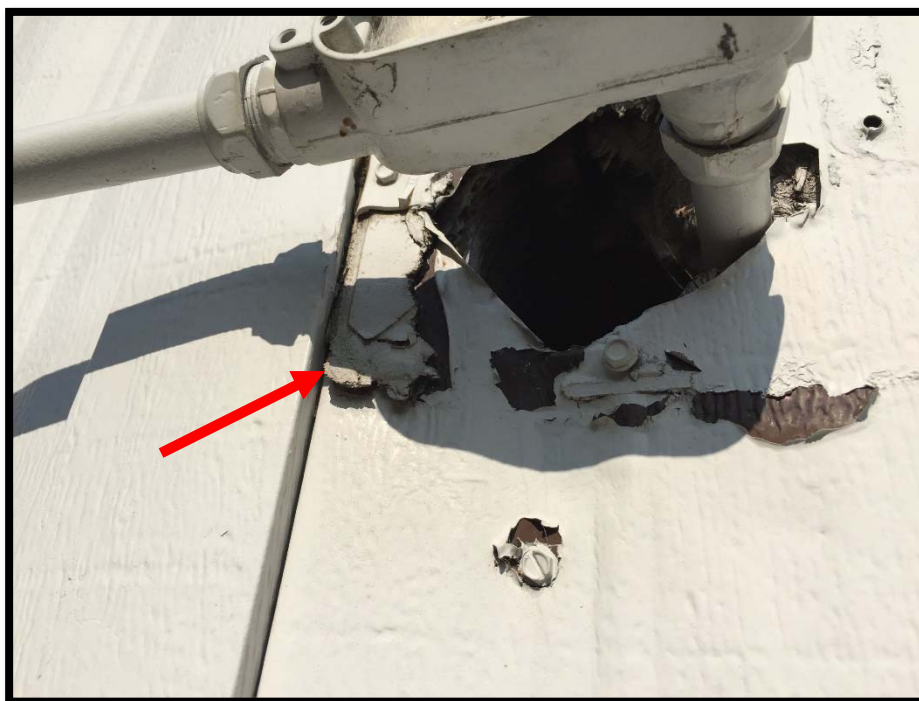
One (1) sample of white firestop was collected during the assessment. The sample collected was found to contain 2.1% Chrysotile asbestos. Asbestos-containing white firestop (see Photograph 1 in Appendix B) was observed in the following location:

- Exterior (approximately 2 ft²).

Photograph 1: Asbestos-Containing White Firestop.

If scheduled for impact, asbestos-containing white firestop should be abated following low-risk abatement work procedures as outlined in the *Saskatchewan Asbestos Abatement Manual* (2017). Alternatively, as the white firestop was observed in good condition, and with a priority rating of 5 (please see the room by room spreadsheet provided in Appendix C for a description of the priority ratings), it can be managed in place if not scheduled for impact.

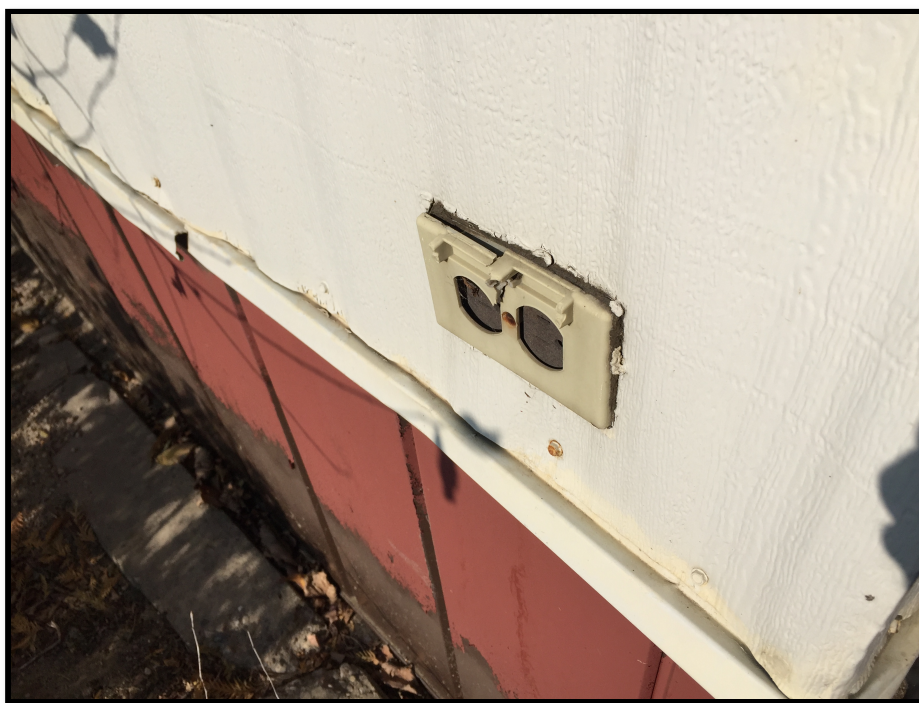
One (1) sample of black firestop was collected during the assessment. The sample collected was found to contain 1.7% Chrysotile asbestos. Asbestos-containing black firestop (see Photograph 2 in Appendix B) was observed in the following location:

- Exterior (approximately 1 ft²).

Photograph 2: Asbestos-Containing Black Firestop.

If scheduled for impact, asbestos-containing black firestop should be abated following low-risk abatement work procedures as outlined in the *Saskatchewan Asbestos Abatement Manual* (2017). Alternatively, as the black firestop was observed in good condition, and with a priority rating of 5 (please see the room by room spreadsheet provided in Appendix C for a description of the priority ratings), it can be managed in place if not scheduled for impact.
