## CITY OF SASKATOON

# Asbestos-Containing Building Materials Assessment Report - City Yards V&E Storage Building 15

**Report Number: 1667963**

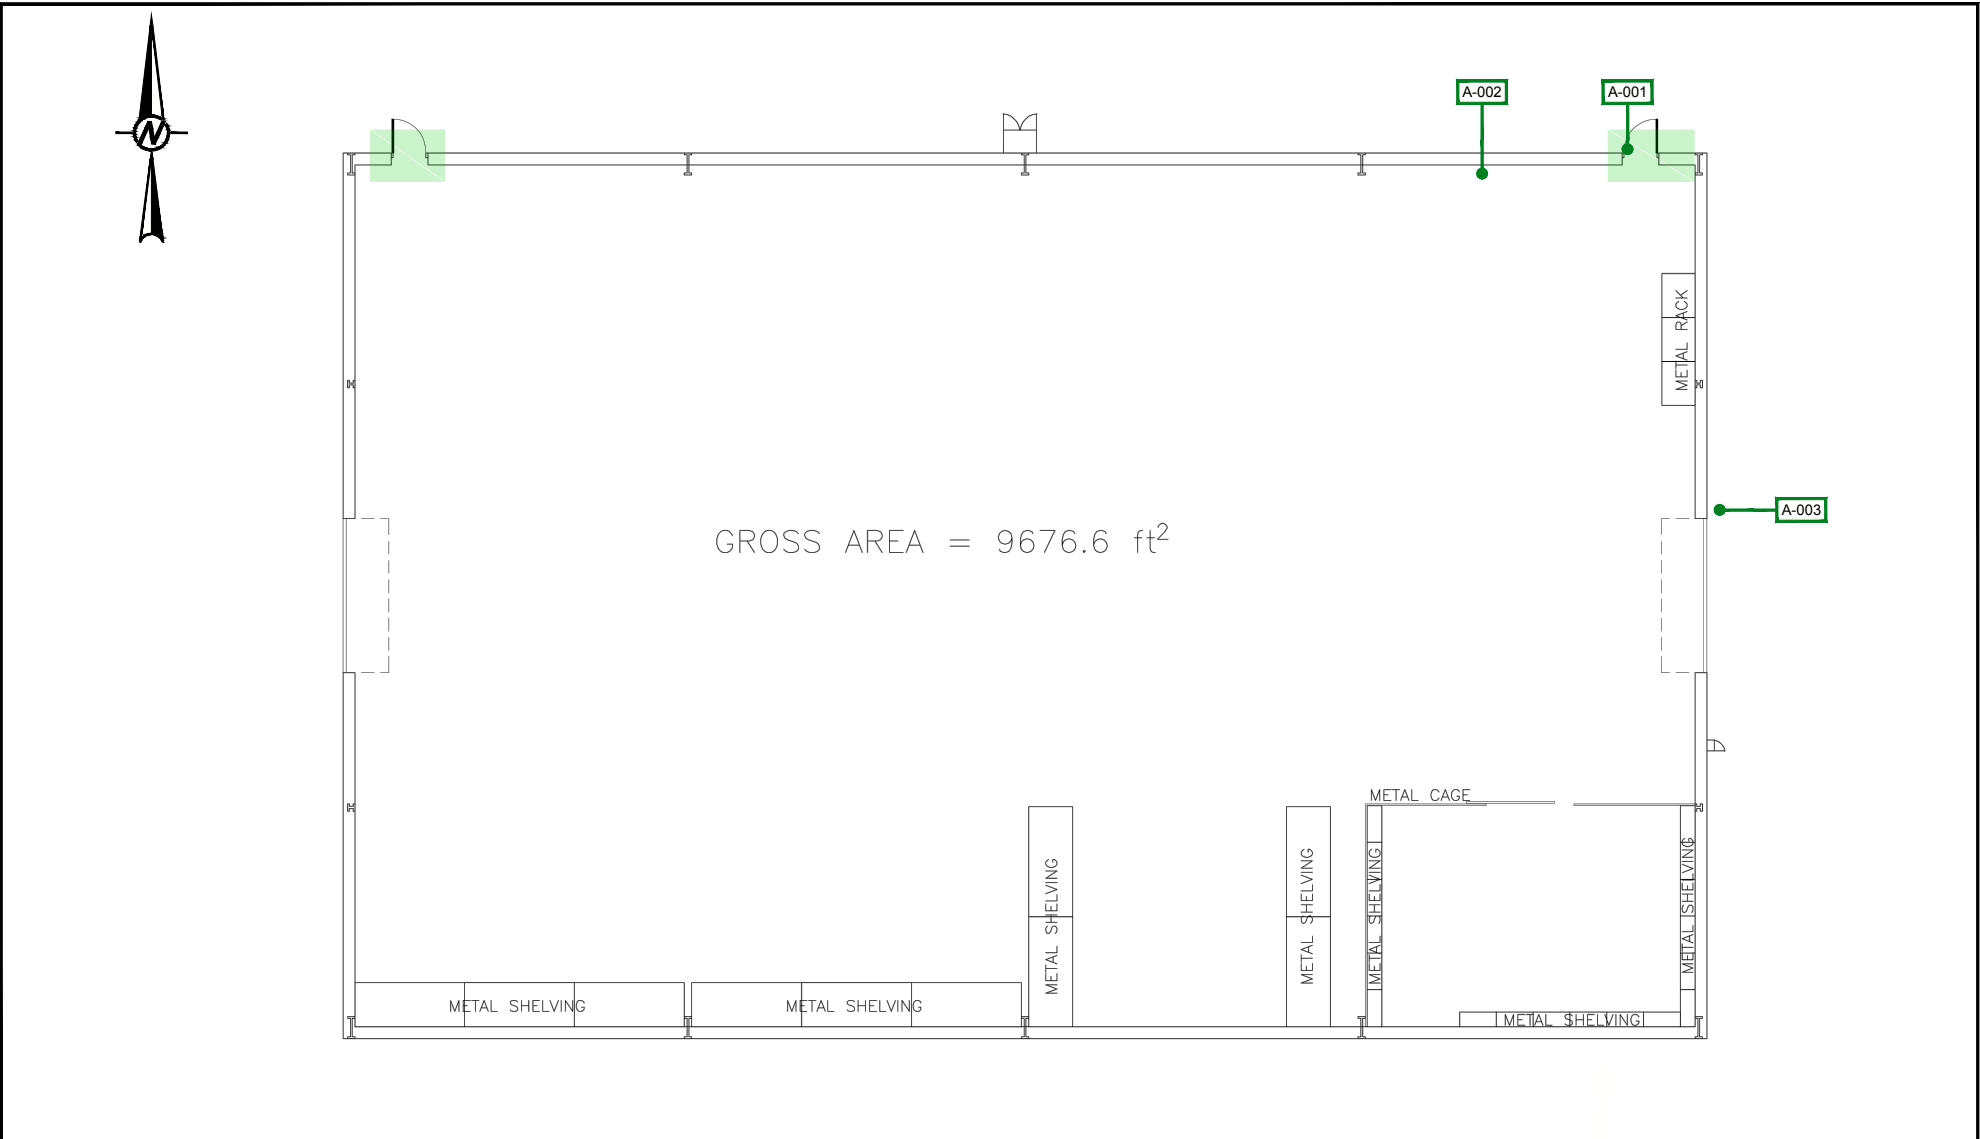
TITLE  
**MAIN FLOOR**

- ASBESTOS SAMPLE LOCATION
- ASBESTOS - CONTAINING WINDOW CAULKING
