## CITY OF SASKATOON

# Asbestos-Containing Building Materials Assessment Report - Nicholson Yards Weigh Shed

**Report Number: 1667963**

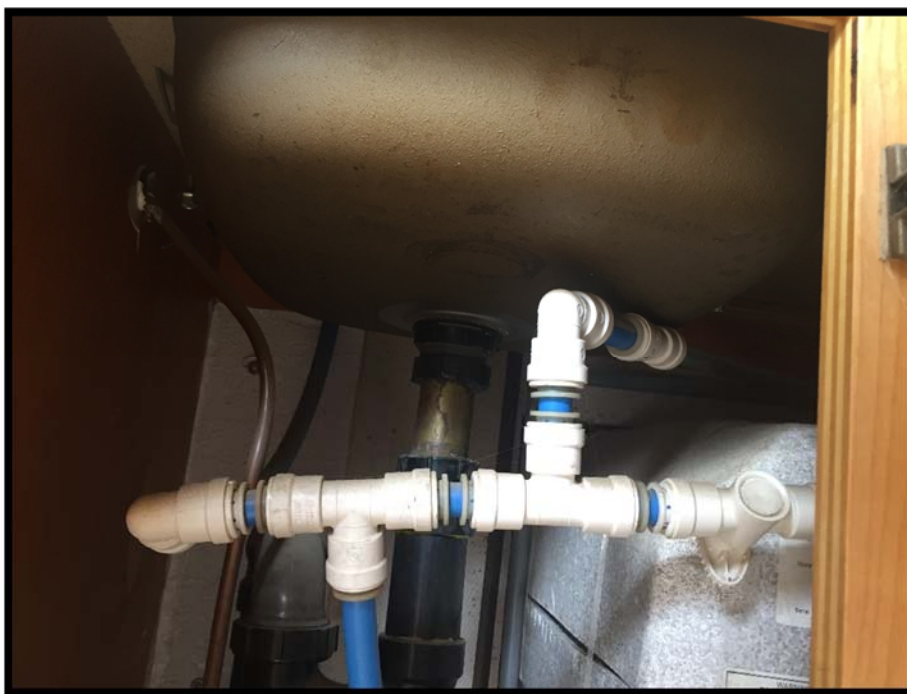
One (1) sample of gold sink undercoat was collected during the assessment. The sample collected was found to contain 3.4% Chrysotile asbestos. Asbestos-containing gold sink undercoat (see Photograph 1 in Appendix B) was observed in the following location:

- Room 100 (approximately 1 sink).

Asbestos was positively identified within the gold sink undercoat on Site. Asbestos was not identified in the remaining samples collected and analyzed.

**Photograph 1: Asbestos-Containing Gold Sink Undercoat.**

If scheduled for impact, the sink with asbestos-containing gold sink undercoat should be abated following low-risk abatement work procedures as outlined in the *Saskatchewan Asbestos Abatement Manual* (2017). Alternatively, as the gold sink undercoat was observed in good condition, and with a priority rating of 5 (please see the room by room spreadsheet provided in Appendix C for a description of the priority ratings), it can be managed in place if not scheduled for impact.
