August 4, 2017

CITY OF SASKATOON

# Asbestos-Containing Building Materials Assessment Report - 1st Avenue Substation

**Report Number: 1667963**

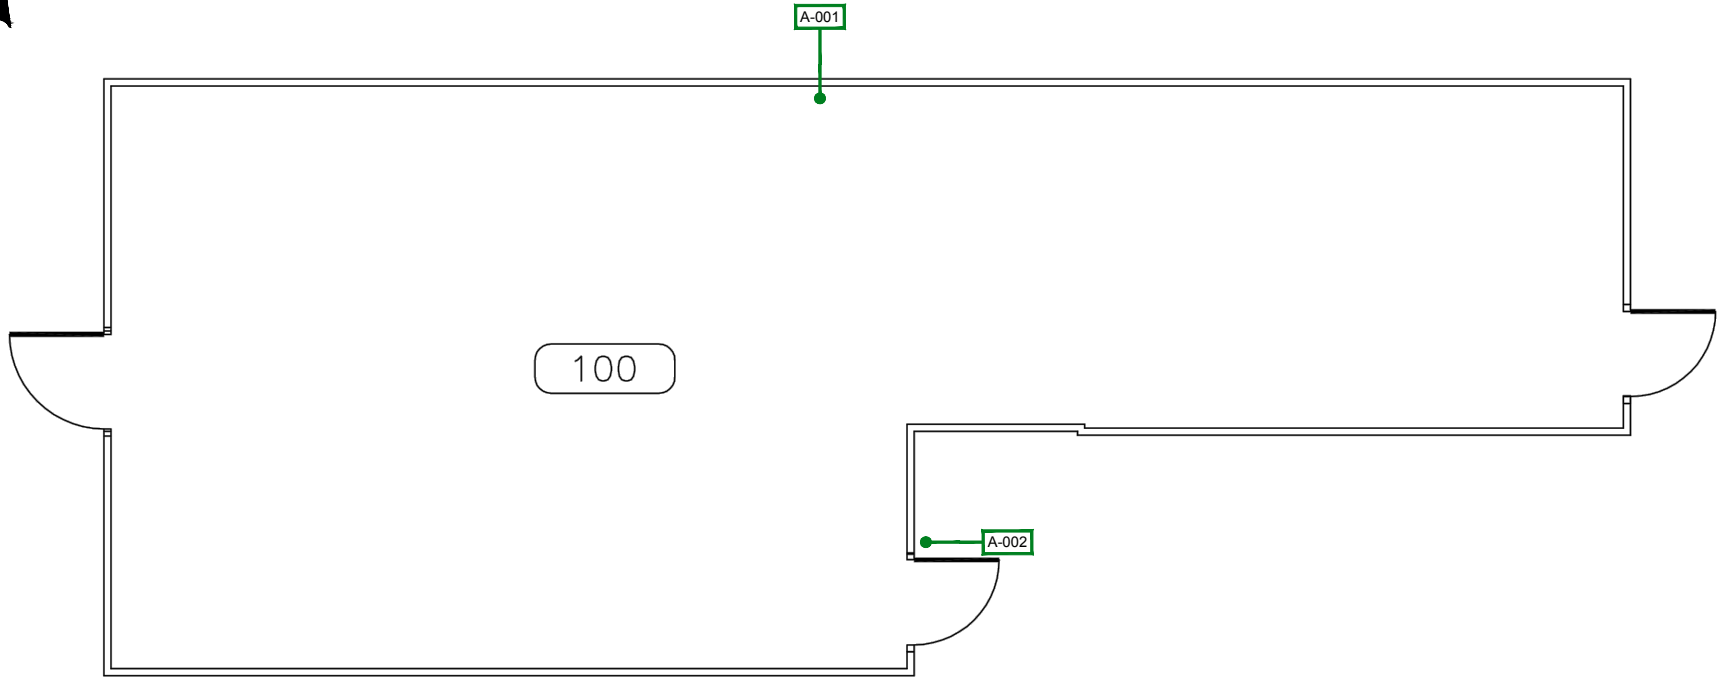
TITLE  
**MAIN FLOOR**

ASBESTOS SAMPLE LOCATION

1. ASBESTOS IS A CARCINOGEN. DO NOT BREATHE ASBESTOS DUST.
2. ASBESTOS-CONTAINING MATERIALS WERE NOT OBSERVED WITHIN THE BUILDING AT THE TIME OF THE ASSESSMENT.
