CITY OF SASKATOON

# Asbestos-Containing Building Materials Assessment Report - Main Street Substation

**Report Number: 1667963**

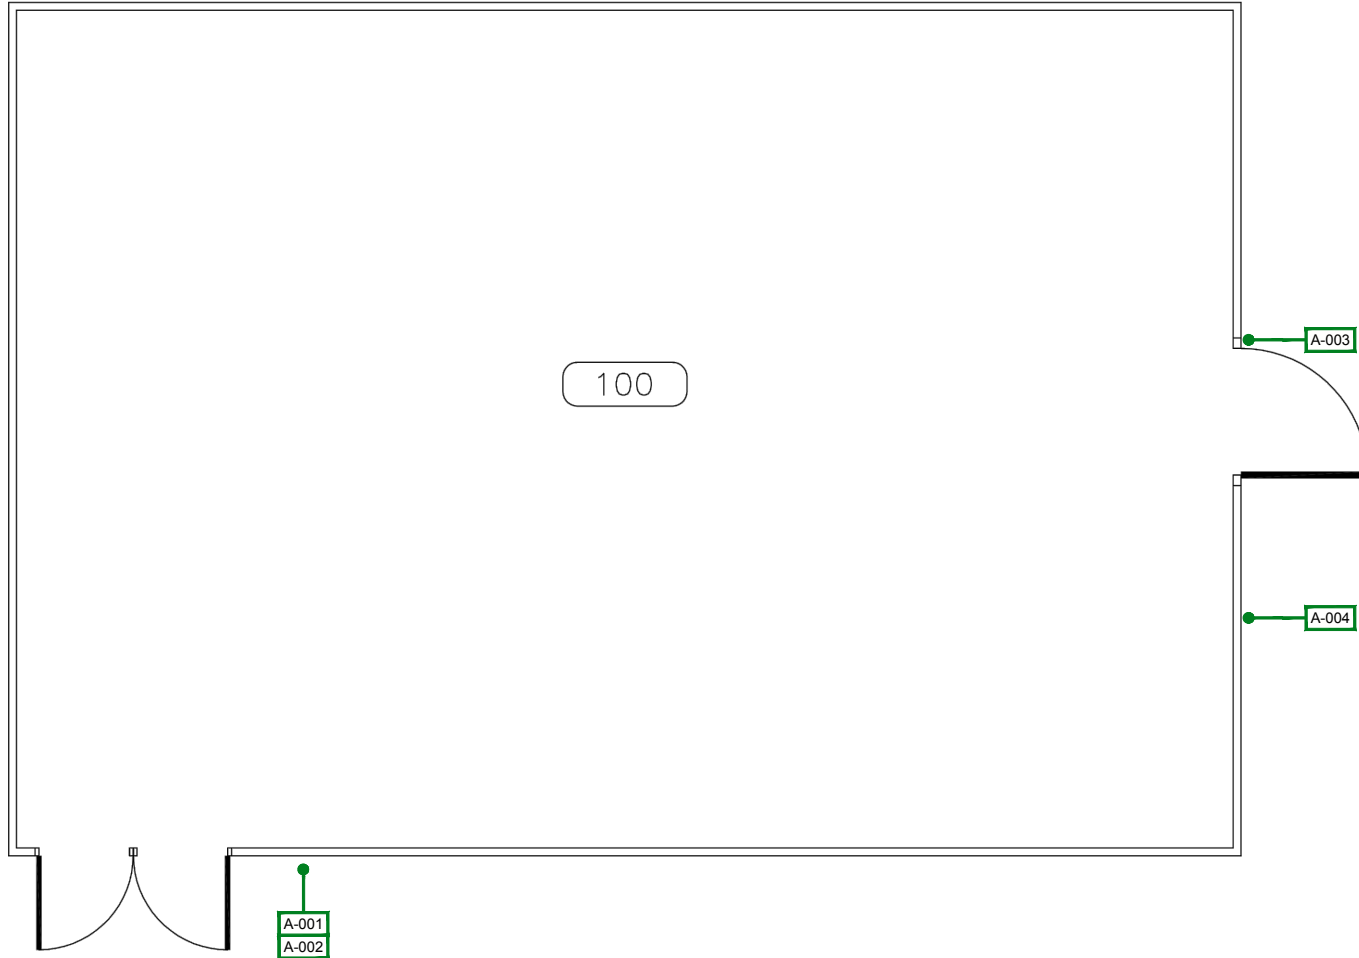
FIGURE  
 1

ASBESTOS SAMPLE LOCATION

1. ASBESTOS IS A CARCINOGEN. DO NOT BREATHE ASBESTOS DUST.
2. ASBESTOS-CONTAINING MATERIALS WERE NOT OBSERVED WITHIN THE BUILDING AT THE TIME OF THE ASSESSMENT.

**MAIN FLOOR**
