CITY OF SASKATOON

# Asbestos-Containing Building Materials Assessment Report - W J Bunn Substation

**Report Number: 1667963**

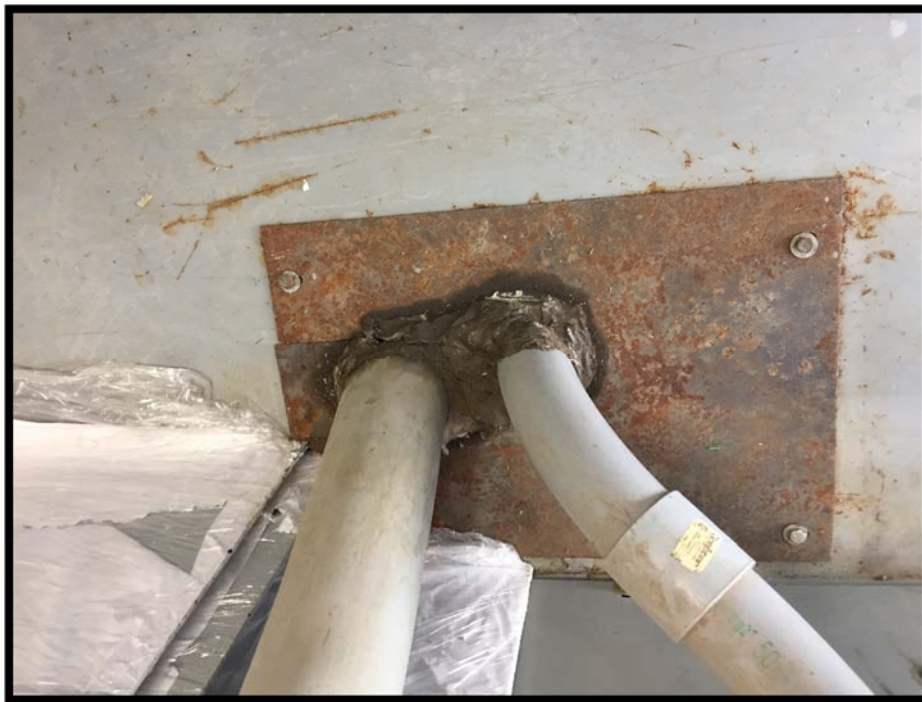
One (1) sample of grey firestop was collected during the assessment. The sample collected was found to contain 10% Chrysotile asbestos. Asbestos-containing grey firestop (see Photograph 1 in Appendix B) was observed in the following locations:

- Room 100 (approximately 2 ft<sup>2</sup>).

**Photograph 1: Asbestos-Containing Grey Firestop.**

| Included/<br>Excluded | Floor | Room # | Area Description | Elements | Subelements | Material Description | Accessibility | Suspect? | Sampled? | Asbestos<br>Containing<br>Material? | Condition | Field Notes | Sample<br>Type | Sample ID | Sample<br>Date | Asbestos<br>Type | ACM Product | % of asbestos | Friable | Sprayed-on | Maintenance | Inspection | Priority | Potential for<br>Disturbance | Recommended<br>Action | Quantity | Photograph ID | Labelling Type |
|---|---|---|---|---|---|---|---|---|---|---|---|---|---|---|---|---|---|---|---|---|---|---|---|---|---|---|---|---|
| Included | M | 100 | General Room | Floor | Firestop | Grey Firestop | High | Yes | Yes | Yes | Good | | Bulk | A-001 | 19-Jun-17 | Chrysotile | Firestop | 10% | No | No | N/A | Annually | 5 | High | Manage in place. | 2 ft <sup>2</sup> | Photograph 1 | Door Jamb |

If scheduled for impact, asbestos-containing grey firestop should be abated following the low-risk abatement work procedures as outlined in the *Saskatchewan Asbestos Abatement Manual* (2017). Alternatively, as the grey firestop was observed in good condition, and with a priority rating of 5 (please see the room by room spreadsheet provided in Appendix C for a description of the priority ratings), it can be managed in place if not scheduled for impact.
