CITY OF SASKATOON

# Asbestos-Containing Building Materials Assessment Report - Wildwood Golf Course Cold Storage Building

**Report Number: 1667963**

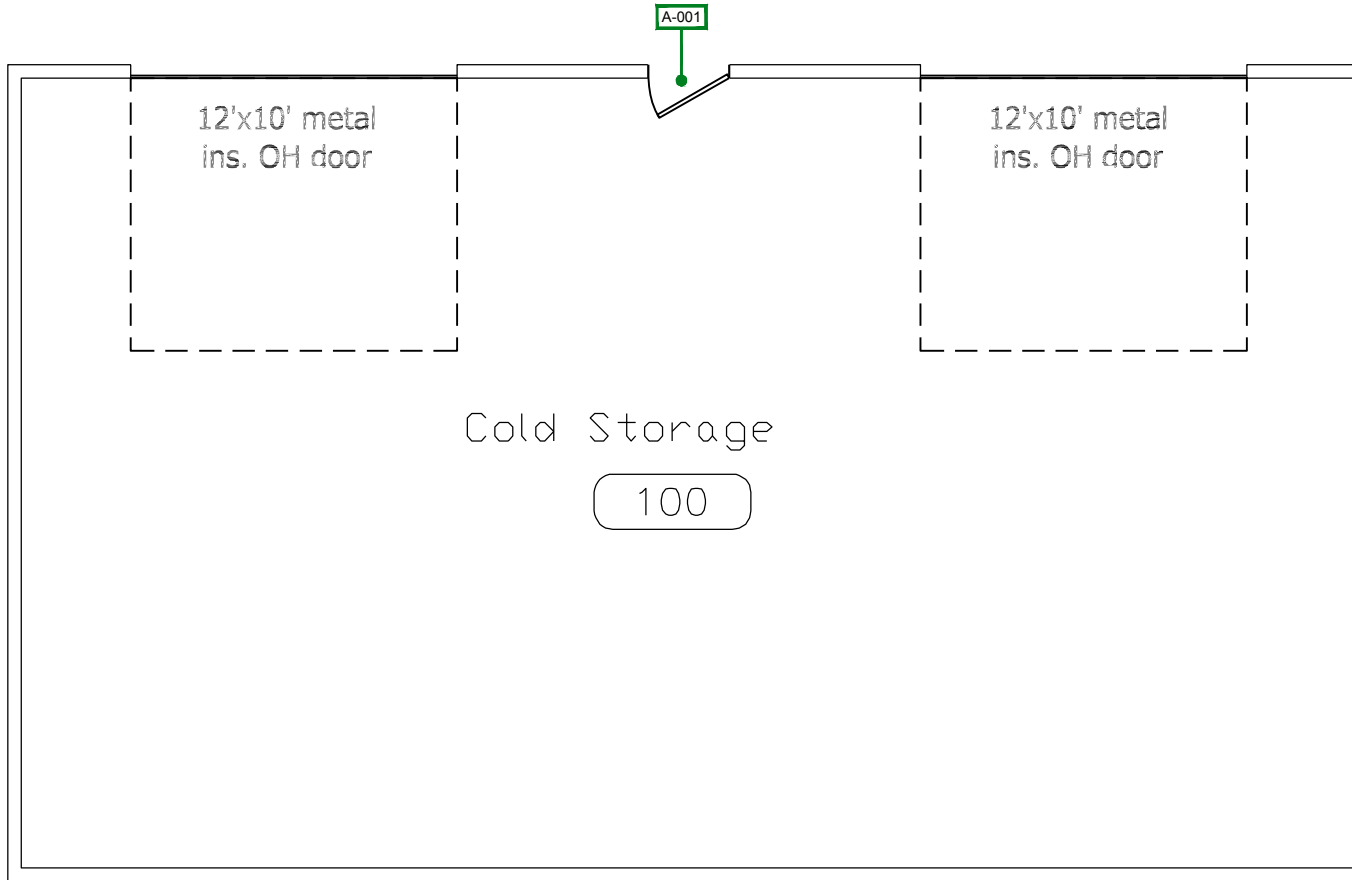
FIGURE  
1

A total of one (1) sample of building materials was collected and tested for asbestos content during the assessment of the Wildwood Golf Course Cold Storage Building. The sample was found to not contain asbestos.

- Grey firestop; and
- The walls and ceilings were observed to be constructed of wood with a concrete floor.

1. ASBESTOS IS A CARCINOGEN. DO NOT BREATHE ASBESTOS DUST.
2. ASBESTOS-CONTAINING MATERIALS WERE NOT OBSERVED ON SITE DURING THE ASSESSMENT.

**COLD STORAGE BUILDING**

If suspect or potential asbestos-containing building materials are encountered during renovation or demolition activities, sampling should be undertaken to evaluate asbestos content.
