October 31, 2017

CITY OF SASKATOON

# Asbestos-Containing Building Materials Assessment Report - Wildwood Park Paddling Pool

**Report Number: 1667963**

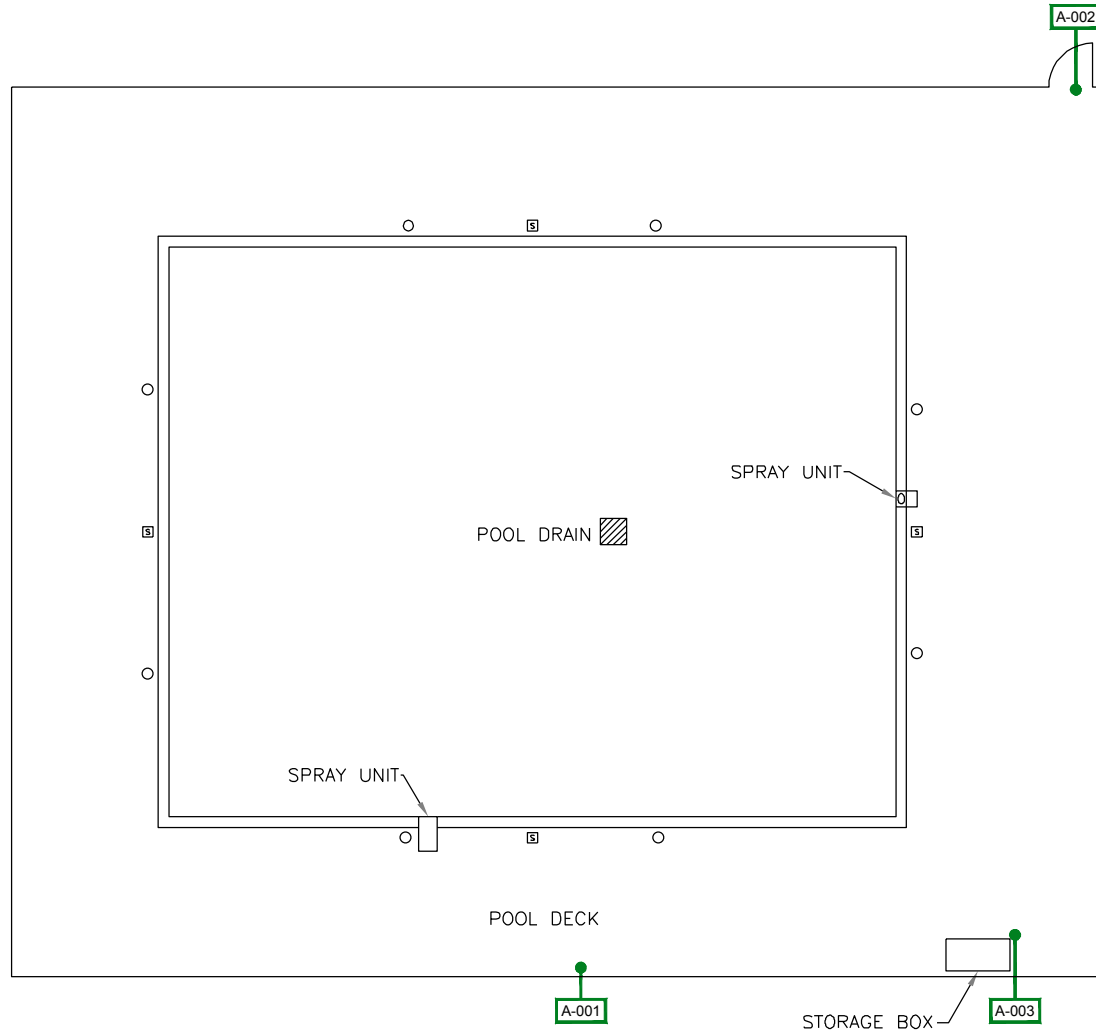
TITLE  
**SITE PLAN**

● # ASBESTOS SAMPLE LOCATION

1. ASBESTOS IS A CARCINOGEN. DO NOT BREATHE ASBESTOS DUST.
2. ASBESTOS-CONTAINING MATERIALS WERE NOT OBSERVED ON SITE DURING THE ASSESSMENT.
