## **SIDEWALK SNOW CLEARING – PICTORIAL REFERENCE**

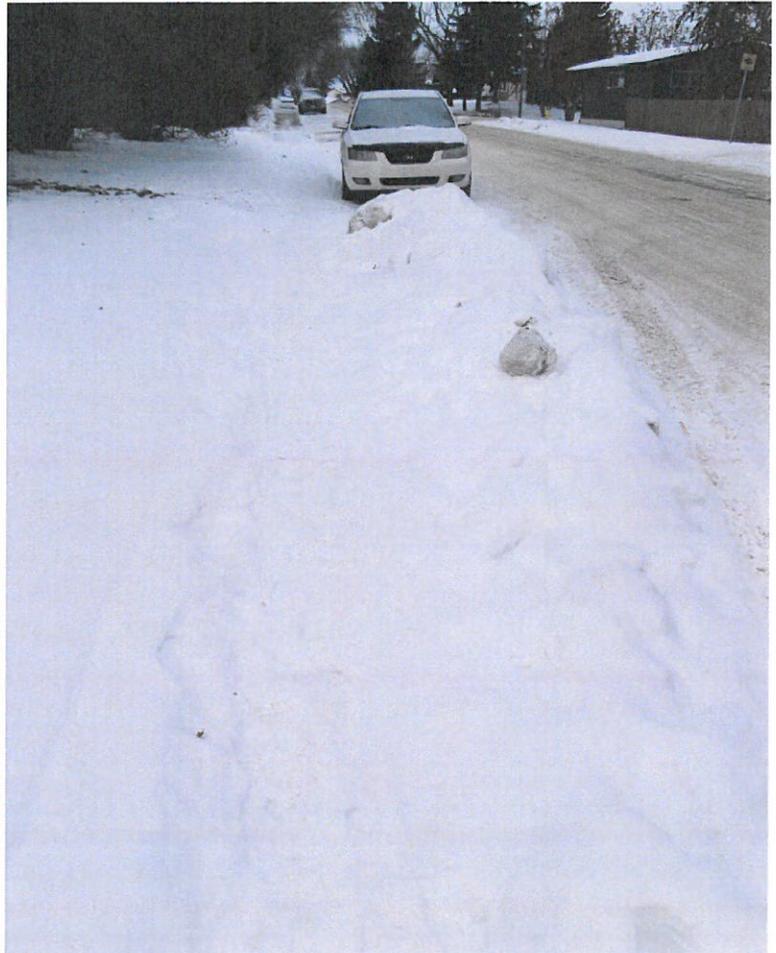
The adjacent picture is an example of a non-compliant sidewalk. There is no visible evidence that any effort has been taken to clear the sidewalk. The pedestrian path (which has been packed only by foot traffic) is a little more than 0.5m in width and uneven would cause significant difficulty for those with mobility challenges.

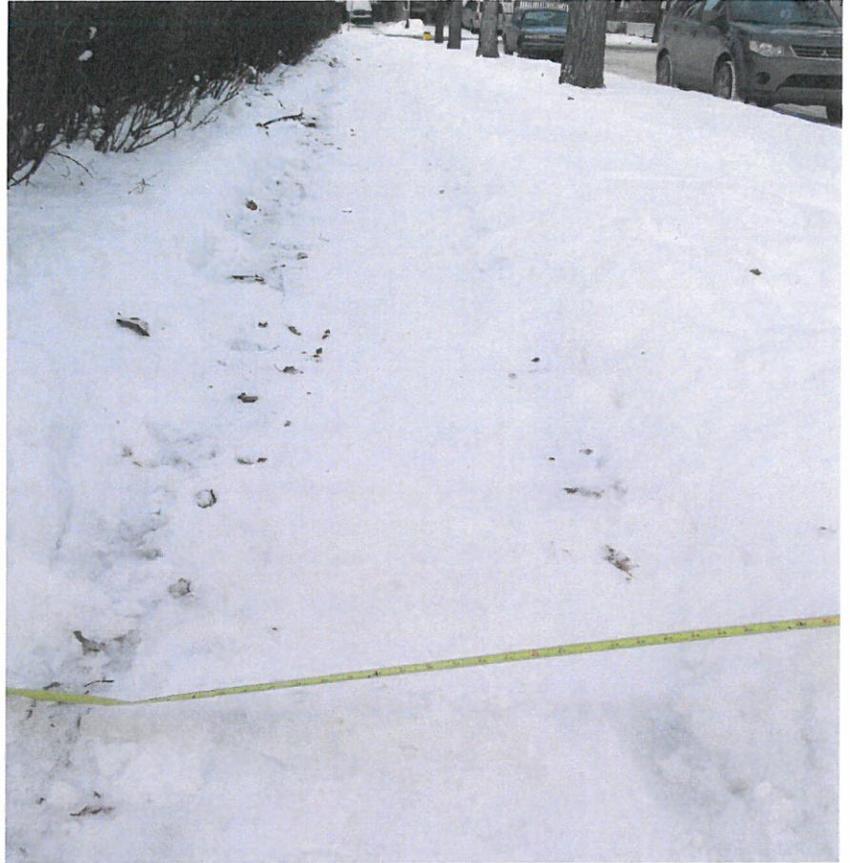
The adjacent picture is another example of a non-compliant sidewalk. While there is evidence that there may have been an attempt to clear a path with a snow blower (evident by uniform width and the apparent tire tracks running along either side of the cleared path). The cleared path, which is only approximately 0.8m in width, remains uneven and would cause significant difficulty for those with mobility challenges.

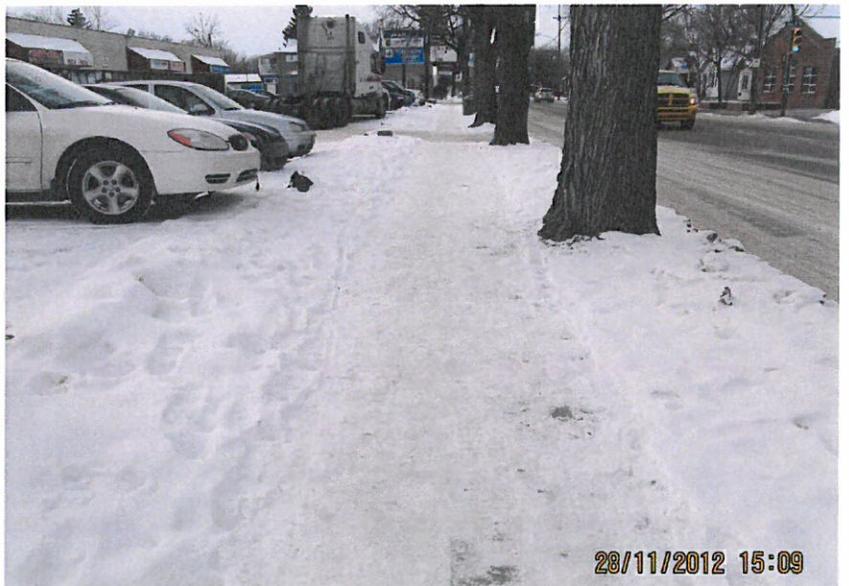
The adjacent picture is an example of a cleared compliant sidewalk. There is clear evidence that there has been an attempt to clear a path with a snow blower as is evident by uniform width which is approximately 1.2m. While there is some packed snow, the areas showing clear concrete is less than 3cm thick.

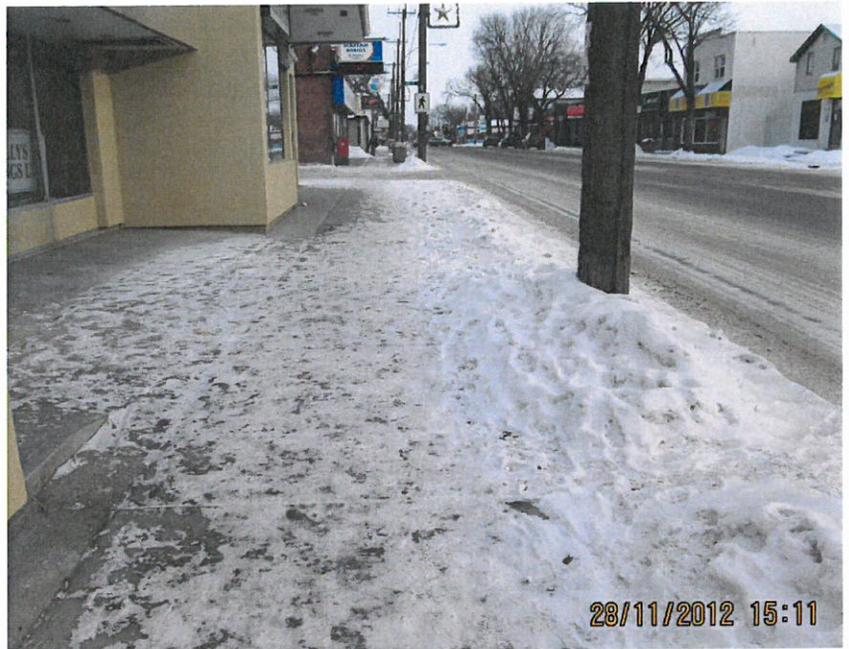
The adjacent picture is another example of a cleared compliant sidewalk. Again, there is clear evidence that there has been an attempt to clear a path with a width which is at least 1.2m. While there is some packed snow, the areas showing clear concrete is less than 3cm thick.

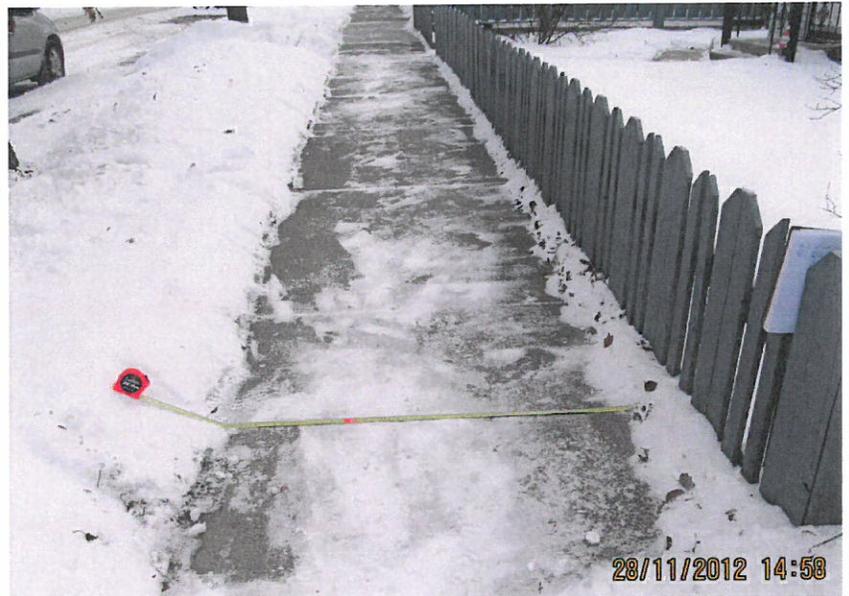
The adjacent picture is another example of a cleared compliant sidewalk. Again, there is clear evidence that there has been an attempt to clear a path which is the width of the entire sidewalk. There is very little snow on the surface of concrete.
