**PUBLIC AGENDA
EXECUTIVE COMMITTEE**

**Wednesday, February 11, 2015, 1:00 p.m.
Council Chamber, City Hall**

Nutana Slope Failure Overview

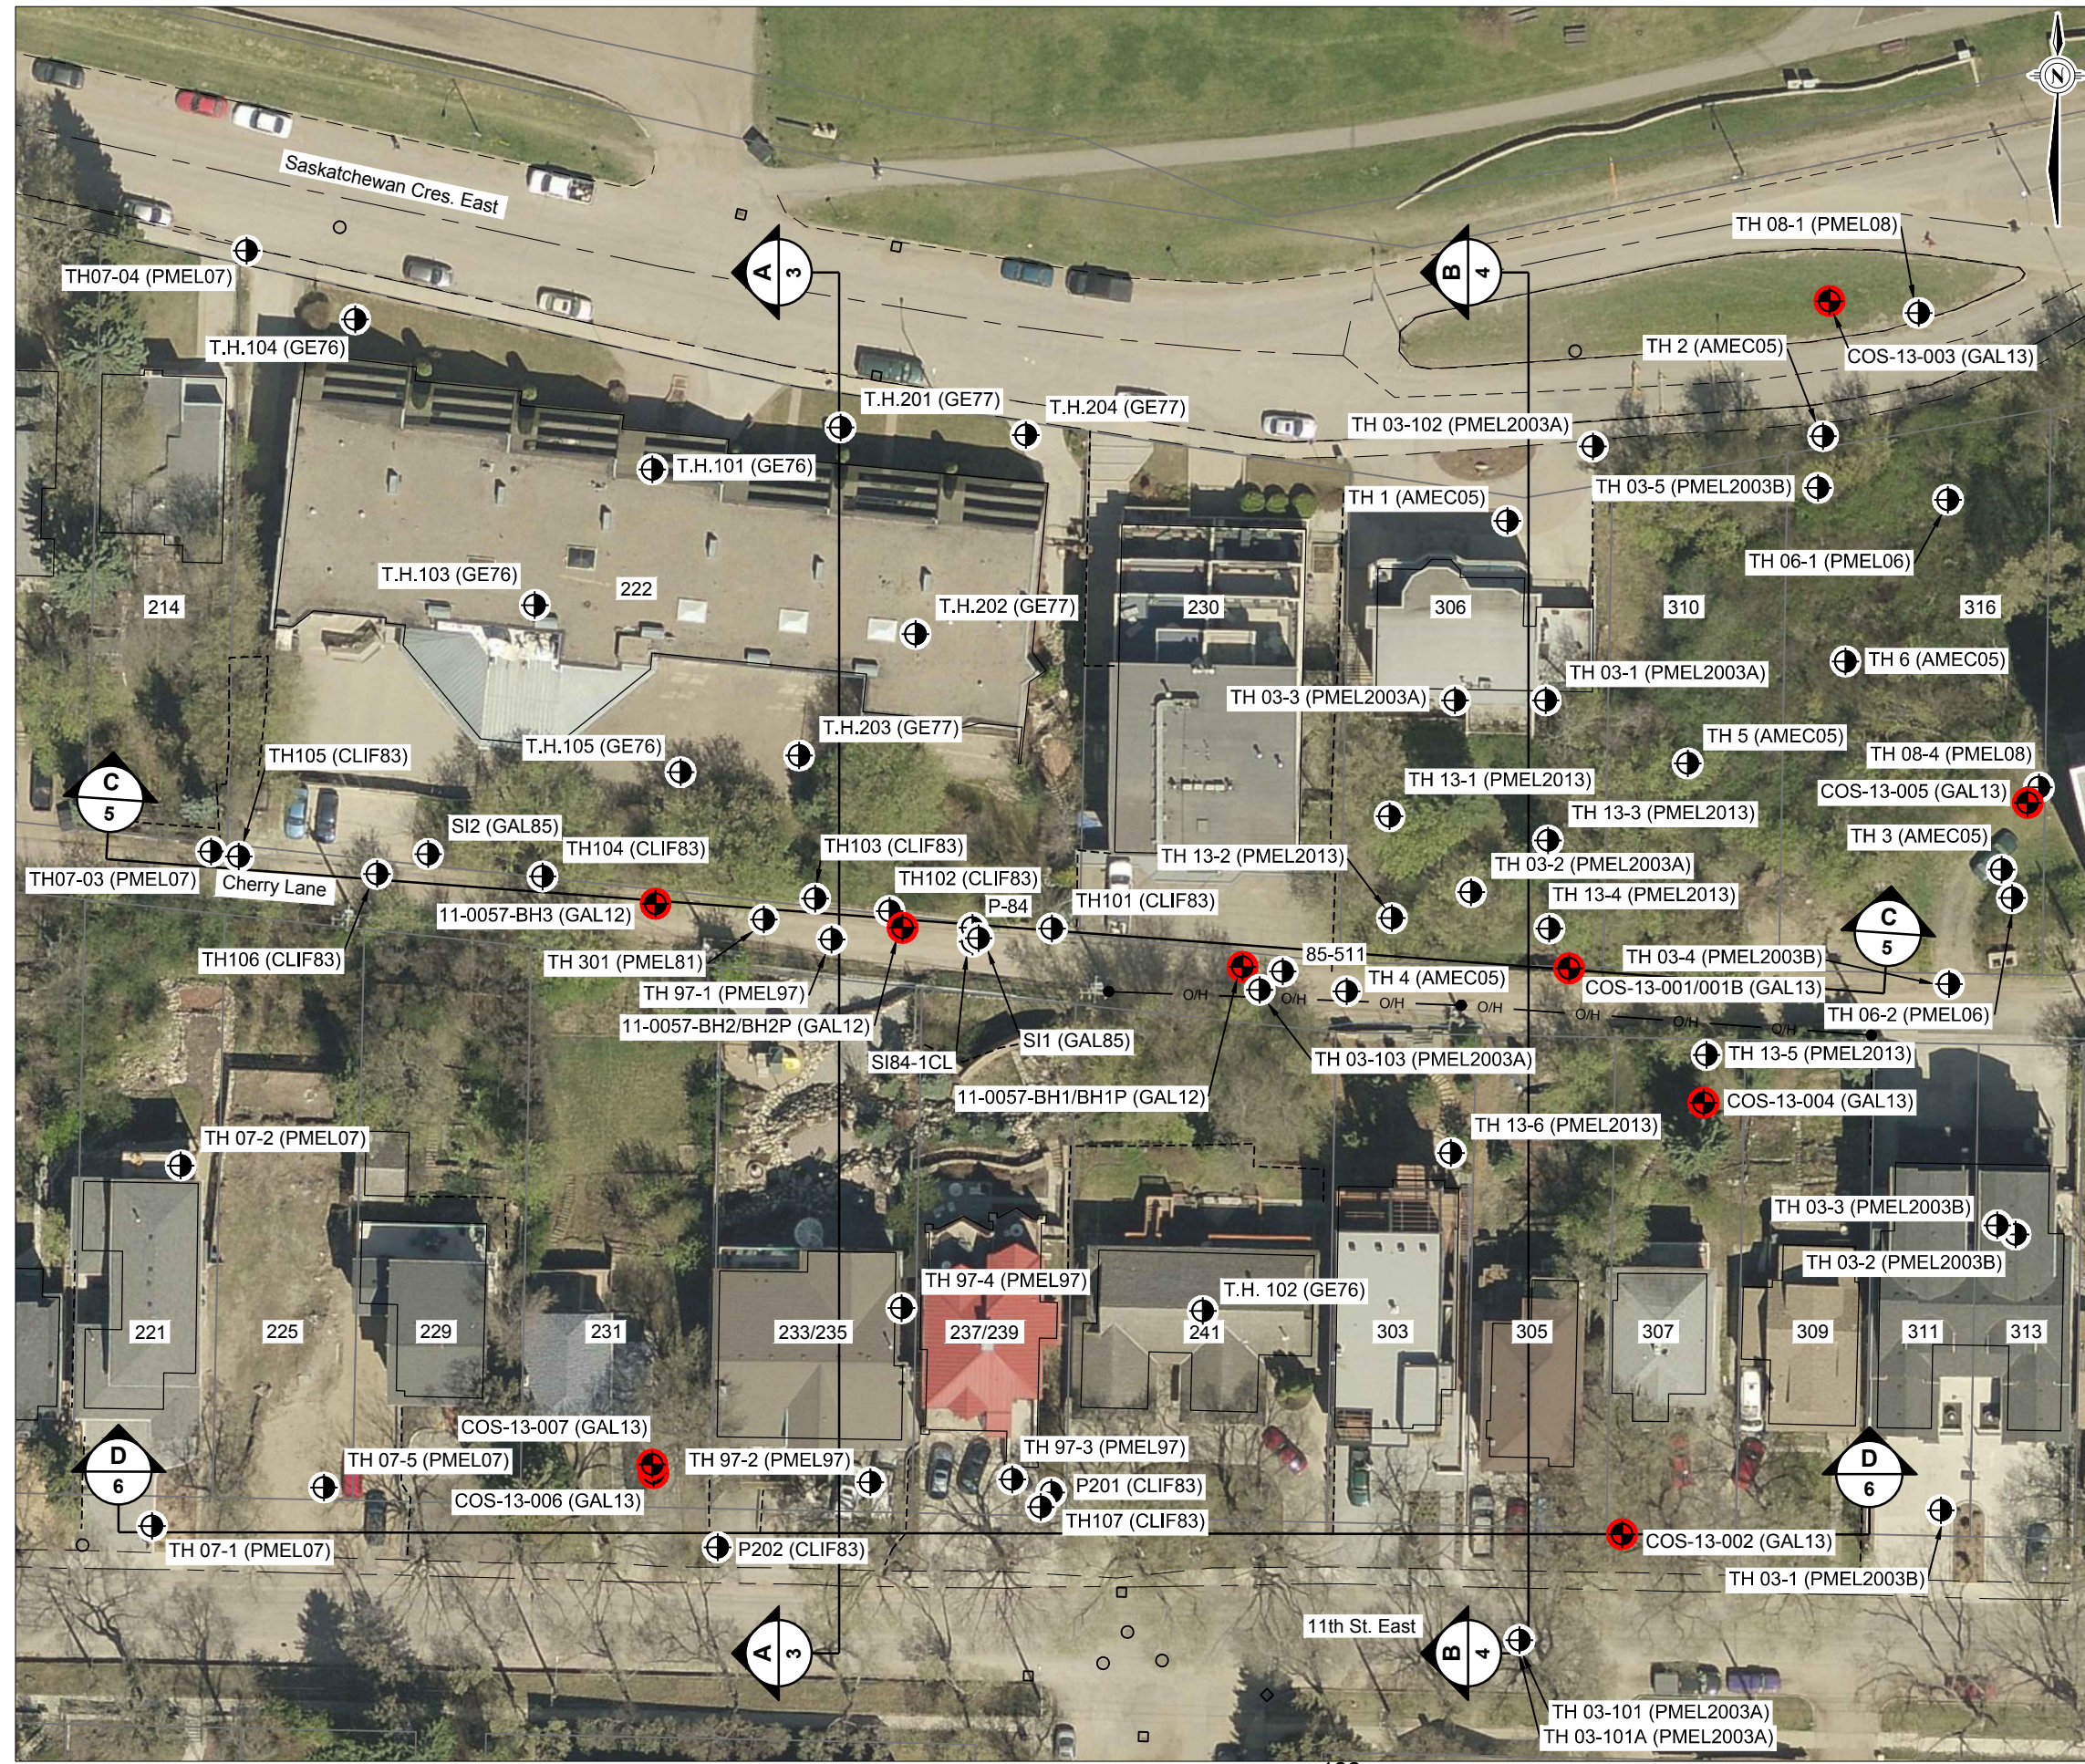
CITY OF SASKATOON		CHERRY LANE SLOPE INSTABILITY	
BOREHOLE AND CROSS SECTION LOCATION PLAN			
PROJECT	11-1362-0057	FILE No.	
DESIGN	LM 08/05/14	SCALE	AS SHOWN REV. 0
CADD	JDS 08/05/14		
CHECK	HV 08/05/14		
REVIEW	PGB 08/05/14		
Golder Associates <small>Saskatoon, Saskatchewan</small>		FIGURE: 2

Two inclinometers, designated as SI84-1CL and 85-511 with locations presented on Figure 2 were installed and monitored in Cherry Lane. However Inclinometer SI84-1CL was blocked in 2004 and inclinometer 85-511 was bent in 2006. Inclinometer SI-84 ICL recorded approximately 20 millimetres (mm) of total movement for the period from November 1992 to October 2001. Inclinometer 85-511 recorded approximately 32 mm of total movement for the period from August 1985 to October 2005.

Borehole information from the various geotechnical reports listed in Section 3.3 was compiled to construct a physical model of the soils at the Site. The boreholes used to construct all cross-sections were obtained from many different studies, and have likely been located using various coordinate systems and survey datums. Efforts were made to reconcile the different elevation datums; however, there may still be some discrepancies in the elevation data due to the use of unknown or older elevation datums, or slope movement. Soil descriptions and laboratory test results were also reviewed and interpreted according to Golder's classification system to provide a more consistent classification of the soils. Two cross-sections, A-A' and B-B' were selected as representative cross-sections for the West Failure and East Failure, respectively. Stratigraphic cross-sections A-A' and B-B' are shown in Figure 12 and Figure 13, respectively. Soil stratigraphic conditions along Cherry Lane and 11th Street East are shown in Figure 14 (longitudinal stratigraphic section C-C') and Figure 15 (longitudinal stratigraphic section D-D'), respectively. Locations of cross sections and longitudinal sections are shown in Figure 2.

Cross-sections A-A and B-B were selected as the primary section for analysis for the West Failure and East Failure, respectively. The location of the cross-sections is shown on Figure 2. Figure 12 and Figure 13 show the inferred stratigraphic soil profiles along each cross-section. Both the West Failure and East Failure were back-analysed to determine the residual (or large strain) shear strength parameters corresponding to failure or a FS of 1.0.

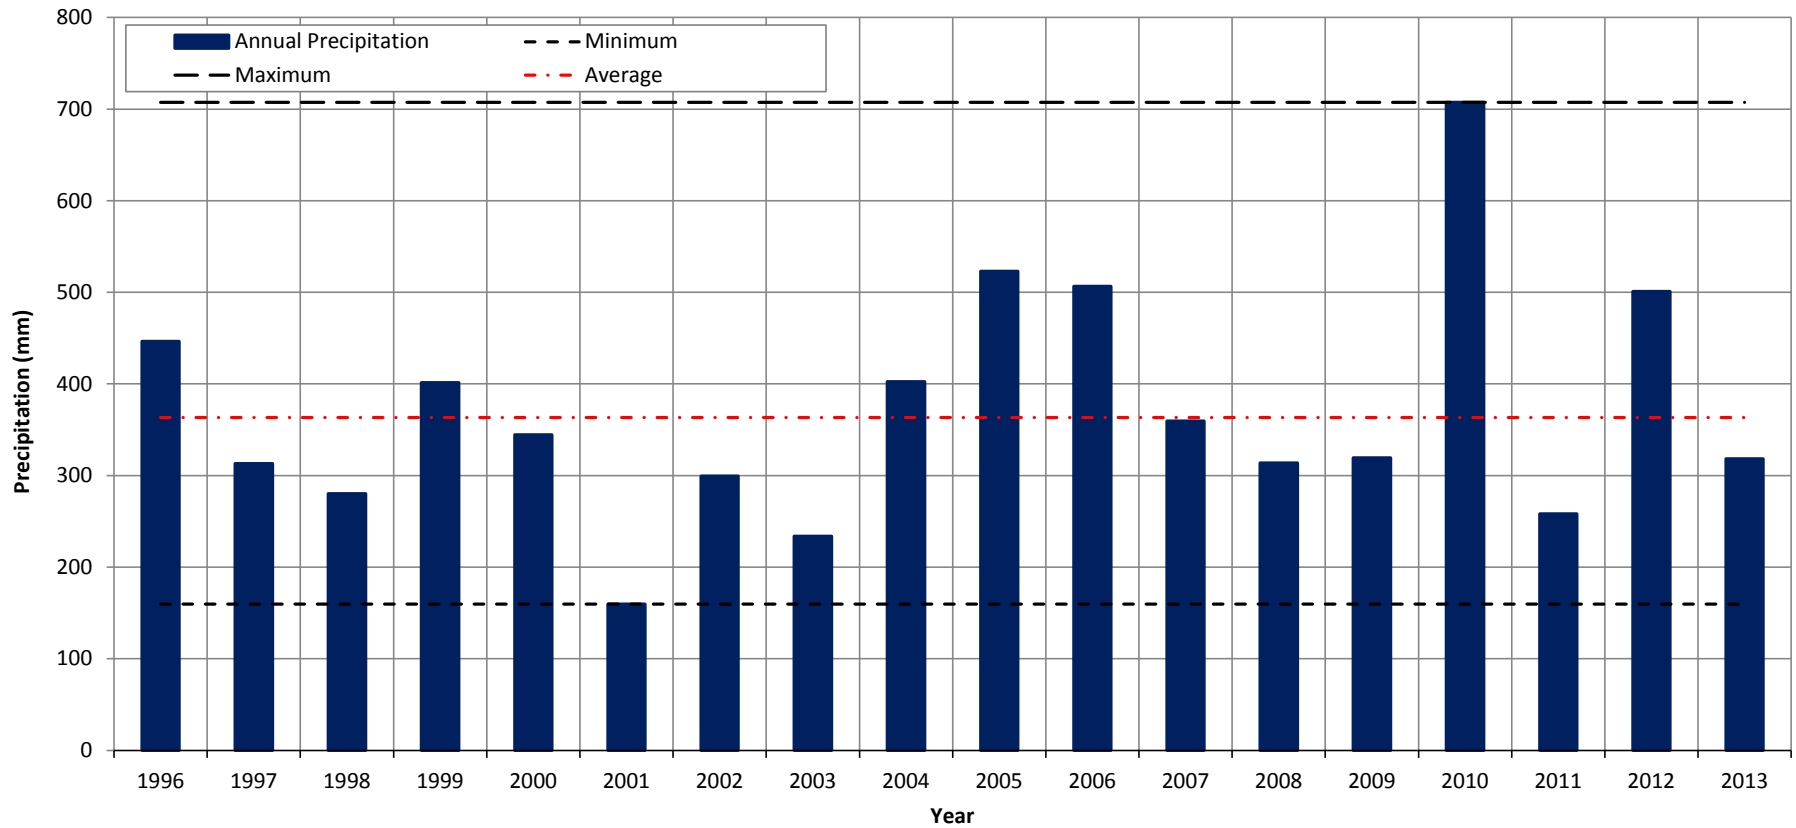
City of Saskatoon		CHERRY LANE SLOPE INSTABILITY	
TITLE SASKATOON AREA ANNUAL PRECIPITATION (1996 - 2013)

Saskatoon has experienced a wet cycle over the past ten years. Following a severe drought from 1997-2003, precipitation was above average between 2004 and 2006 (Figure 3) with 2005 and 2006 being the fourth and fifth wettest years on record, respectively. Although precipitation was below average between 2007 and 2009, the wettest year on record occurred in 2010 when 708 mm fell, almost double the historic average. High precipitation in 2010 created the antecedent conditions that led to flooding throughout the Prairie Provinces during 2011.

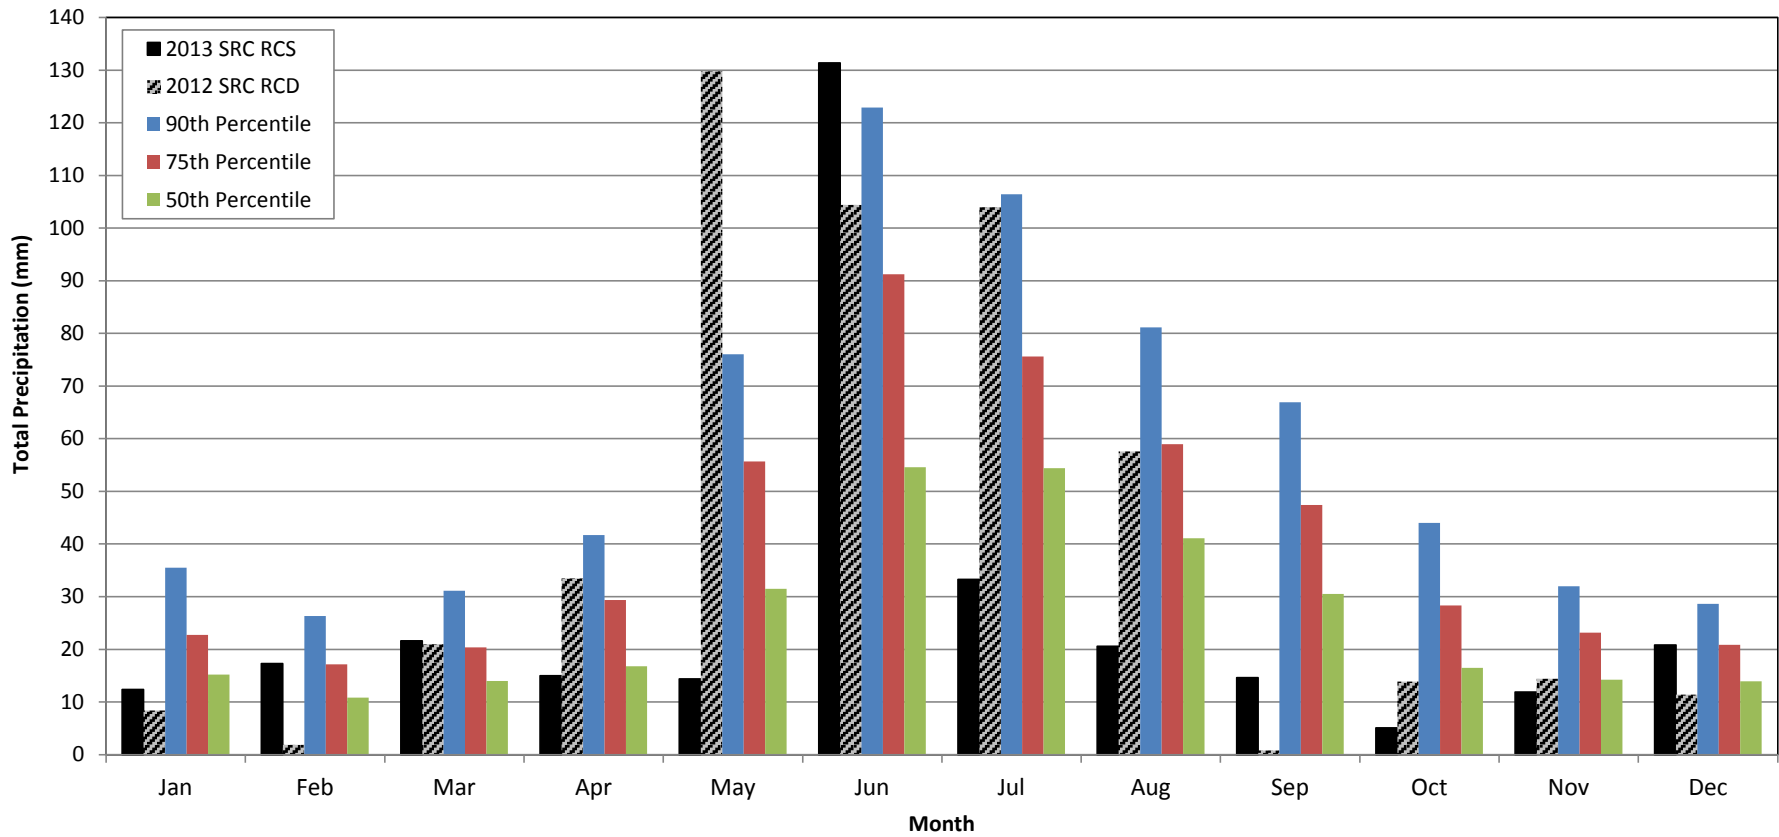
CHERRY LANE SLOPE INSTABILITY	
TITLE SASKATOON AREA TOTAL PRECIPITATION (1908 - 2013)			
		PROJECT 11-1362-0057 DESIGN LNM 08/05/14 CADD CHECK PGB 08/05/14 REVIEW HQV 08/05/14	FILE No. SCALE N/A REV.
FIGURE: 4

Although low through the winter of 2011-2012, precipitation was above normal during the spring and summer of 2012, particularly May and June (Figure 4). Several rain events between 10 and 25 mm led to a total precipitation of 129.8 mm in May 2012, making it the third wettest year observed between 1908 and 2012 and more than three times the median value of 31.5 mm: 69.6 mm of rain fell in the first week of May with 61.2 mm concentrated on May 5 and 6, 2012. On May 22 and 23, 2012, 33.6 mm of rain fell.

Rainfall in June 2012 was 104.4 mm, making it almost twice the median June precipitation of 54.6 mm (Figure 4). Sustained daily rainfall between June 9 and June 19, 2012 amounted to 81mm with 47.6 mm concentrated on June 9 and 10, 2012 (Figure 5). An additional 18.6 mm fell between June 24 and June 27, 2012.

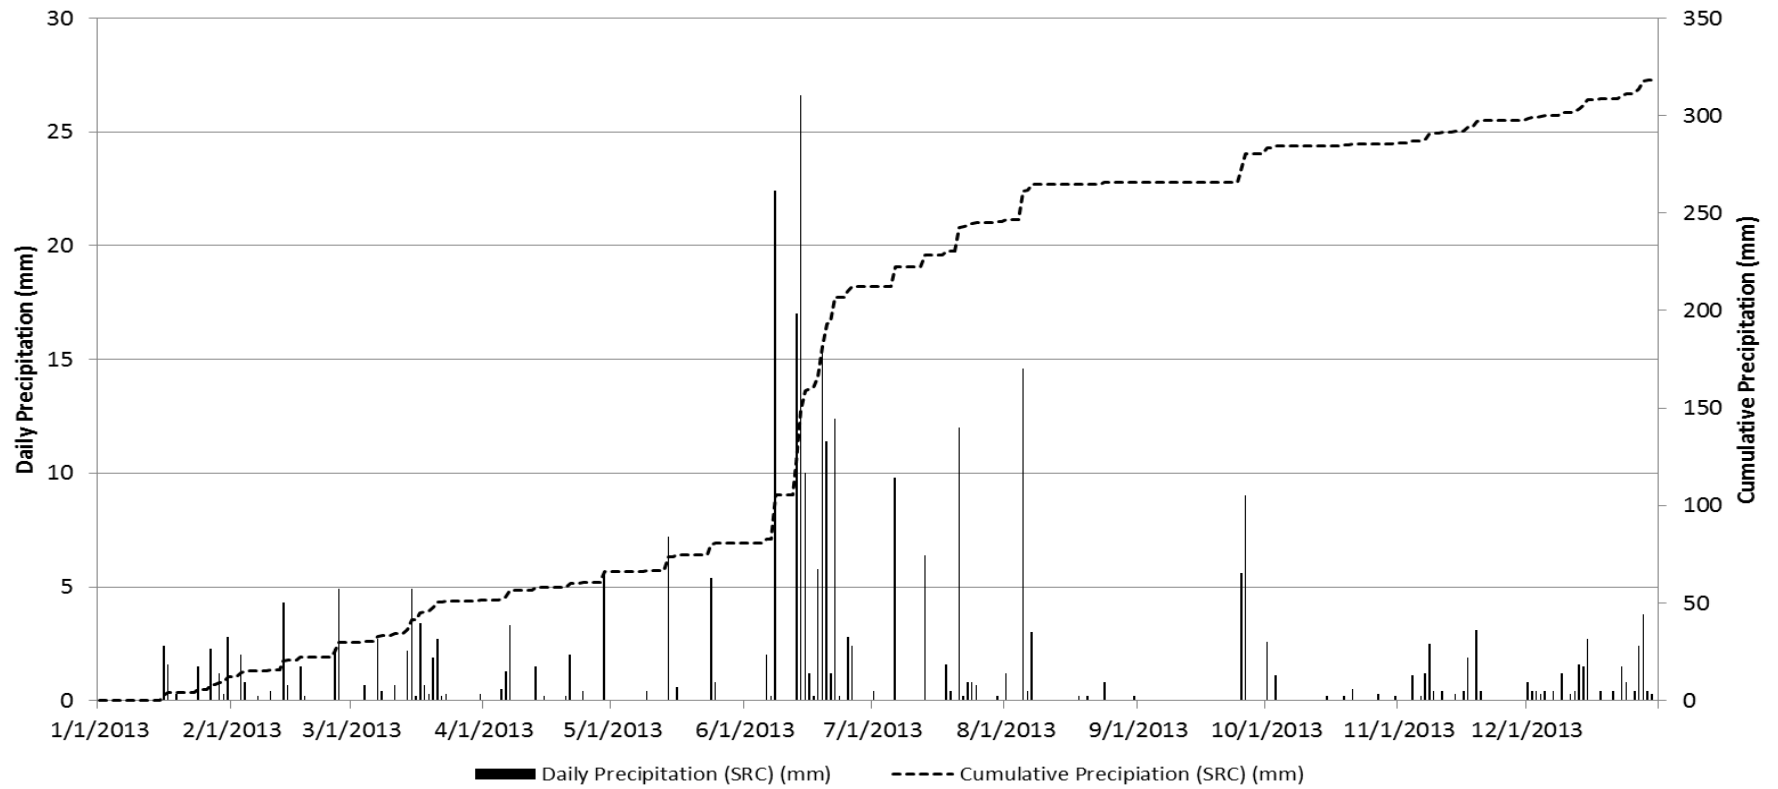
CHERRY LANE SLOPE INSTABILITY	
TITLE SASKATOON AREA DAILY AND CUMULATIVE PRECIPITATION (2013)			
		PROJECT 11-1362-0057 DESIGN LNM 08/05/14 CADD CHECK PGB 08/05/14 REVIEW HQV 08/05/14	FILE No. SCALE N/A REV.
			FIGURE: 6

The 2012-2013 winter snowpack leading up to the spring runoff was high. Cumulative winter precipitation from November 1, 2012 to March 4, 2013 exceeded 200% of average in Saskatoon (WSA 2013). There was below normal precipitation during April and May of 2013 (Figure 5). However, total June precipitation was approximately twice the median with 131.4 mm total precipitation of which 101.6 mm fell between June 13, 2013 and June 23, 2013 (Figure 6).

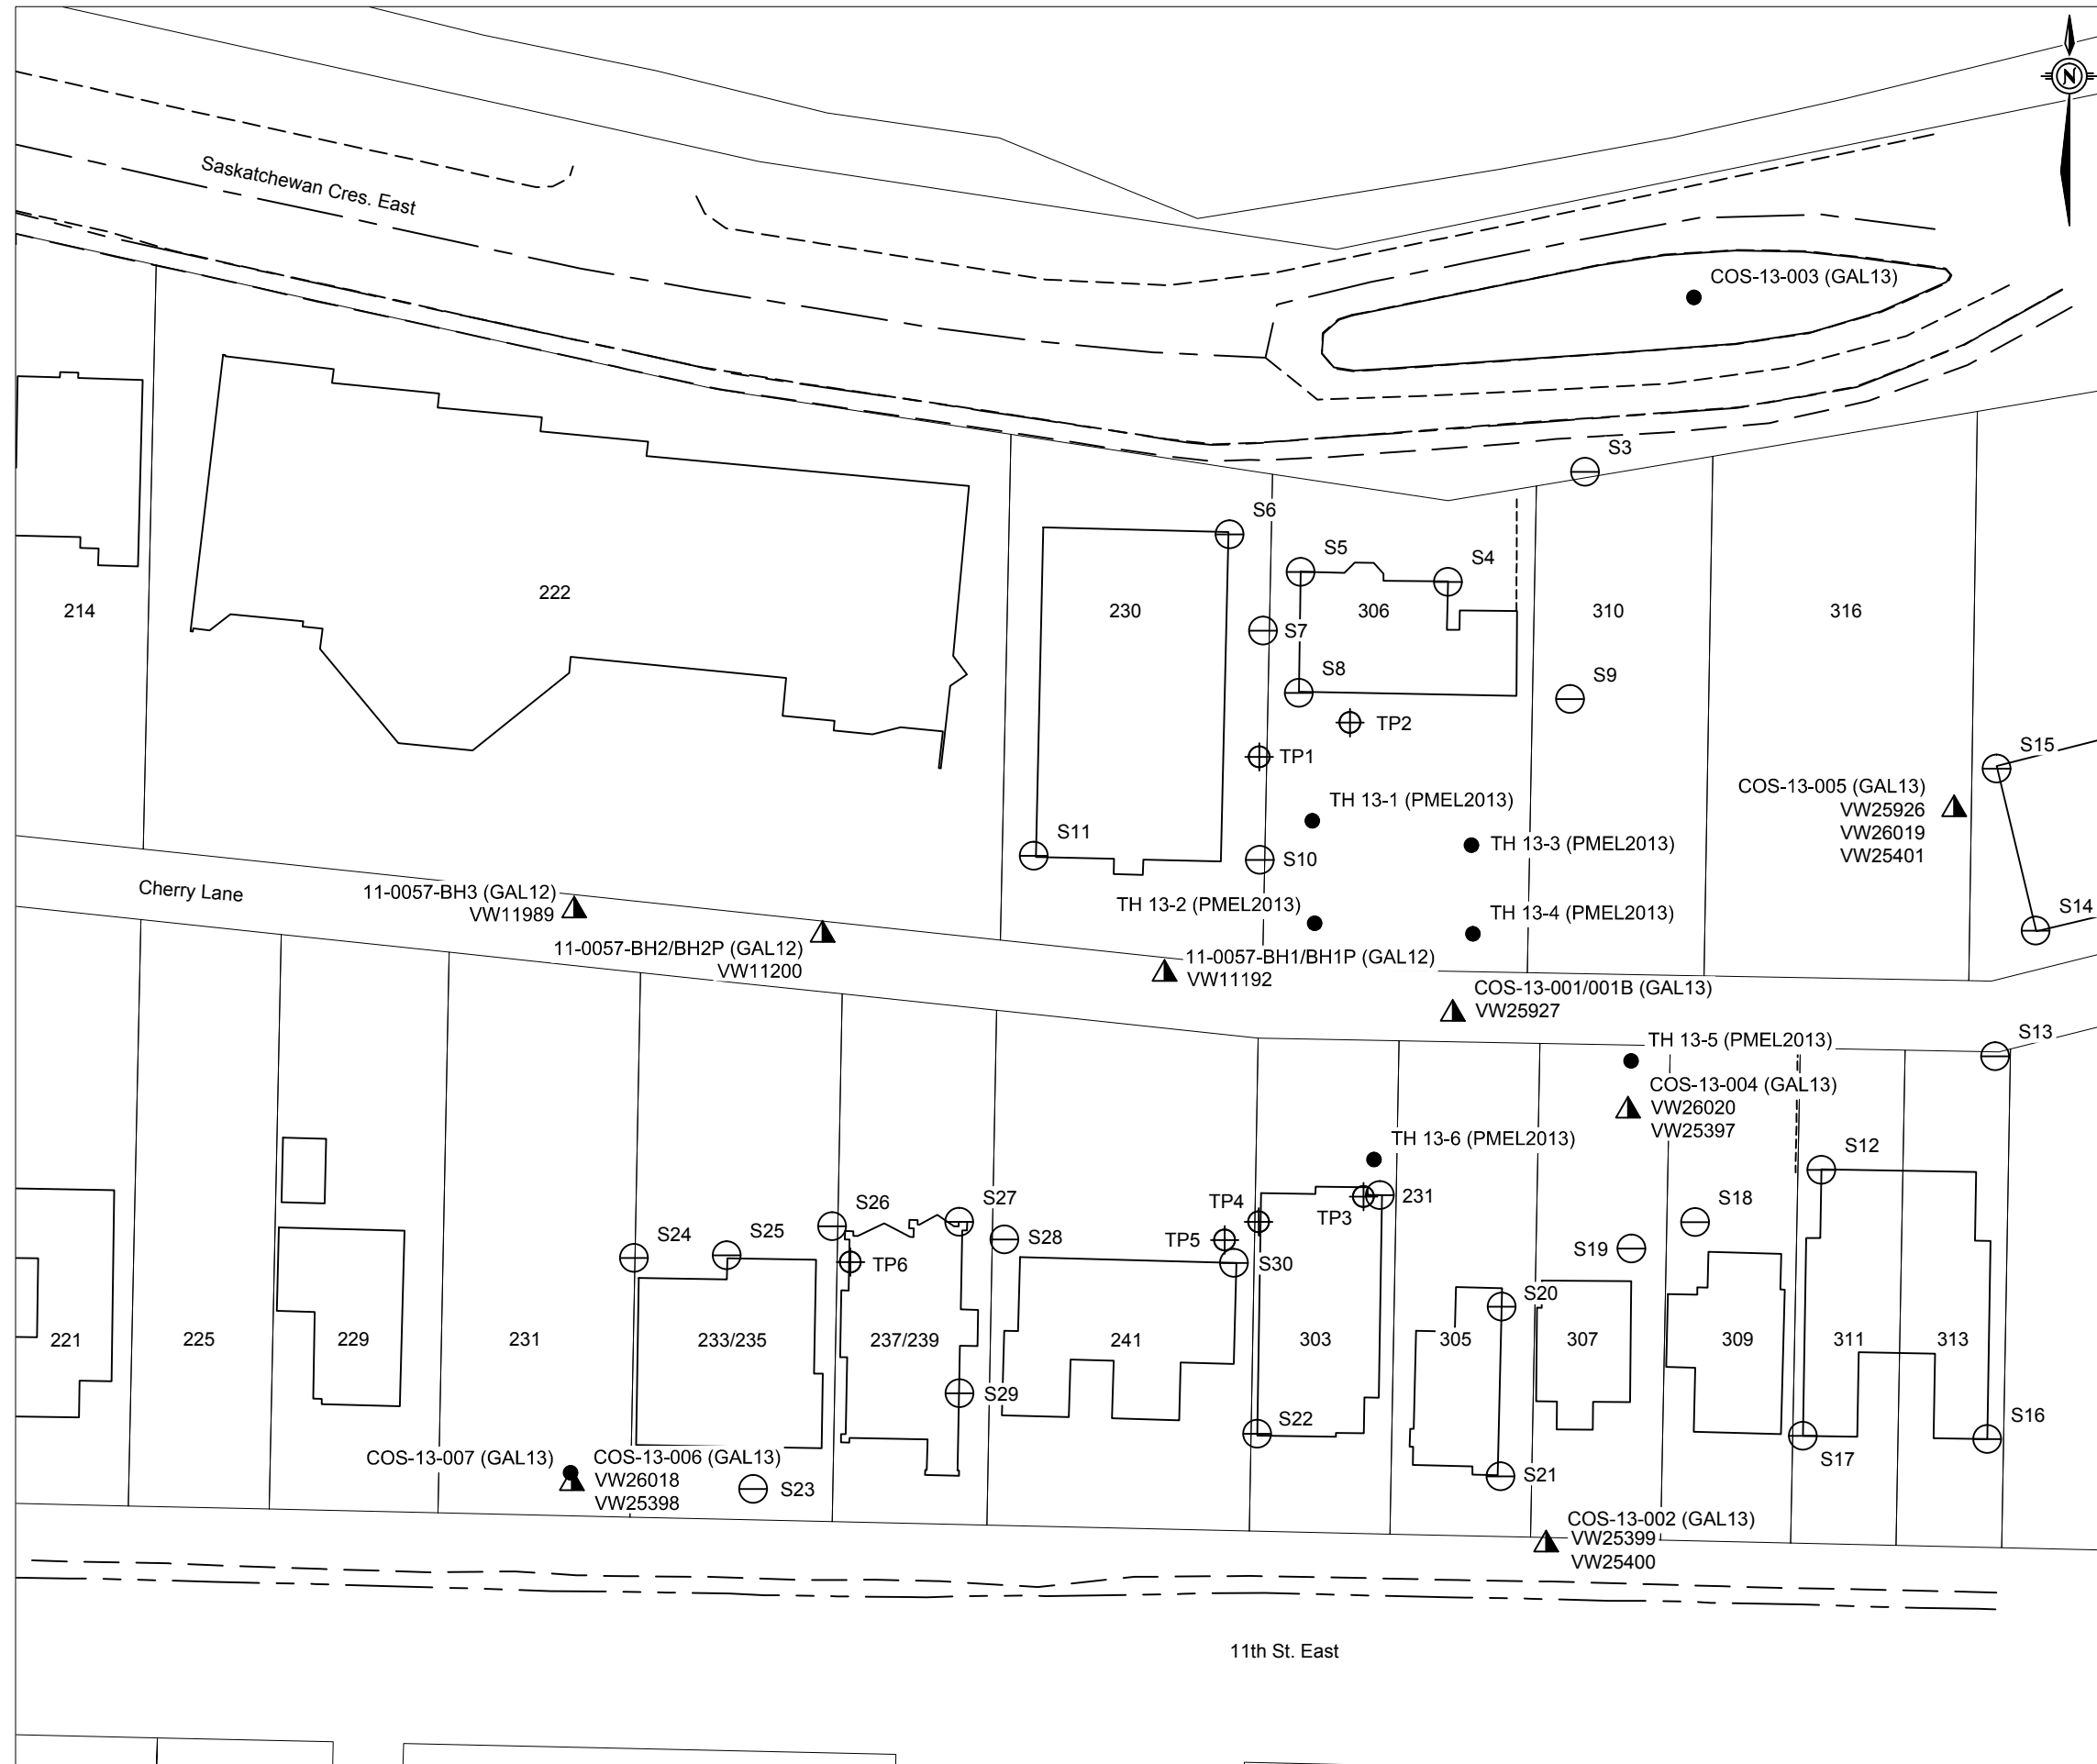
Table 3 provides a summary of installed downhole instrumentation, locations of boreholes are shown in Figure 2, and locations of installed instrumentation are shown in Figure 8. Borehole records and instrumentation installation details are provided in Appendix E.

The monitoring results for the slope inclinometers are included in Appendix F. Location of historical inclinometers (i.e., SI84-1CL and SI85-511) are shown in Figure 2. Location of inclinometers installed by Golder in 2012 and 2013 are shown on Figure 8.

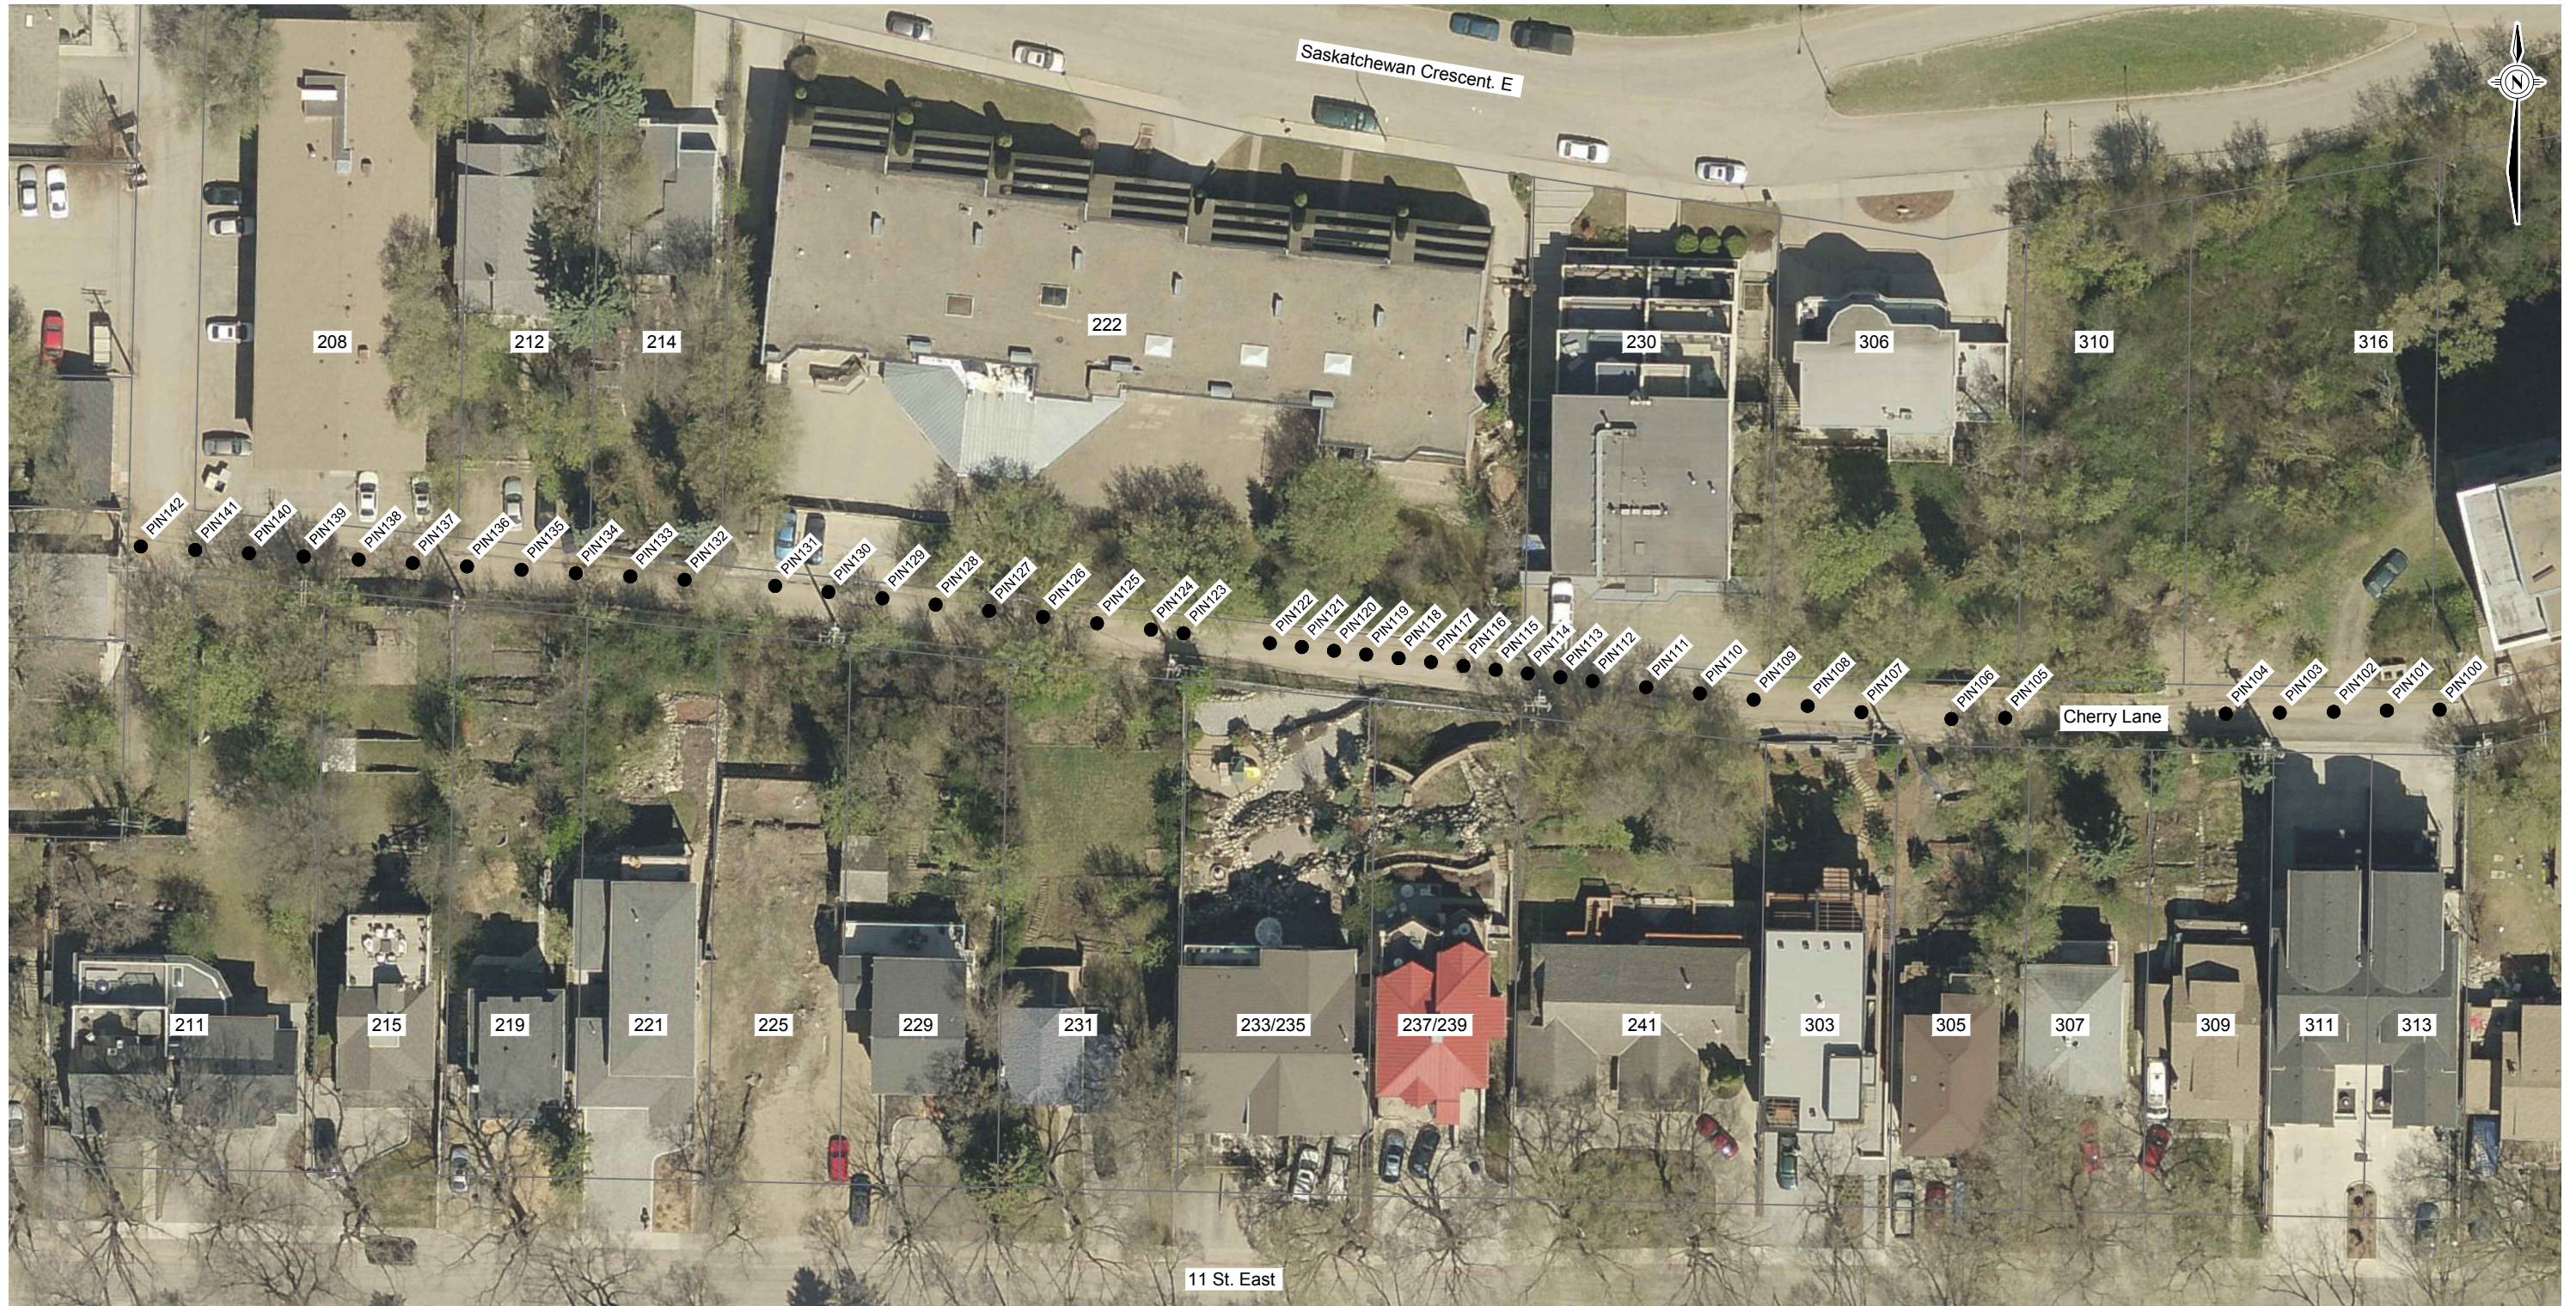
CHERRY LANE SLOPE INSTABILITY	
CHERRY LANE SURVEY PIN LOCATION PLAN - 100 SERIES PINS (2012)			
	PROJECT	11-1362-0057	FILE No.
	DESIGN	LM 08/05/14	SCALE AS SHOWN REV. 0
	CADD	JDS 08/05/14	
	CHECK	HV 08/05/14	
	REVIEW	PGB 08/05/14	
FIGURE: 9

Survey Pins 100 to 142 (Figure 9) were installed on June 28, 2012, along Cherry Lane at approximately 5 m intervals, to monitor the slope movement along the lane using a survey line. This series of pins was surveyed from July 4, 2012 to June 4, 2013. Horizontal movement of this series of survey pins was monitored every third day from June 28 to August 2, 2012; the rate of movement then reduced, and the frequency of monitoring was reduced to weekly. Cumulative horizontal movements and rates of movement between June 28, 2012 and June 4, 2013 are shown in Figure 20 and Figure 21, respectively.

Figure 22 presents the results of GPS survey of the 100 series pins between June 28, 2012 and June 27, 2013 for the Cherry Lane at the East Failure. The results show 765 mm of horizontal movement for Pin 106, 555 mm for Pin 107, and 366 mm for Pin 108. Most of these movements occurred in June 2013 because less than 5 mm of movement was measured by line survey for this location up to June 4, 2013 (Figure 20).

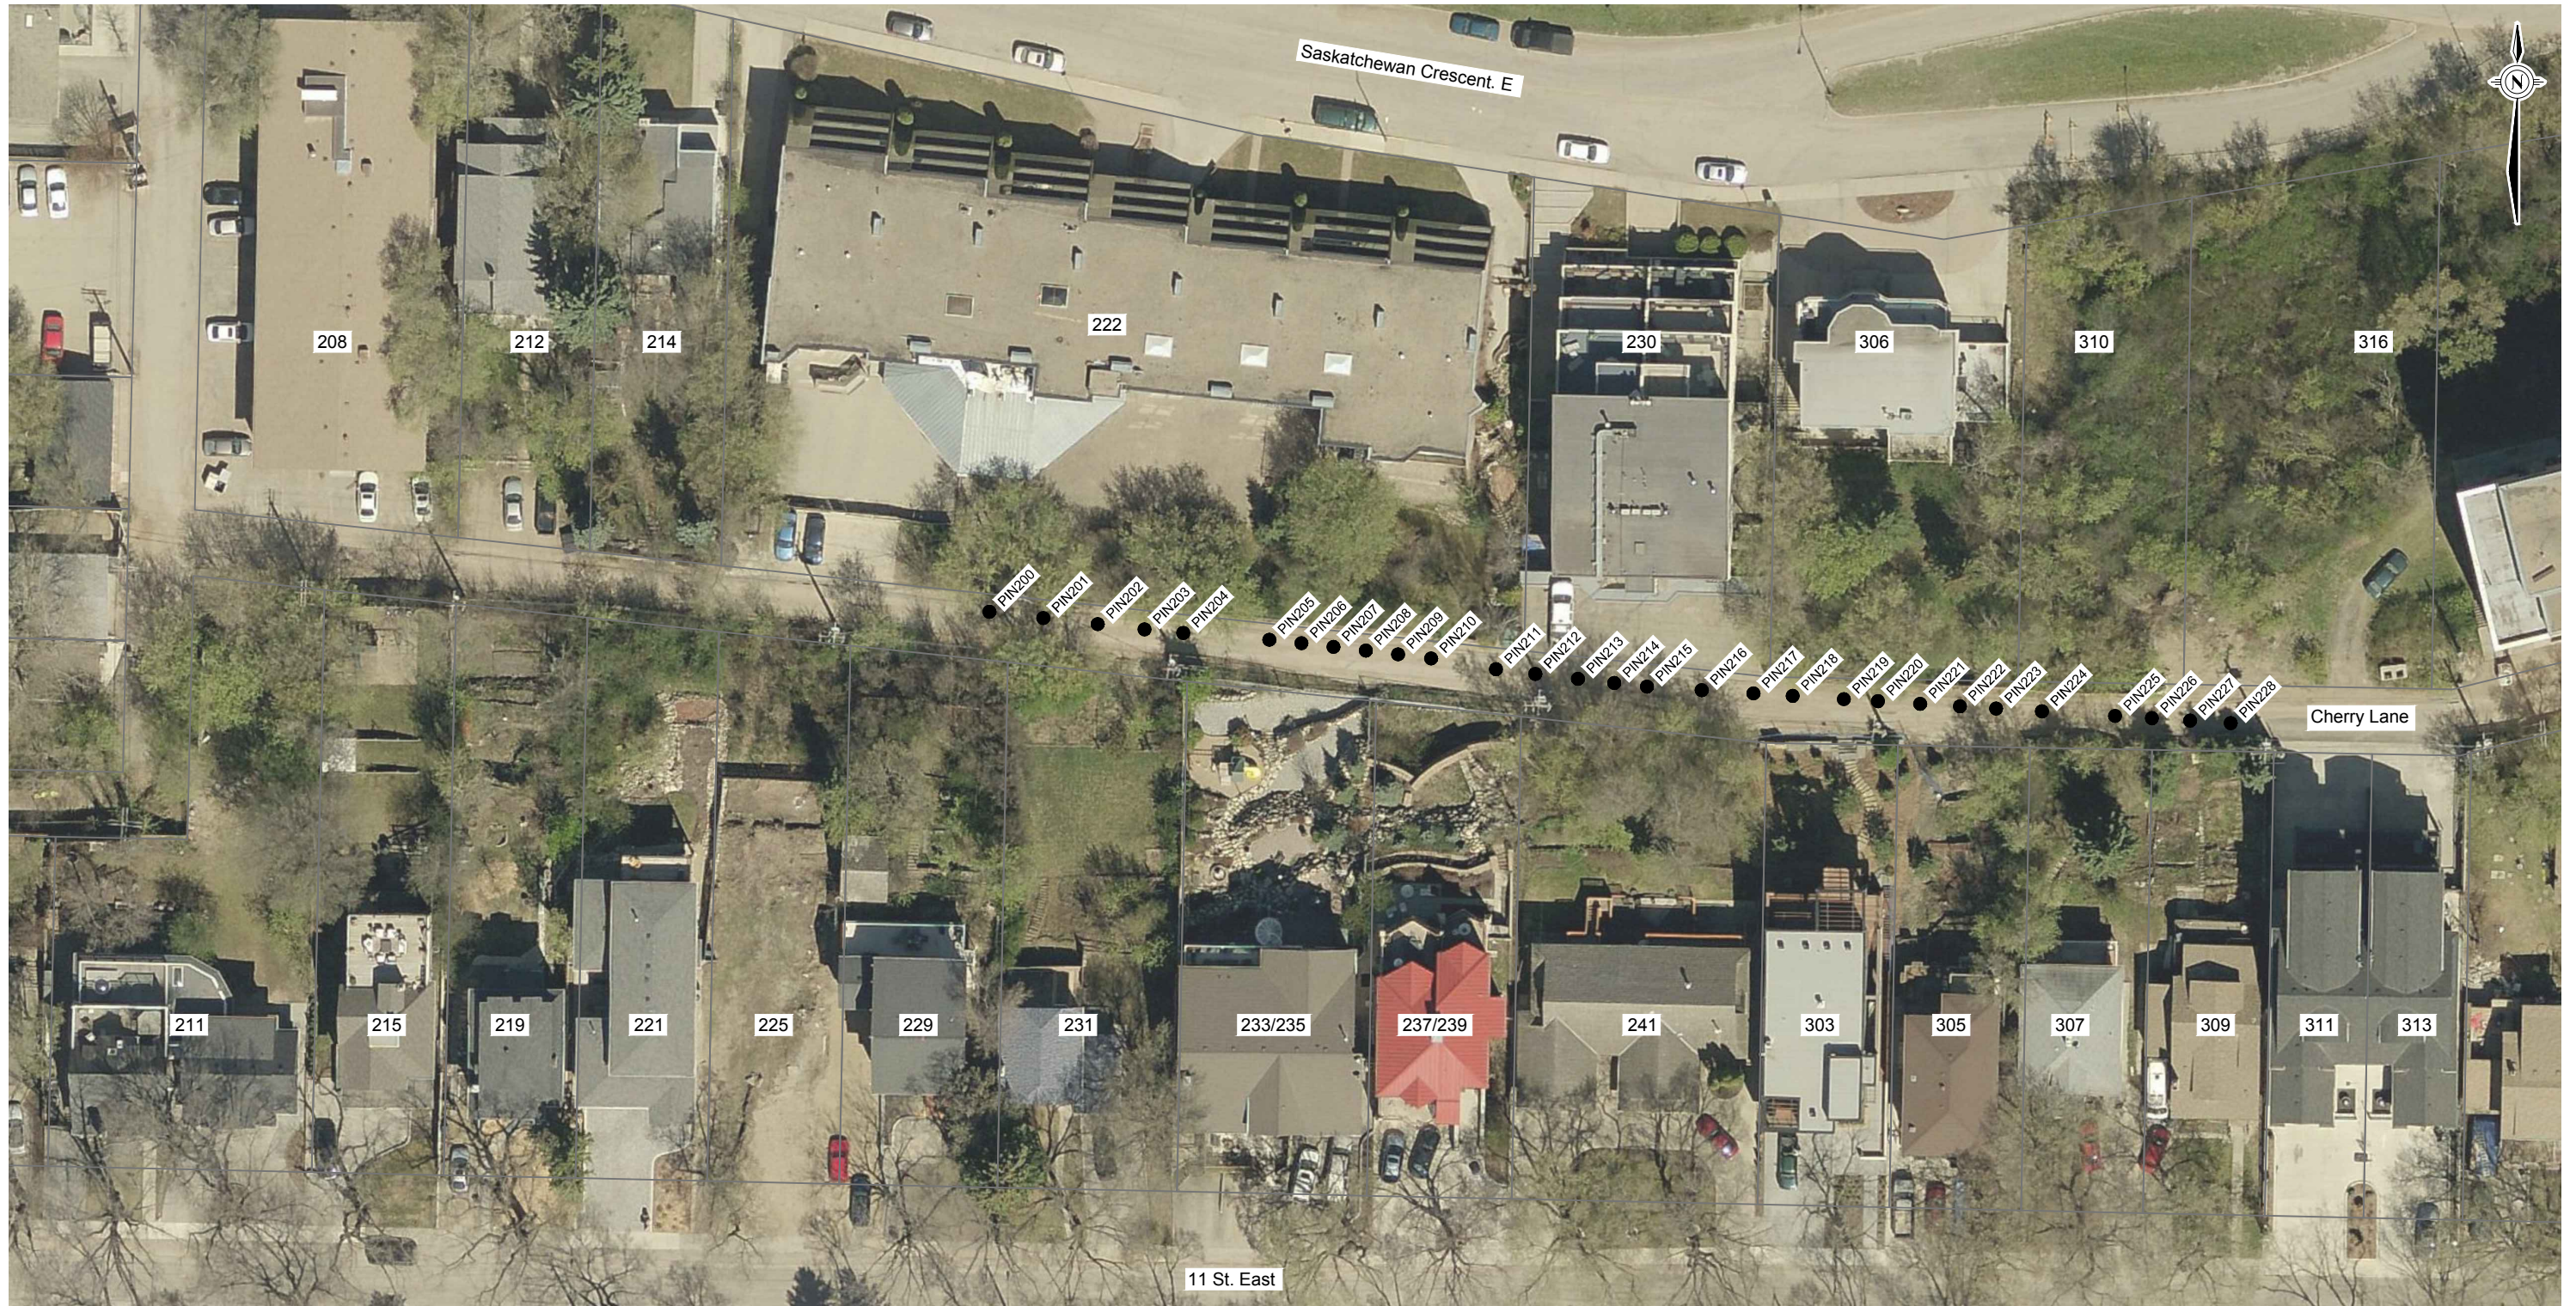
PROJECT		CHERRY LANE SLOPE INSTABILITY	
TITLE			
CHERRY LANE SURVEY PIN LOCATION PLAN - 200 SERIES PINS (2013)			
PROJECT		11-1362-0057	FILE No.
DESIGN	LM	08/05/14	SCALE AS SHOWN REV. 0
CADD	JDS	08/05/14	FIGURE: 10
CHECK	HV	08/05/14	
REVIEW	PGB	08/05/14

The 100 series pins were replaced with Survey Pins 200 to 228 (Figure 10) to monitor horizontal slope movement along the Cherry Lane. This series of pins was surveyed from June 25 to September 11, 2013. Cumulative horizontal movements and rates of movement during this period are shown in Figure 23 and Figure 24, respectively. A summary of the ground movement monitoring for this series of survey pins is as follows:

- Monitoring results show that a 45 m section of Cherry Lane, from Pin 202 to Pin 213, was impacted within the West Failure area and a 35 m section of Cherry Lane, from Pin 218 to Pin 226, was impacted within the East Failure area.
