**PUBLIC AGENDA
EXECUTIVE COMMITTEE**

**Wednesday, February 11, 2015, 1:00 p.m.
Council Chamber, City Hall**

Nutana Slope Failure Overview

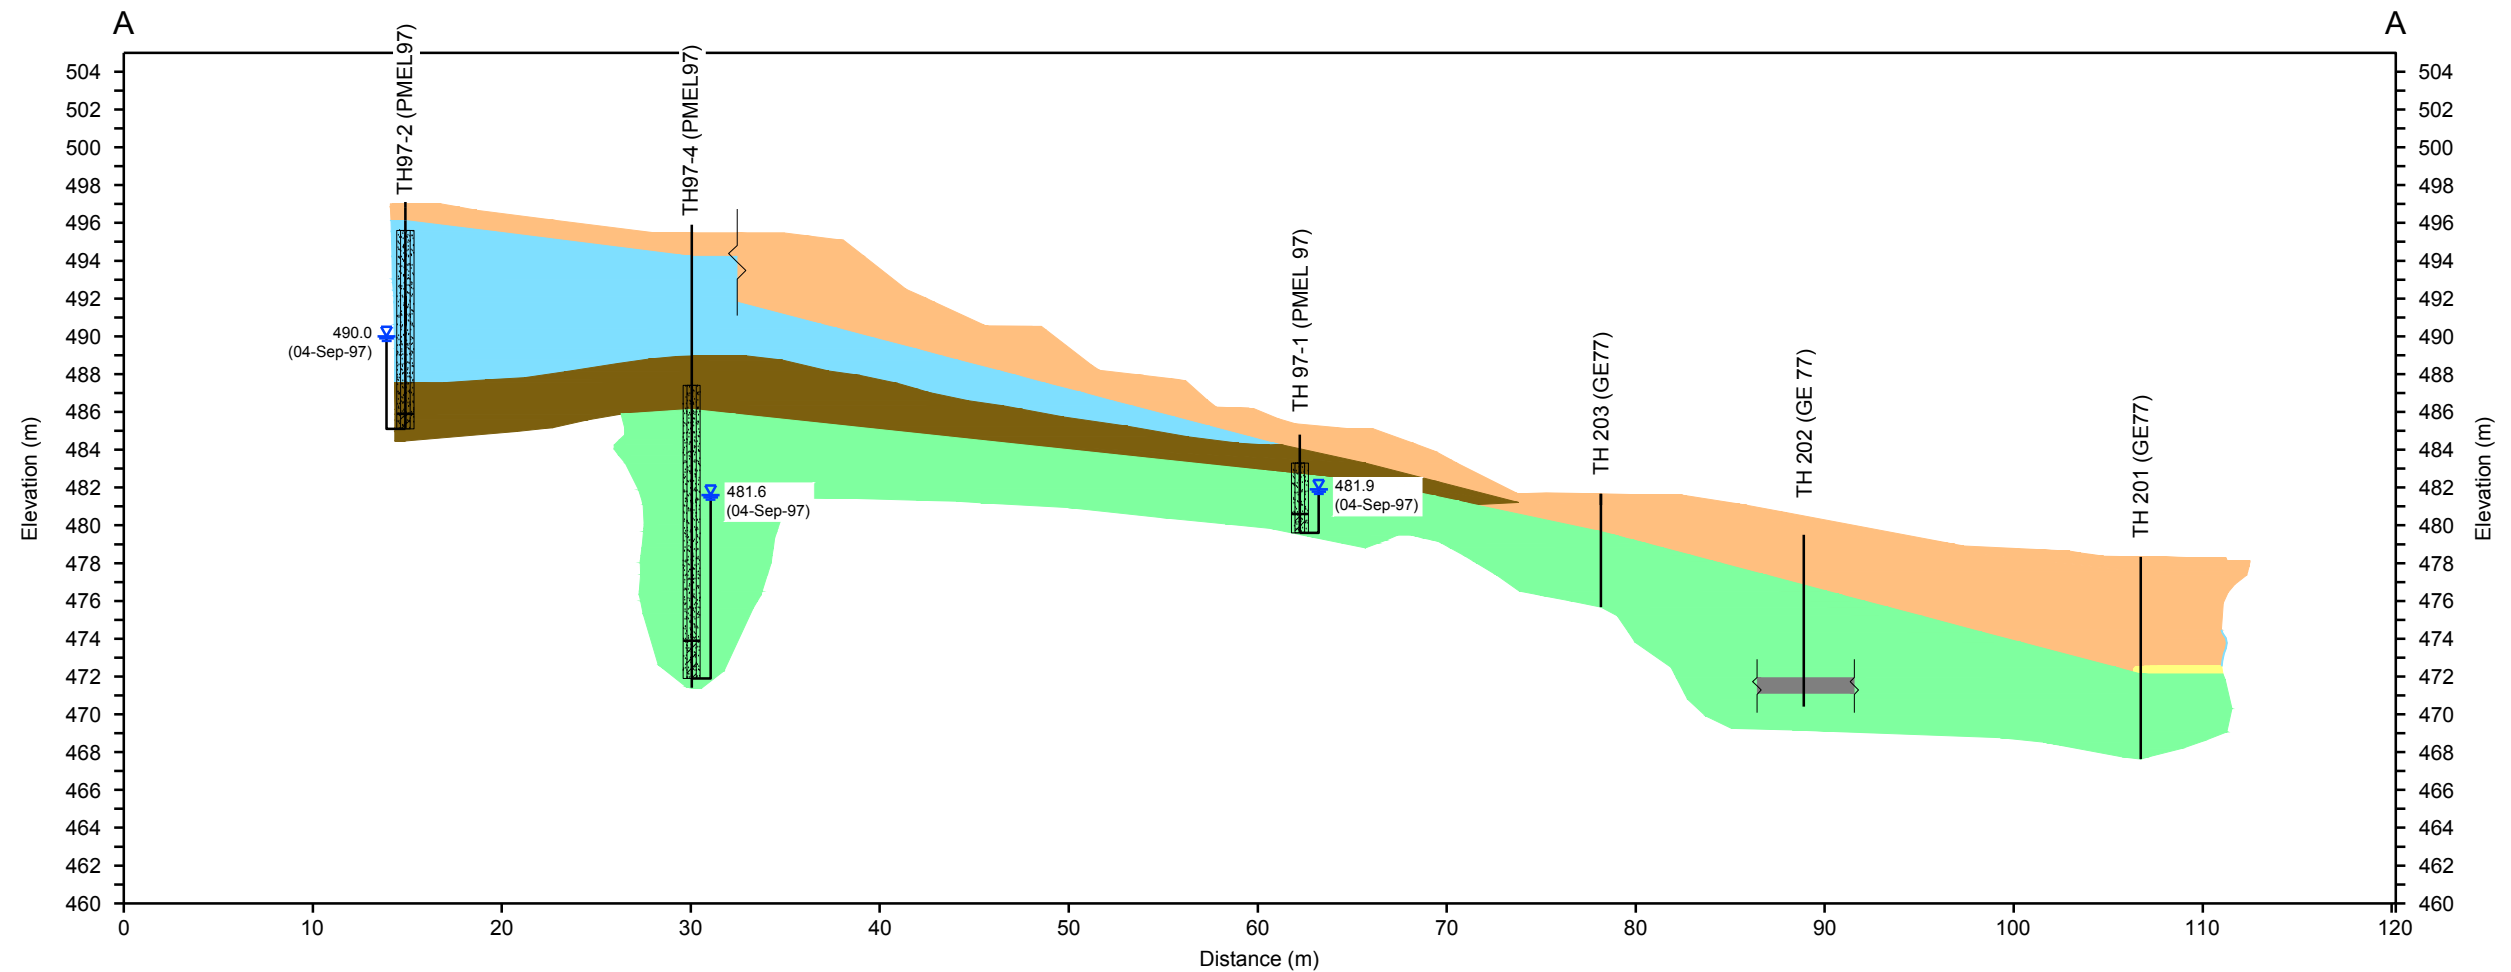
CHERRY LANE SLOPE INSTABILITY																
CROSS SECTION A-A (WEST FAILURE)																
	FIGURE: 12

Cross-sections A-A and B-B were selected as the primary section for analysis for the West Failure and East Failure, respectively. The location of the cross-sections is shown on Figure 2. Figure 12 and Figure 13 show the inferred stratigraphic soil profiles along each cross-section. Both the West Failure and East Failure were back-analysed to determine the residual (or large strain) shear strength parameters corresponding to failure or a FS of 1.0.

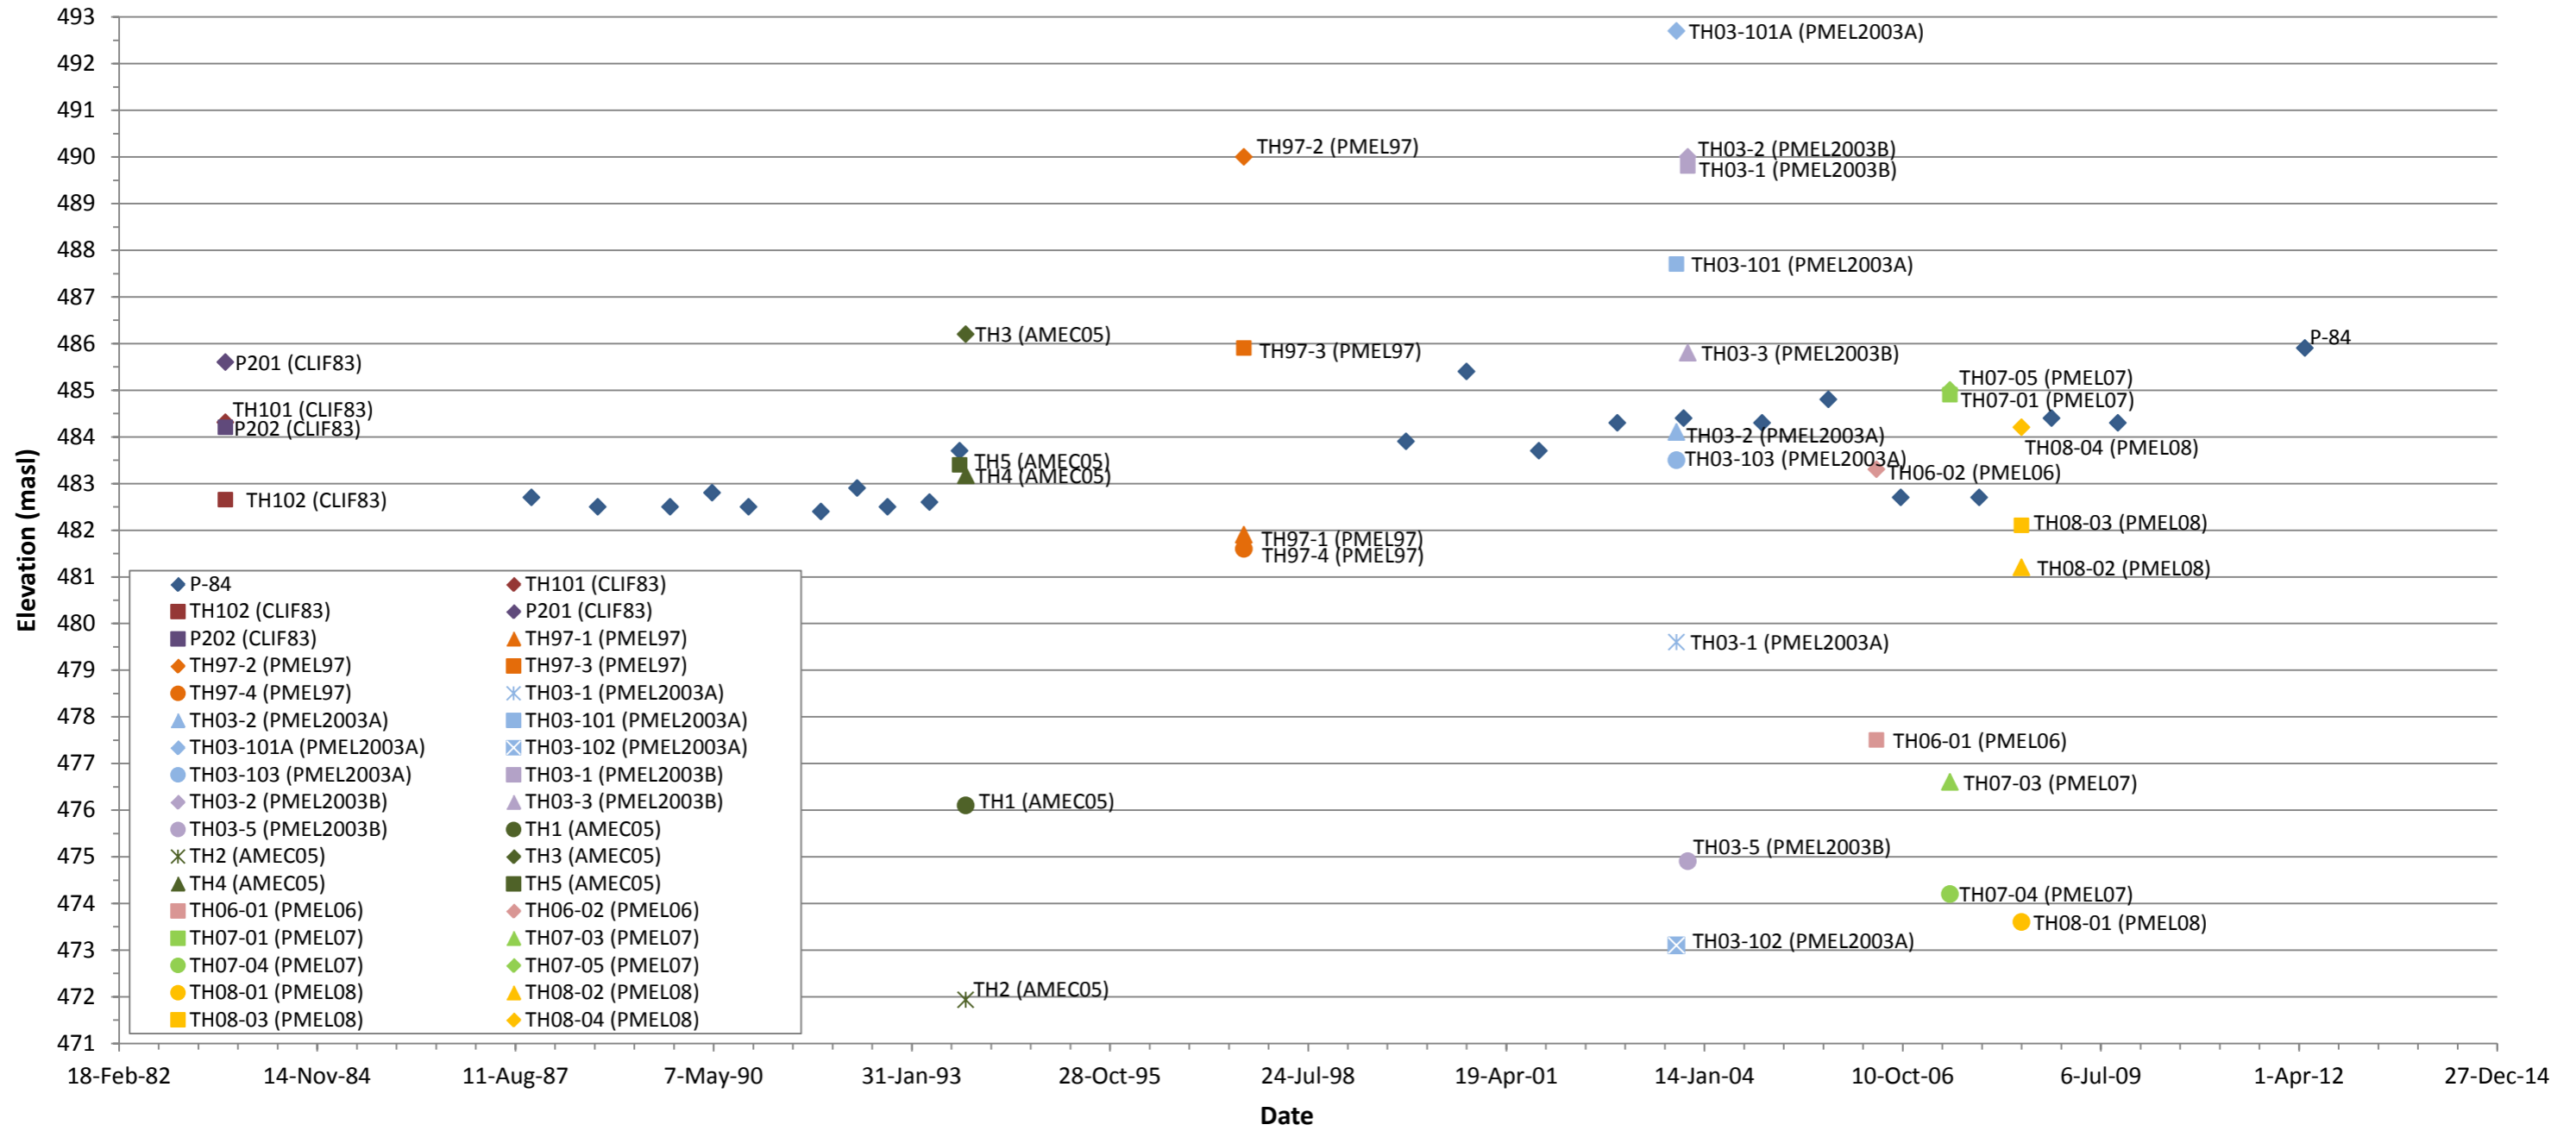
CHERRY LANE SLOPE INSTABILITY	
HISTORICAL GROUNDWATER LEVELS			
	PROJECT 11-1362-0057 DESIGN LNM 08/05/14 CADD CHECK HQV 08/05/14 REVIEW PGB 08/05/14	FILE No. SCALE N/A REV.	FIGURE: 16

Historical groundwater levels (i.e., total head) in the area of Cherry Lane were compiled from data provided in the geotechnical reports reviewed and the East River Bank Monitoring Program reports provided by AMEC (2005b, 2009, 2013), PMEL (1994) and Ireland (2000) and are summarized in Figure 16. The groundwater table slopes downwards across the site from 11th Street to the river. Adjacent to 11th Street, the water table measured in September 1997 in TH07-2 was at about elevation 489.2, approximately 7 m below the ground surface. It should be noted that all groundwater elevations taken from the PMEL (1997) report have been converted from a local elevation presented in the report to be consistent with the surveyed elevations of the slope. It was noted that seepage was encountered during the August 5, 1997 investigation from sand layer at 490.3 masl in TH97-2, located in the front yard of 233/235 11th Street East.

With the exception of the data from piezometer P-84 (Figure 16), which was monitored on an annual basis from 1987 to 2012, there is insufficient data to interpret historical groundwater levels in this area. The highest groundwater elevation measured in P-84 was at 485.9 masl, or approximately 0.3 m below ground surface. It was recorded at this location in May 2012 prior to the occurrence of the West Failure. It should be noted that groundwater levels for this piezometer were generally monitored in fall or winter (October to December), when there is little recharge on ground surface and groundwater levels are expected to be at the lowest. High water table condition can be expected following spring thaw, or after heavy, prolonged precipitation during the summer.

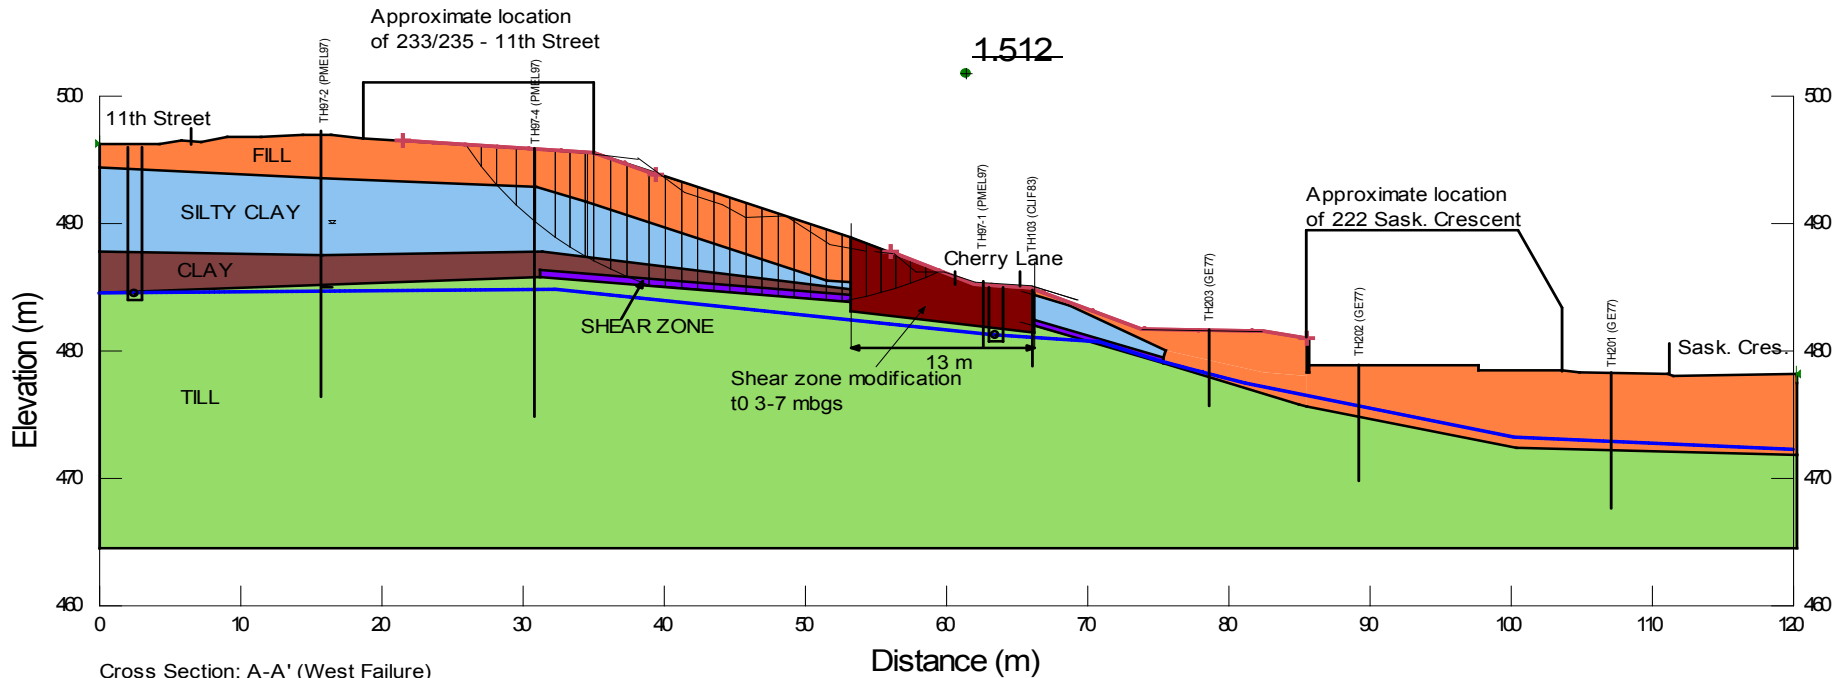
CHERRY LANE SLOPE INSTABILITY		
SLOPE STABILITY ANALYSIS CROSS SECTION A-A' SHEAR ZONE MODIFICATION OPTION				
	PROJECT	11-1362-0057	FILE No.	
	DESIGN	LNLM	08/05/14	SCALE N/A REV.
	CADD			
	CHECK	HQV	08/05/14	FIGURE: 37
REVIEW	PGB	08/05/14

Figure 37 and Figure 38 show the stability analyses for this conceptual remedial option. Figure 39 shows the plan view of the estimated extent of shear zone modification required along Cherry Lane to achieve a minimum FS = 1.5. The approximate extent of the conceptual shear zone modification area is approximately 120 m long and 4 to 13 m wide. Detailed design will refine the overall dimensions of this option.

Cross Section: A-A' (West Failure)
 File Name: AA Shear Zone Modification_v2.gsz

Installation of a drainage system will be required along 11th Street East and Cherry Lane in order to maintain long term stability of the slope with this option.

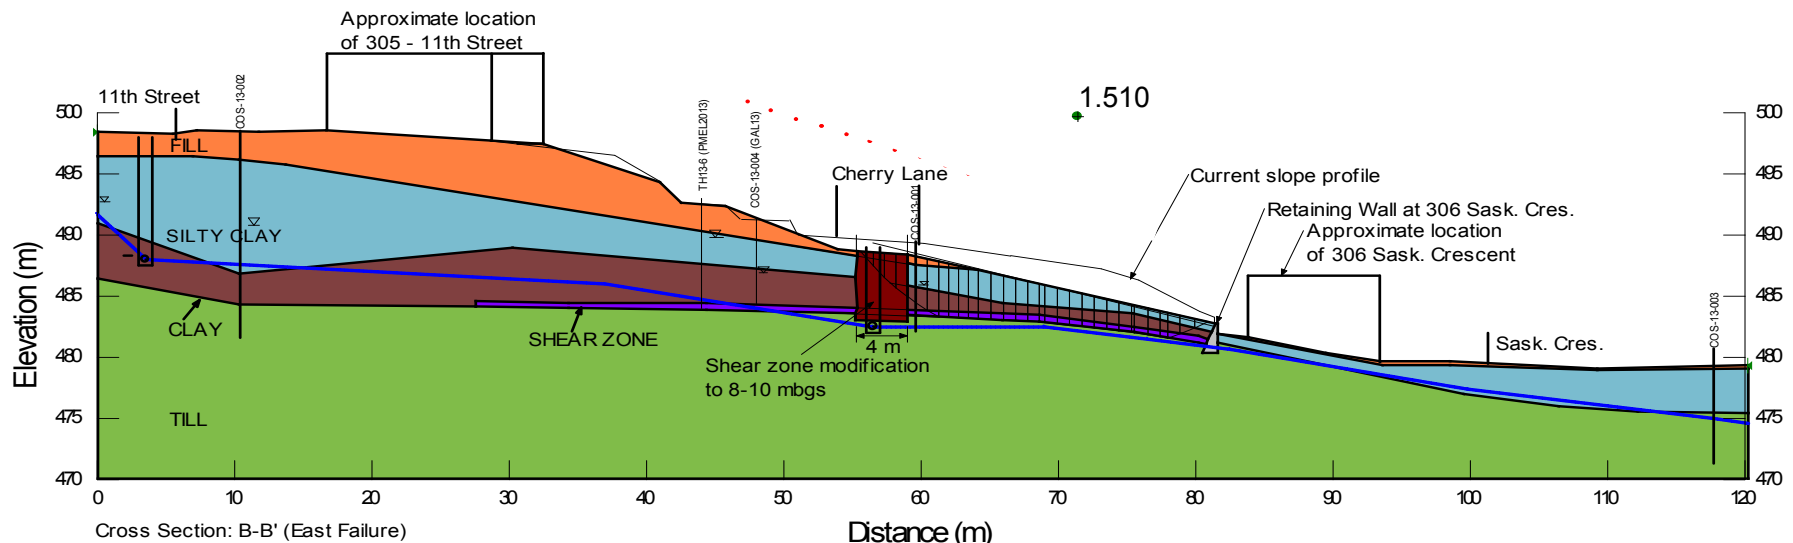
Cross Section: B-B' (East Failure)
File Name: BB Shear Zone Modification_v2.gsz

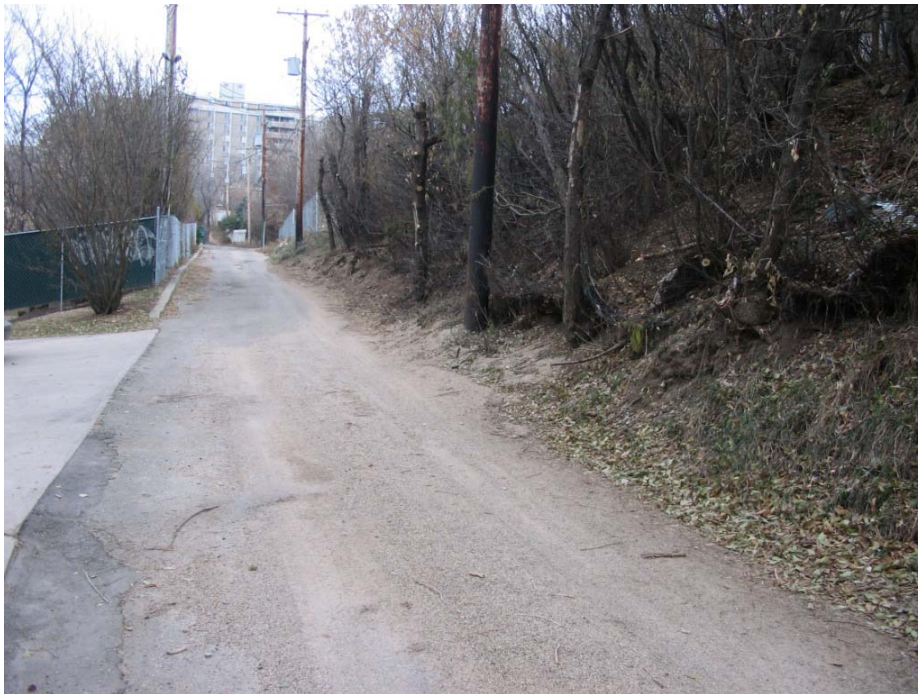
Photo C.1. Looking East at Deflection of Curb and Fence Line along Cherry Lane (Nov 5, 2006)

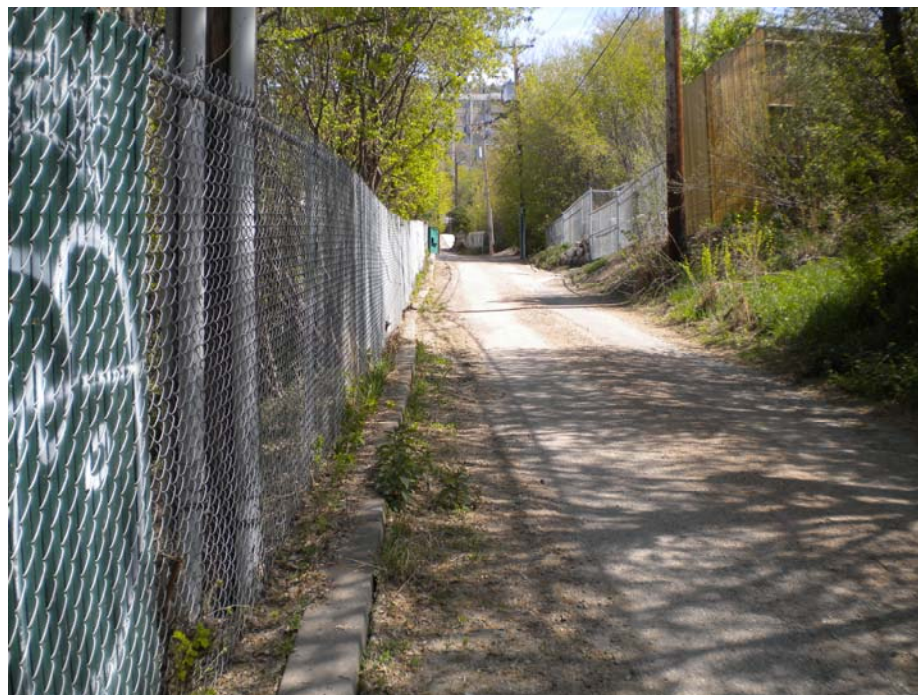
Photo C.2. Looking East at Deflection of Curb and Fence Line along Cherry Lane (May 27, 2010)

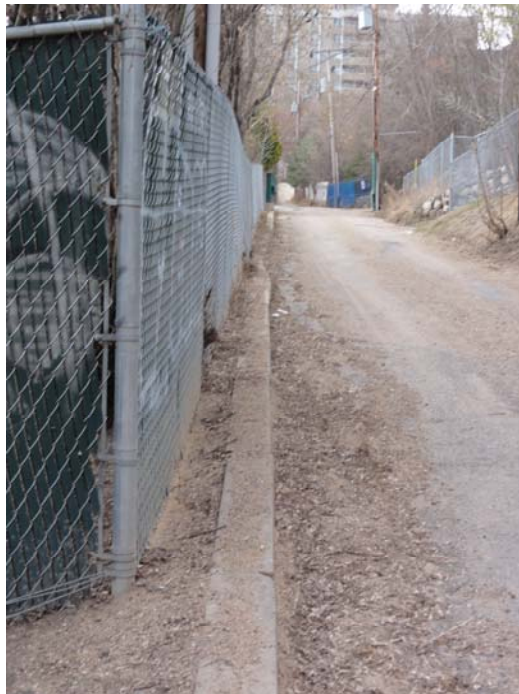
Photo C.3. Looking East at Deflection of Curb and Fence Line along Cherry Lane (April 26, 2012)

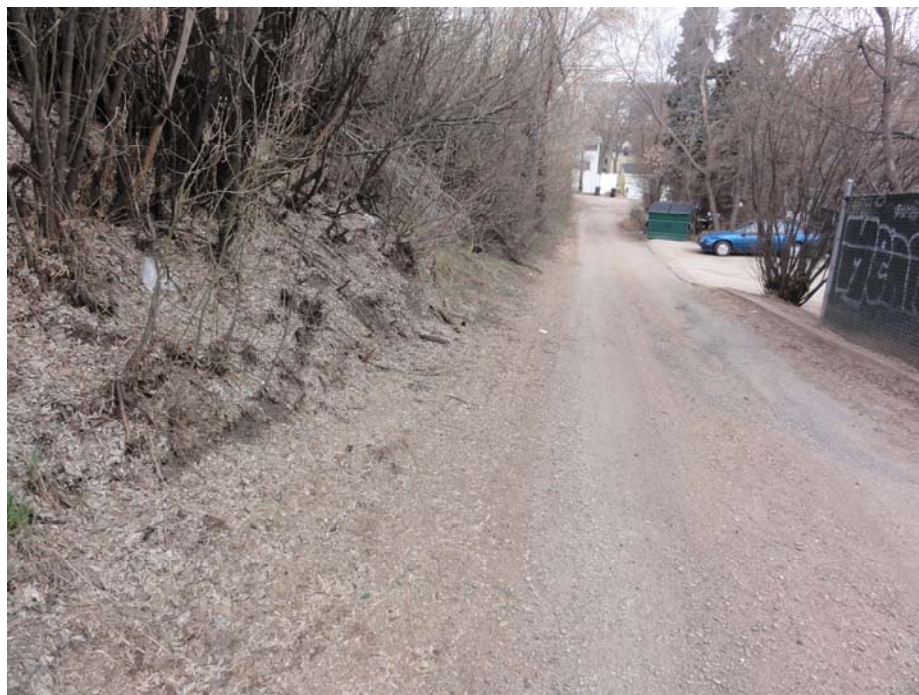
Photo C.4. Looking West at Toe of Upper Slope (April 26, 2012)

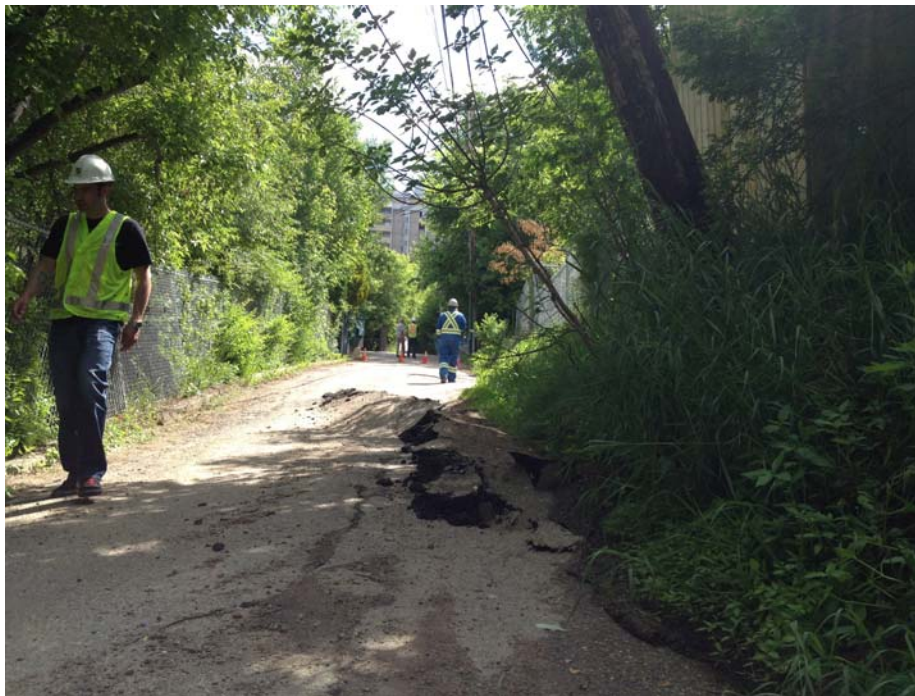
Photo C.6. Bulging Toe of Slide on Cherry Lane (June 21, 2012)

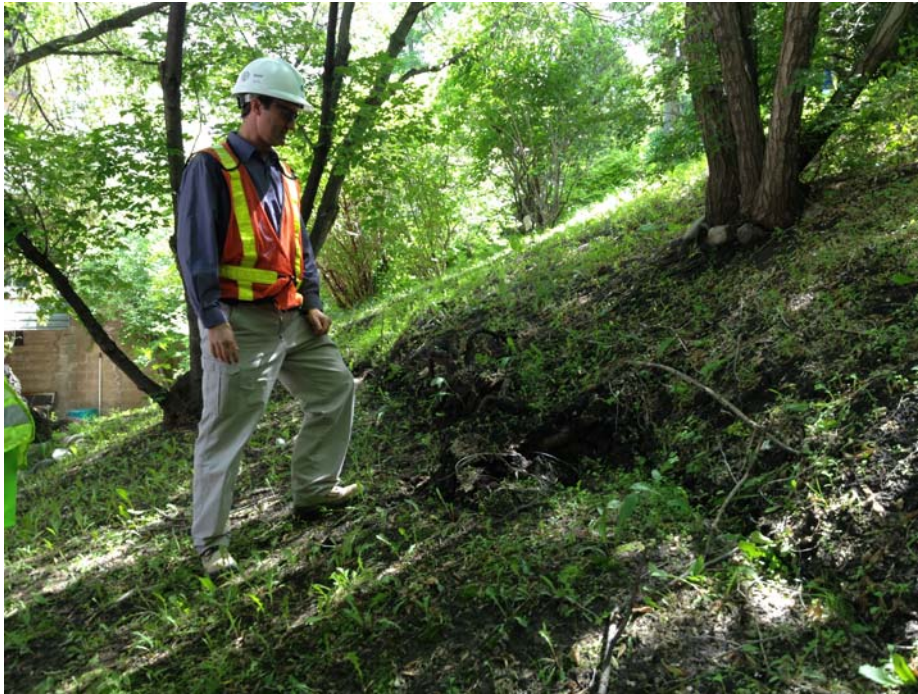
Photo C.7. Bulging Toe of Slide below Cherry Lane (June 21, 2012)

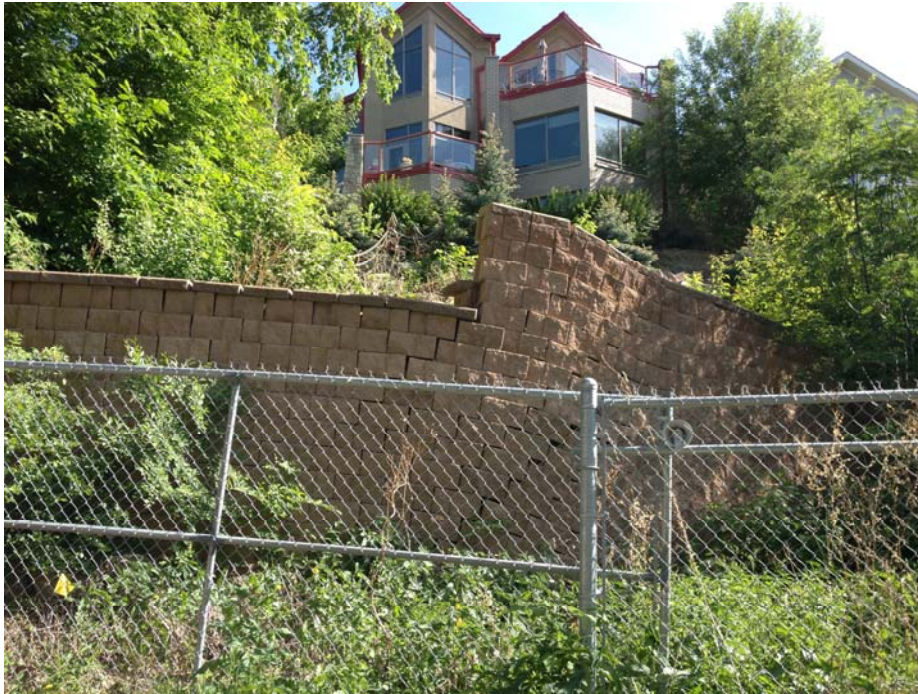
Photo C.17. Retaining Wall in Backyard of 237-239 11th St. E. (June 4, 2013)

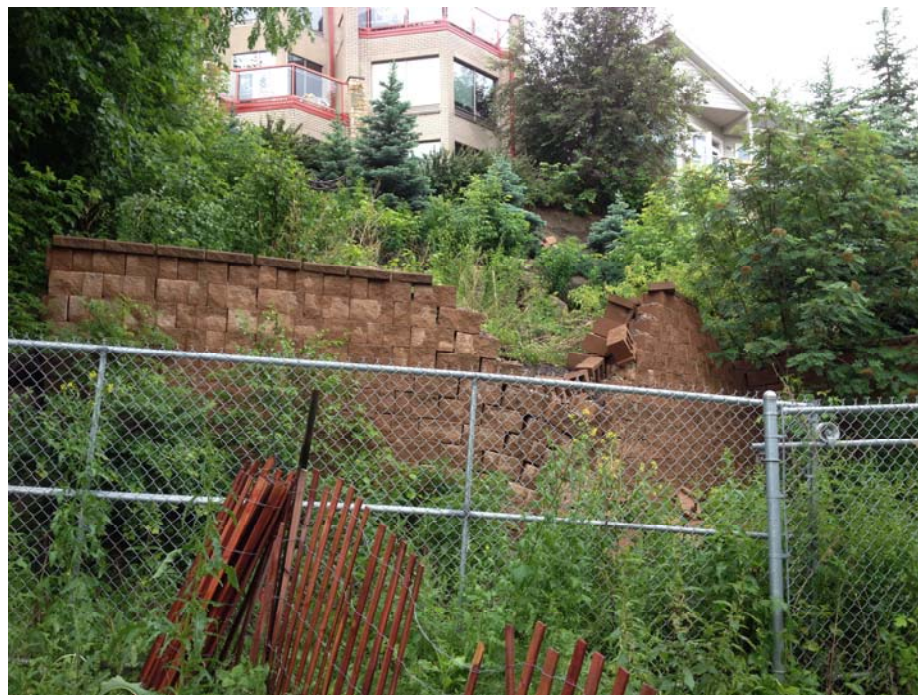
Photo C.18. Retaining Wall in Backyard of 237-239 11th St. E. (June 20, 2013)

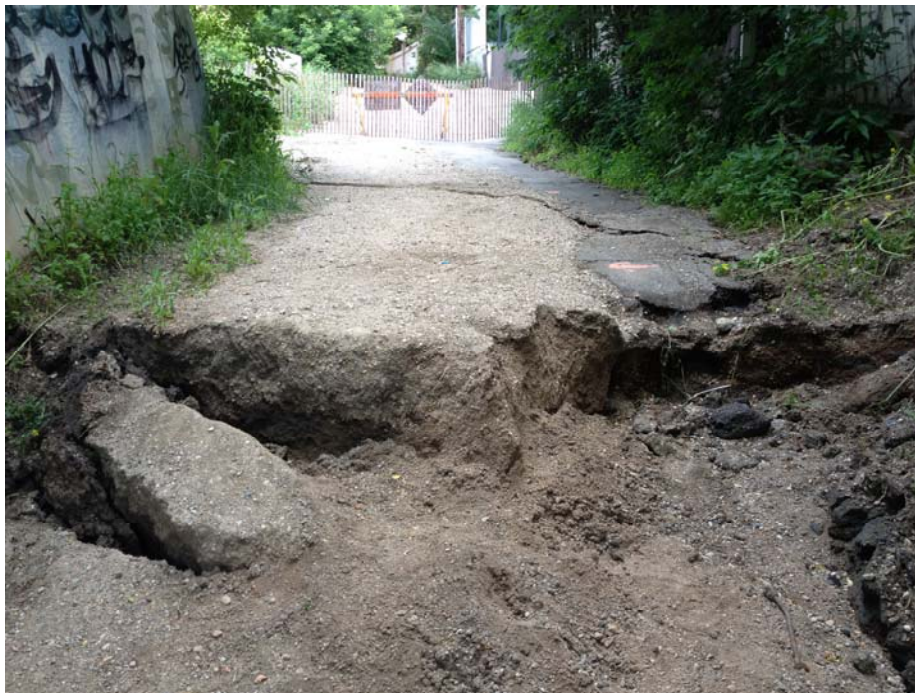
Photo C.20. Looking East at Drop in Pavement behind 305 11th St. E.; Approx 53 cm Drop (June 4, 2013)

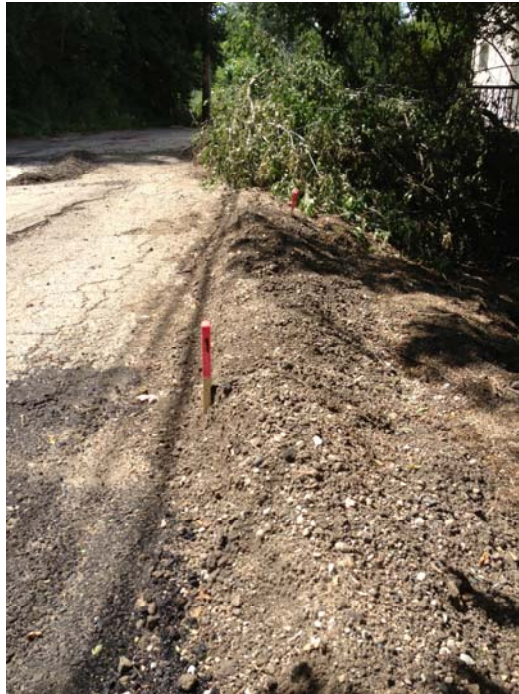
Photo C.23. Looking West at Berm Along North Edge of Cherry Lane, behind 306 Sask. Cres. E. (July 7, 2013)

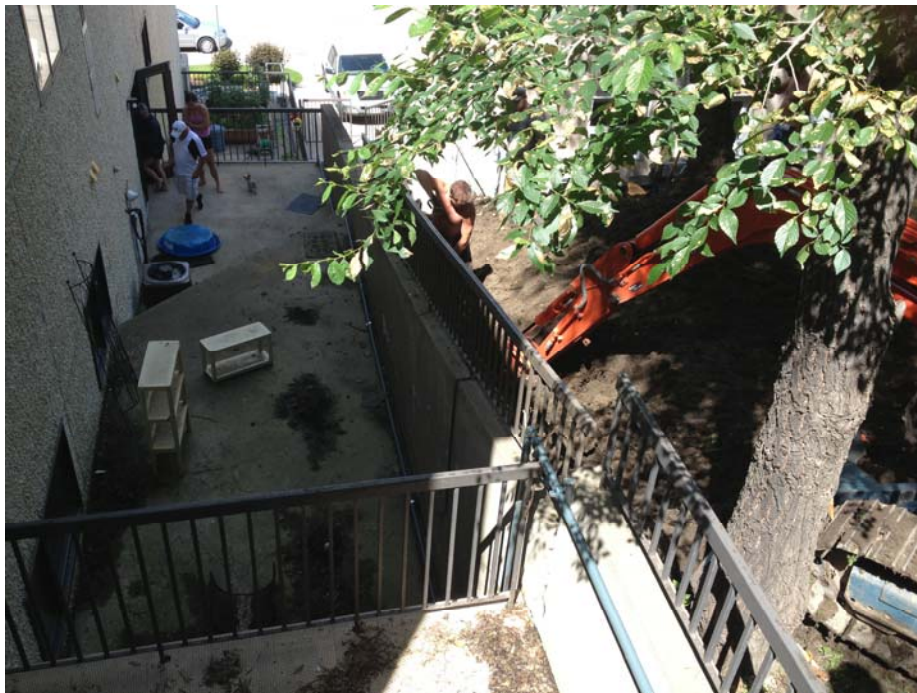
Photo C.24. Looking Northeast at Trench being Excavated Adjacent to Wall between 230 & 306 Sask. Cres. E. (July 7, 2013)

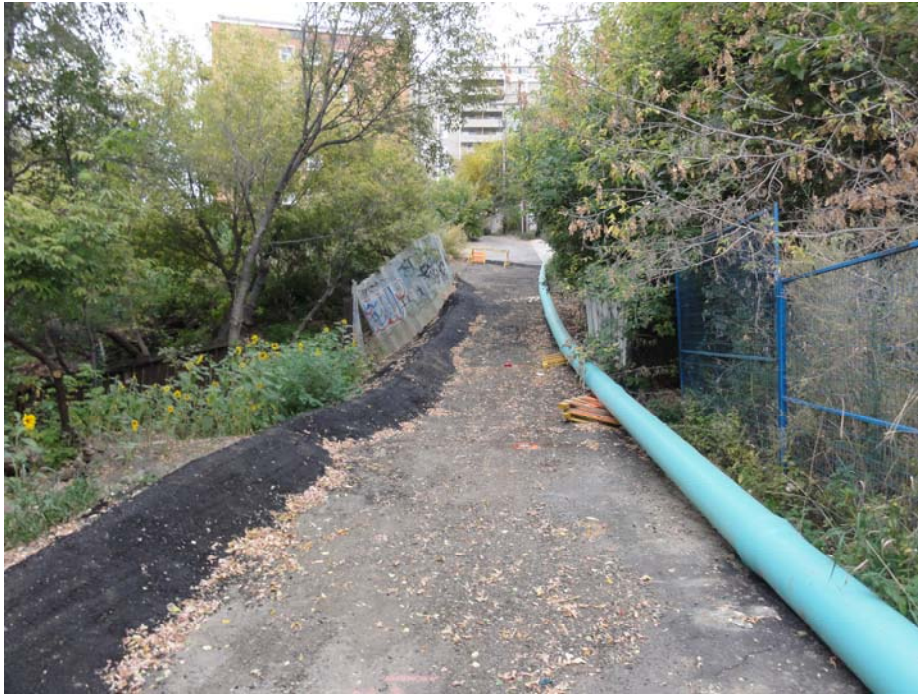
Photo C.29. Looking East at Above Ground Driantage System Installed on Cherry Lane (September 18, 2013)
