Span 5

Traffic Bridge  
Span #5 175'-0" Truss

## 2010 Traffic Bridge Inspection

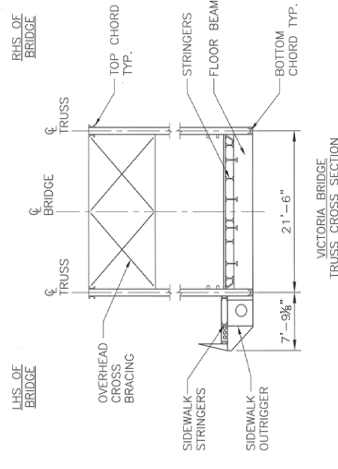
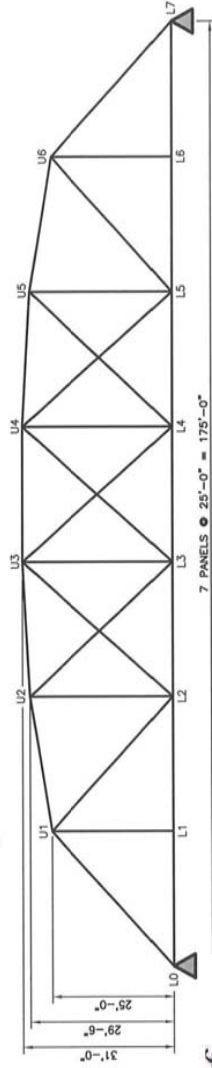
Member	Designation	Fracture Critical	Defects	Performance Deficiency	Photo's
LO - U1	RHS UPPER CHORD	Yes	Minor permanent deformations. Localized medium corrosion with light corrosion throughout.	0	
LO - U1	LHS UPPER CHORD	Yes	Minimal localized medium to severe corrosion with light corrosion throughout.	0	
LO - L1	RHS LOWER CHORD	Yes	Localized medium to severe corrosion with perforations near L1 and light corrosion throughout.	1	1
LO - L1	LHS LOWER CHORD	Yes	Localized medium to severe corrosion with perforations and light corrosion throughout. Up to 20% section loss.	1	
L1 - U1	RHS VERTICAL	Yes	Localized medium to severe corrosion with light corrosion throughout.	1	
L1 - U1	LHS VERTICAL	Yes	New plates bolted to flange of angle, which nearly has complete section loss. Plates have localized medium corrosion with light corrosion throughout and original angle has localized medium to severe corrosion with light corrosion throughout.	1	2, 3

L0	RHS CONNECTION	Yes	Localized medium to severe corrosion on heads of rivets. Gusset plate has localized medium to severe corrosion and light corrosion throughout.	0	
L0	LHS CONNECTION	Yes	Localized medium to severe corrosion with light corrosion throughout.	0	
L1	RHS CONNECTION	Yes	Localized medium to severe corrosion with significant loss of section on heads of rivets. Extensive pack rust surrounding clip angles. Pack rust has resulted in the misalignment of the angle. Gusset plate has localized medium to severe corrosion and light corrosion throughout. All pack rust was not removed from connection.	1	
L1	LHS CONNECTION	Yes	Localized medium to severe corrosion with significant loss of section on heads of rivets. Extensive pack rust surrounding clip angles. Pack rust has resulted in the misalignment of the angle. Gusset plate has localized medium to severe corrosion and light corrosion throughout. All pack rust was not removed from connection.	1

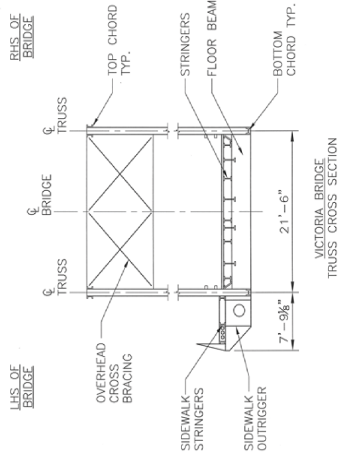
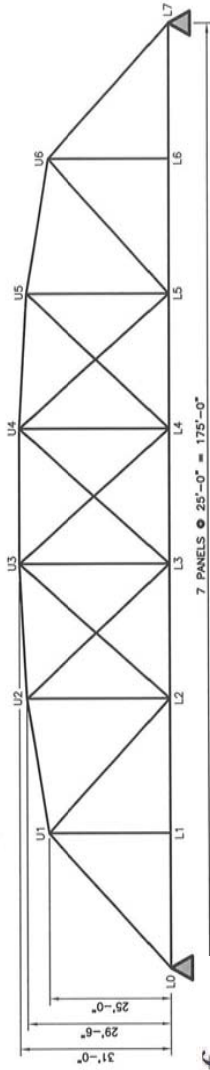
Member	Designation	Fracture Critical	Defects	Performance Deficiency	Photo's
L0 - L1	BELOW DECK STRINGER #8	No	Top flange has localized light to severe corrosion with light corrosion throughout.	0	
L0 - L1	BELOW DECK STRINGER #9	No	Localized medium to severe corrosion on top and bottom flange with light corrosion throughout.	0	
L0 - L1	BELOW DECK CROSS BRACING	No	Light to severe corrosion with perforations on gusset plates and light corrosion throughout.	1	4
U1	PORTAL BRACING	No	Light corrosion throughout. Appears to be functioning as intended.	0

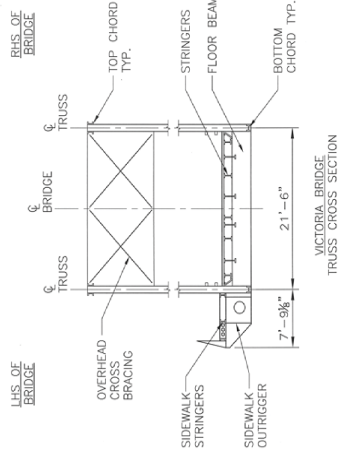
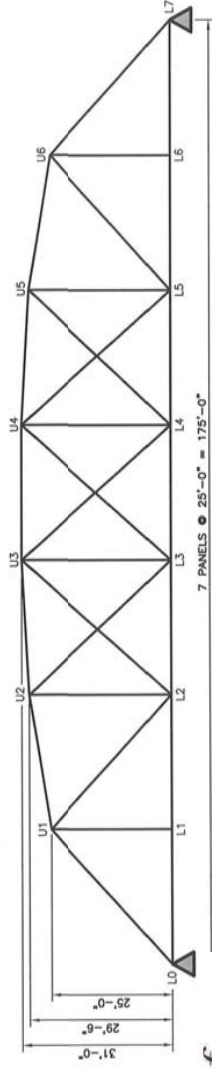
Member	Designation	Fracture Critical	Defects	Performance Deficiency	Photo's
U1 - U2	RHS UPPER CHORD	Yes	Localized medium corrosion with light corrosion throughout.	0	
U1 - U2	LHS UPPER CHORD	Yes	Localized medium corrosion with light corrosion throughout.	0	
L1 - L2	RHS LOWER CHORD	Yes	Localized medium to severe corrosion with perforations at L2. All pack rust was not removed from member.	1	5, 6
L1 - L2	LHS LOWER CHORD	Yes	Localized medium to severe corrosion with light corrosion throughout.	1	
L2 - U2	RHS VERTICAL	Yes	Member is misaligned due to rust jacking between outer channel and outer gusset plate at lower connection. Localized medium to severe corrosion with light corrosion throughout.	1	
L2 - U2	LHS VERTICAL	Yes	Minor permanent deformations. Localized medium to severe corrosion with perforations on inner channel web. Approximately 60% of the original section remains, therefore elements ability to withstand design loads is greatly in question.	1

U1 - L2	RHS DIAGONAL	Yes	Localized medium to severe corrosion with light corrosion throughout.	1	
U1 - L2	LHS DIAGONAL	Yes	Localized medium to severe corrosion with light corrosion throughout. Member is misaligned potentially due to overstressing.	1	
L2	RHS CONNECTION	Yes	Localized medium to severe corrosion with significant loss of section on heads of rivets. Extensive pack rust surrounding clip angles. Pack rust has resulted in the misalignment of the angle. Gusset plate has localized medium to severe corrosion and light corrosion throughout. All pack rust was not removed from connection.	1	
L2	LHS CONNECTION	Yes	Localized medium to severe corrosion with significant loss of section on heads of rivets. Extensive pack rust surrounding clip angles. Pack rust has resulted in the misalignment of the angle. Gusset plate has localized medium to severe corrosion and light corrosion throughout. All pack rust was not removed from connection.	1

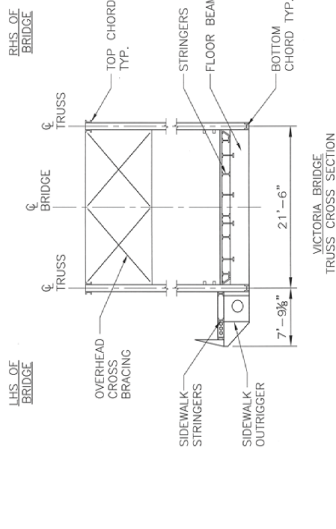
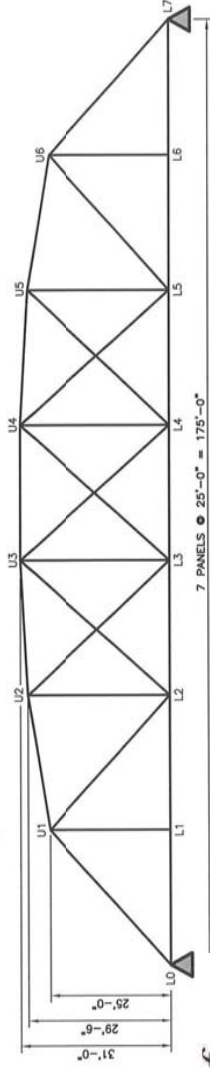
Member	Designation	Fracture Critical	Defects	Performance Deficiency	Photo's
U2 - U3	RHS UPPER CHORD	Yes	Localized medium corrosion with light corrosion throughout.	0	
U2 - U3	LHS UPPER CHORD	Yes	Localized medium corrosion with light corrosion throughout.	0	
L2 - L3	RHS LOWER CHORD	Yes	Localized medium to severe corrosion with perforations and light corrosion throughout. All pack rust was not removed from member.	1	9
L2 - L3	LHS LOWER CHORD	Yes	Localized medium to severe corrosion with light corrosion throughout. All pack rust was not removed from member. Up to 30% section loss.	1	
L3 - U3	RHS VERTICAL	Yes	Minor permanent deformations. Member is misaligned due to rust jacking between outer channel and outer gusset plate at lower connection. Localized medium to severe corrosion with perforations and light corrosion throughout.	1	
L3 - U3	LHS VERTICAL	Yes	Localized medium to severe corrosion with perforations on inside face channel web and flange. Approximately 60% of the original section remains, therefore elements ability to withstand design loads is greatly in question.	1

U2 - L3	RHS DIAGONAL	Yes	Bottom portion of member has been replaced. Localized medium corrosion with light corrosion throughout.	0	
U2 - L3	LHS DIAGONAL	Yes	Localized medium to severe corrosion with perforations at wearing surface elevation. Member is misaligned potentially due to overstressing and twisting due to rust jacking between stitch plates and angles.	1	
L2 - U3	RHS DIAGONAL	Yes	Member is highly vibratory under live loads, member is misaligned. Localized medium to severe corrosion with light corrosion throughout.	1 & 2	
L2 - U3	LHS DIAGONAL	Yes	Bottom portion of member has been replaced. Localized medium corrosion with light corrosion throughout. Member is misaligned.	0	
L3	RHS CONNECTION	Yes	Localized medium to severe corrosion with significant loss of section on heads of rivets. Extensive pack rust surrounding clip angles. All pack rust was not removed from connection.	1	
L3	LHS CONNECTION	Yes	Localized medium to severe corrosion with significant loss of section on heads of rivets. Extensive pack rust surrounding clip angles. Pack rust has resulted in the misalignment of the angle. Gusset plate has localized medium to severe corrosion and light corrosion throughout. All pack rust was not removed from connection.	1

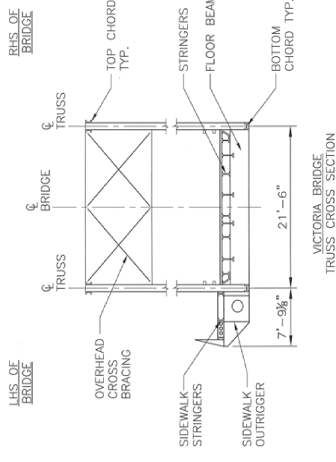
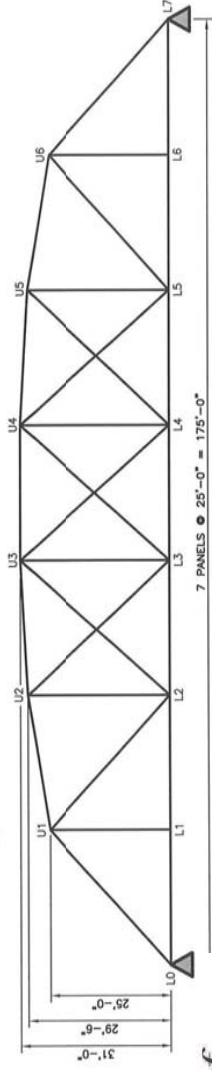
Member	Designation	Fracture Critical	Defects	Performance Deficiency	Photo's
L2 - L3	BELOW DECK CROSS BRACING	No	Both sides have localized medium to severe corrosion with perforations.	1	
U2 - U3	TOP CHORD CROSS BRACING	No	Permanent deformations in angles and light corrosion throughout.	0	
U3	OVERHEAD CROSS BRACING	No	Light corrosion throughout. Appears to be functioning as intended.	0

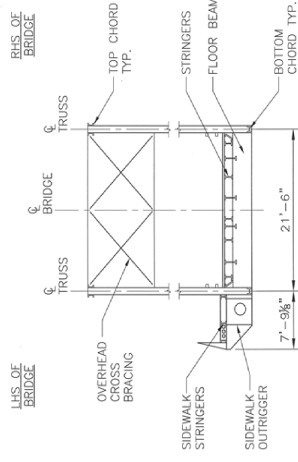
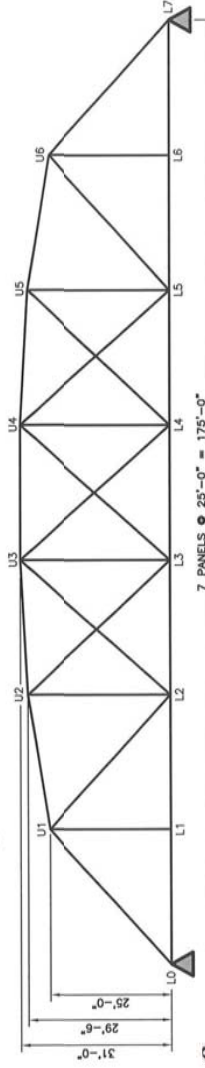
Member	Designation	Fracture Critical	Defects	Performance Deficiency	Photo's
U3 - U4	RHS UPPER CHORD	Yes	Localized medium corrosion with light corrosion throughout.	0	
U3 - U4	LHS UPPER CHORD	Yes	Localized medium corrosion with light corrosion throughout.	0	
L3 - L4	RHS LOWER CHORD	Yes	Localized medium to severe corrosion with light corrosion throughout. All pack rust was not removed from member.	1	
L3 - L4	LHS LOWER CHORD	Yes	Localized medium to severe corrosion with light corrosion throughout. All pack rust was not removed from member. Up to 20% section loss.	1	
L4 - U4	RHS VERTICAL	Yes	Member is misaligned due to rust jacking between outer channel and outer gusset plate at lower connection. Localized medium to severe corrosion with perforations on flange of inner channel.	1	
L4 - U4	LHS VERTICAL	Yes	Localized medium to severe corrosion with perforations and light corrosion throughout.	1	10
U3 - L4	RHS DIAGONAL	Yes	Localized medium to severe corrosion with perforations and light corrosion throughout.	1

U3 - L4	LHS DIAGONAL	Yes	Bottom portion of member has been replaced. Localized medium corrosion with light corrosion throughout.	0	
L3 - U4	RHS DIAGONAL	Yes	Bottom portion of member has been replaced, and is misaligned. Localized medium corrosion with light corrosion throughout.	0	
L3 - U4	LHS DIAGONAL	Yes	Localized medium to severe corrosion with light corrosion throughout.	0	
L4	RHS CONNECTION	Yes	Localized medium to severe corrosion with significant loss of section on heads of rivets. Extensive pack rust surrounding clip angles. Pack rust has resulted in the misalignment of the angle. Gusset plate has localized medium to severe corrosion and light corrosion throughout. All pack rust was not removed from connection.	1	
L4	LHS CONNECTION	Yes	Localized medium to severe corrosion with significant loss of section on heads of rivets. Extensive pack rust surrounding clip angles. Pack rust has resulted in the misalignment of the angle. Gusset plate has localized medium to severe corrosion and light corrosion throughout. All pack rust was not removed from connection.	1

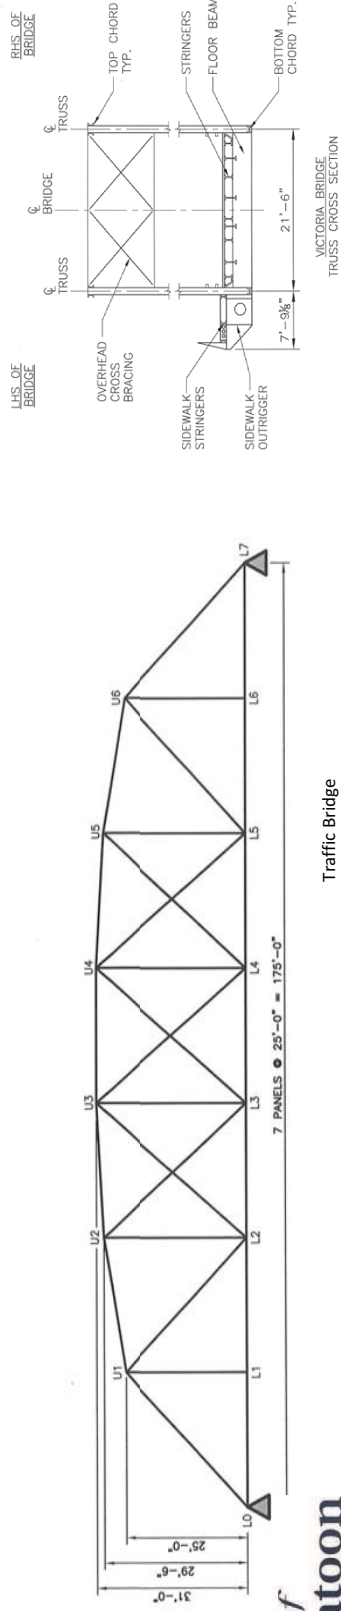
Member	Designation	Fracture Critical	Defects	Performance Deficiency	Photo's
L3 - L4	BELOW DECK STRINGER #7	No	Localized medium corrosion with light corrosion throughout.	0	
L3 - L4	BELOW DECK STRINGER #8	No	Top flange has localized medium to severe corrosion with light corrosion throughout.	0	
L3 - L4	BELOW DECK STRINGER #9	No	Top flange and bottom flange have localized medium to severe corrosion with light corrosion throughout.	0	
L3 - L4	BELOW DECK CROSS BRACING	No	Localized medium to severe corrosion with perforations on gusset plates.	1	
U3 - U4	TOP CHORD CROSS BRACING	No	Light corrosion throughout. Appears to be functioning as intended.	0	
U4	OVERHEAD CROSS BRACING	No	Light corrosion throughout. Appears to be functioning as intended.	0

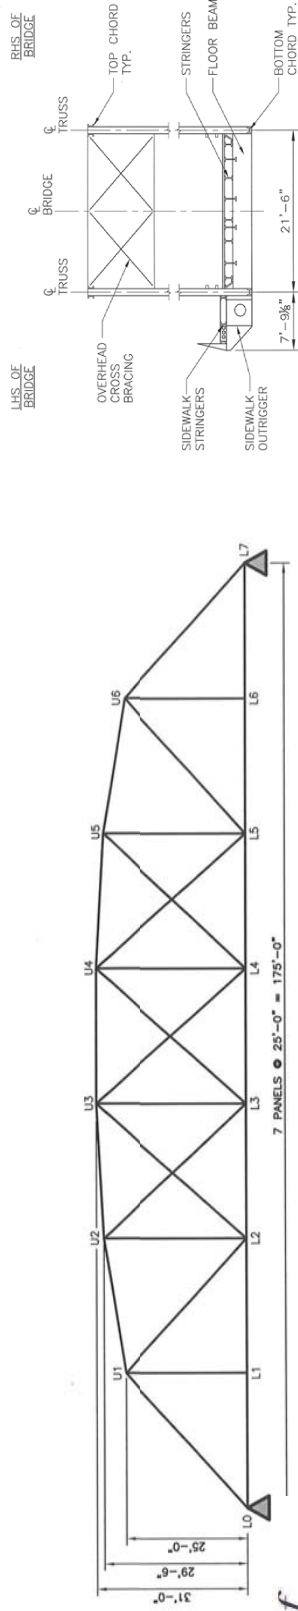
VICTORIA BRIDGE  
TRUSS CROSS SECTION

Member	Designation	Fracture Critical	Defects	Performance Deficiency	Photo's
U4 - U5	RHS UPPER CHORD	Yes	Localized medium corrosion with light corrosion throughout.	0	11
U4 - U5	LHS UPPER CHORD	Yes	Localized medium corrosion with light corrosion throughout.	0	
L4 - L5	RHS LOWER CHORD	Yes	Localized medium to severe corrosion with light corrosion throughout. All pack rust was not removed from member.	1	
L4 - L5	LHS LOWER CHORD	Yes	Localized medium to severe corrosion with light corrosion throughout. All pack rust was not removed from member.	1	
L5 - U5	RHS VERTICAL	Yes	Member is misaligned due to rust jacking between outer channel and outer gusset plate at lower connection. Localized medium to severe corrosion with light corrosion throughout.	1	
L5 - U5	LHS VERTICAL	Yes	Minor permanent deformations, and localized medium to severe corrosion with light corrosion throughout.	1	
U4 - L5	RHS DIAGONAL	Yes	Significant permanent deformation due to impact, with localized medium to severe corrosion with light corrosion throughout.	1 & 2	12

U4 - L5	LHS DIAGONAL	Yes	Minor permanent deformations, member is misaligned due to impact. Localized medium to severe corrosion with light corrosion throughout.	1	
L4 - U5	RHS DIAGONAL	Yes	Localized medium to severe corrosion with light corrosion throughout.	1	
L4 - U5	LHS DIAGONAL	Yes	Localized medium to severe corrosion on inside face angle at wearing surface elevation, with light corrosion throughout.	1	
L5	RHS CONNECTION	Yes	Localized medium to severe corrosion with significant loss of section on heads of rivets. Extensive pack rust surrounding clip angles. Pack rust has resulted in the misalignment of the angle. Gusset plate has localized medium to severe corrosion and light corrosion throughout. All pack rust was not removed from connection.	1	
L5	LHS CONNECTION	Yes	Localized medium to severe corrosion with significant loss of section on heads of rivets. Extensive pack rust surrounding clip angles. Pack rust has resulted in the misalignment of the angle. Gusset plate has localized medium to severe corrosion and light corrosion throughout. All pack rust was not removed from connection.	1

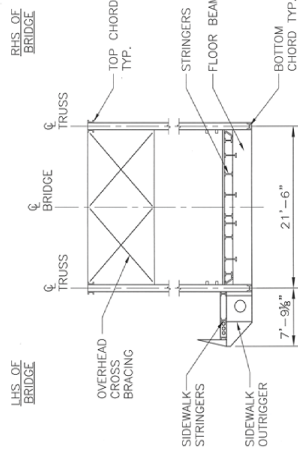
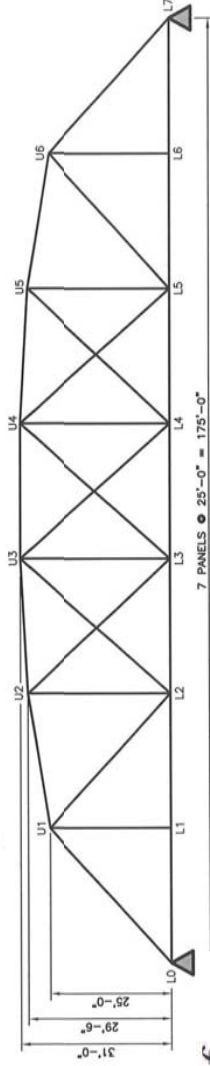
Member	Designation	Fracture Critical	Defects	Performance Deficiency	Photo's
L4 - L5	BELOW DECK STRINGER #7	No	Localized medium corrosion with light corrosion throughout.	0	
L4 - L5	BELOW DECK STRINGER #8	No	Areas of localized medium to severe corrosion at top flange with light corrosion throughout.	0	
L4 - L5	BELOW DECK STRINGER #9	No	Top and bottom flanges have localized medium to severe corrosion with light corrosion throughout.	0	
L4 - L5	BELOW DECK CROSS BRACING	No	Both sides have localized medium to severe corrosion with perforations.	1	
U4 - U5	TOP CHORD CROSS BRACING	No	Permanent deformations in angles and light corrosion throughout.	0	
U5	OVERHEAD CROSS BRACING	No	Light corrosion throughout. Appears to be functioning as intended.	0

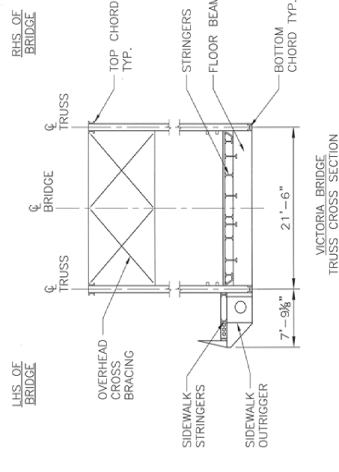
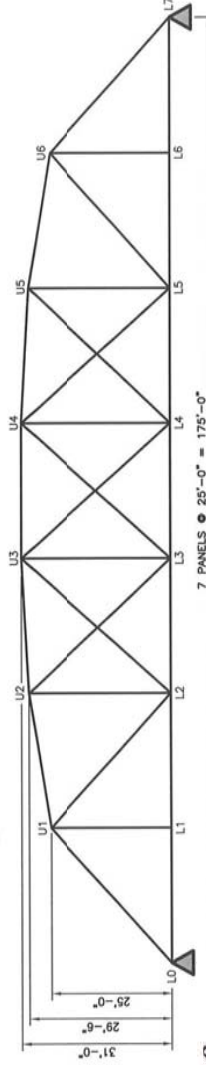
Member	Designation	Fracture Critical	Defects	Performance Deficiency	Photo's
U5 - U6	RHS UPPER CHORD	Yes	Localized medium corrosion with light corrosion throughout.	0	
U5 - U6	LHS UPPER CHORD	Yes	Localized medium corrosion with light corrosion throughout.	0	
L5 - L6	RHS LOWER CHORD	Yes	Localized medium to severe corrosion with light corrosion throughout. All pack rust was not removed from member.	1	
L5 - L6	LHS LOWER CHORD	Yes	Localized medium to severe corrosion with light corrosion throughout. All pack rust was not removed from member.	1	
L6 - U6	RHS VERTICAL	Yes	Minor permanent deformations, localized medium to severe corrosion with light corrosion throughout.	1	
L6 - U6	LHS VERTICAL	Yes	New switch plate at bottom, localized medium to severe corrosion with perforations on inside face of angles. Members are twisting due to rust jacking between stitch plates and angles. Approximately 60% of the original section remains, therefore elements ability to withstand design loads is greatly in question.	1

L5 - U6	RHS DIAGONAL	Yes	Localized medium to severe corrosion on inside face angle, with light corrosion throughout.	1	
L5 - U6	LHS DIAGONAL	Yes	Localized medium to severe corrosion on inside face angle at wearing surface elevation with light corrosion throughout.	1	
L6	RHS CONNECTION	Yes	Localized medium to severe corrosion with significant loss of section on heads of rivets. Extensive pack rust surrounding clip angles. Pack rust has resulted in the misalignment of the angle. Gusset plate has localized medium to severe corrosion and light corrosion throughout. All pack rust was not removed from connection.	1	
L6	LHS CONNECTION	Yes	Localized medium to severe corrosion with significant loss of section on heads of rivets. Extensive pack rust surrounding clip angles. Pack rust has resulted in the misalignment of the angle. Gusset plate has localized medium to severe corrosion and light corrosion throughout. All pack rust was not removed from connection.	1

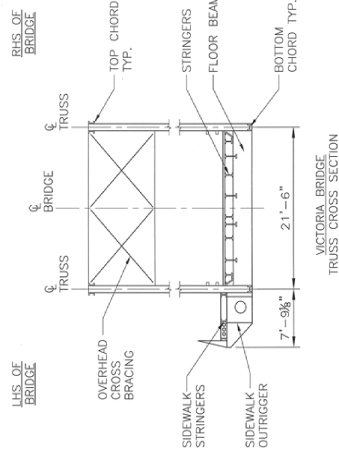
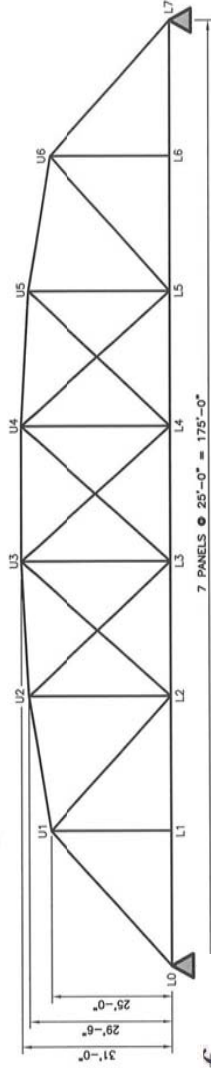
Member	Designation	Fracture Critical	Defects	Performance Deficiency	Photo's
L5 - L6	BELOW DECK STRINGER #7	No	Localized medium corrosion with light corrosion throughout.	0	
L5 - L6	BELOW DECK STRINGER #8	No	Localized medium corrosion with light corrosion throughout.	0	
L5 - L6	BELOW DECK STRINGER #9	No	Top flange has localized medium to severe corrosion with light corrosion throughout. Both top and bottom have localized medium to severe corrosion with perforations.	0	
L5 - L6	BELOW DECK CROSS BRACING	No	Light corrosion throughout. Appears to be functioning as intended.	1	
U5 - U6	TOP CHORD CROSS BRACING	No	Light corrosion throughout. Appears to be functioning as intended.	0	
U6	PORTAL BRACING	No	Light corrosion throughout. Appears to be functioning as intended.	0

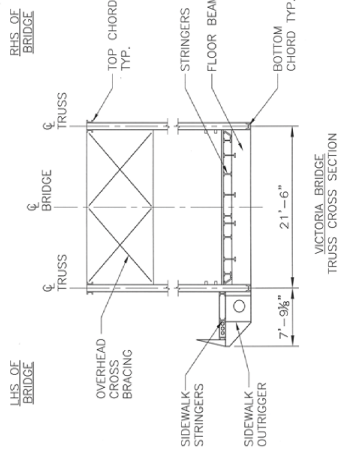
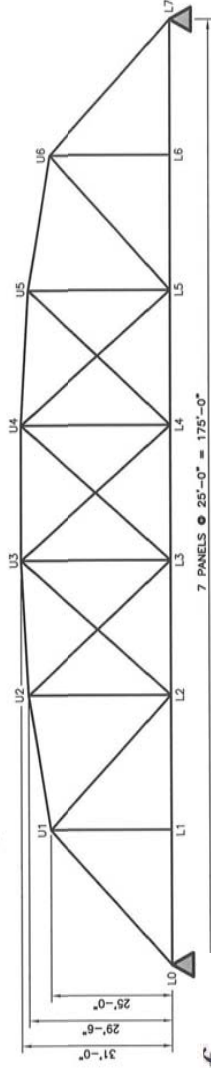
Member	Designation	Fracture Critical	Defects	Performance Deficiency	Photo's
U6 - L7	RHS UPPER CHORD	Yes	Localized medium corrosion with light corrosion throughout.	0	
U6 - L7	LHS UPPER CHORD	Yes	Minor permanent deformations, localized medium to severe corrosion with light corrosion throughout.	0	13
L6 - L7	RHS LOWER CHORD	Yes	Localized medium to severe corrosion with light corrosion throughout. All pack rust was not removed from member.	1	
L6 - L7	LHS LOWER CHORD	Yes	Localized medium to severe corrosion with light corrosion throughout. All pack rust was not removed from member.	1	
L7	RHS CONNECTION	Yes	Localized medium corrosion with light corrosion throughout.	0	
L7	LHS CONNECTION	Yes	Localized medium corrosion with light corrosion throughout.	0	
L2 - L3	BELOW SIDEWALK STRINGER #1	No	Light to medium corrosion throughout with localized severe corrosion on top flange.	0	
L2 - L3	BELOW SIDEWALK STRINGER #2	No	Light to medium corrosion throughout with localized severe corrosion on top flange.	0

L2 - L3	BELOW SIDEWALK STRINGER #3	No	Light to medium corrosion throughout with localized severe corrosion on top flange.	0	
L6 - L7	BELOW DECK STRINGER #1	Yes	Localized medium corrosion with light corrosion throughout.	0	
L6 - L7	BELOW DECK STRINGER #2	Yes	Localized medium corrosion with light corrosion throughout.	0	
L6 - L7	BELOW DECK STRINGER #3	Yes	Localized medium corrosion with light corrosion throughout.	0	
L6 - L7	BELOW DECK STRINGER #4	Yes	Localized medium corrosion with light corrosion throughout.	0	
L6 - L7	BELOW DECK STRINGER #5	Yes	Localized medium corrosion with light corrosion throughout.	0	
L6 - L7	BELOW DECK STRINGER #6	Yes	Localized medium corrosion with light corrosion throughout.	0	
L6 - L7	BELOW DECK STRINGER #7	Yes	Localized medium corrosion with light corrosion throughout.	0	
L6 - L7	BELOW DECK STRINGER #8	Yes	Top flange has areas of localized medium to severe corrosion with light corrosion throughout.	0

L6 - L7	BELOW DECK STRINGER #9	No	Top flange has localized medium to severe corrosion with light corrosion throughout.	0	
L6 - L7	BELOW DECK CROSS BRACING	No	Both sides have localized medium to severe corrosion with perforations.	1
