July 10, 2017

CITY OF SASKATOON

Asbestos-Containing Building Materials Assessment Report - Archibald Arena

Report Number: 1667963

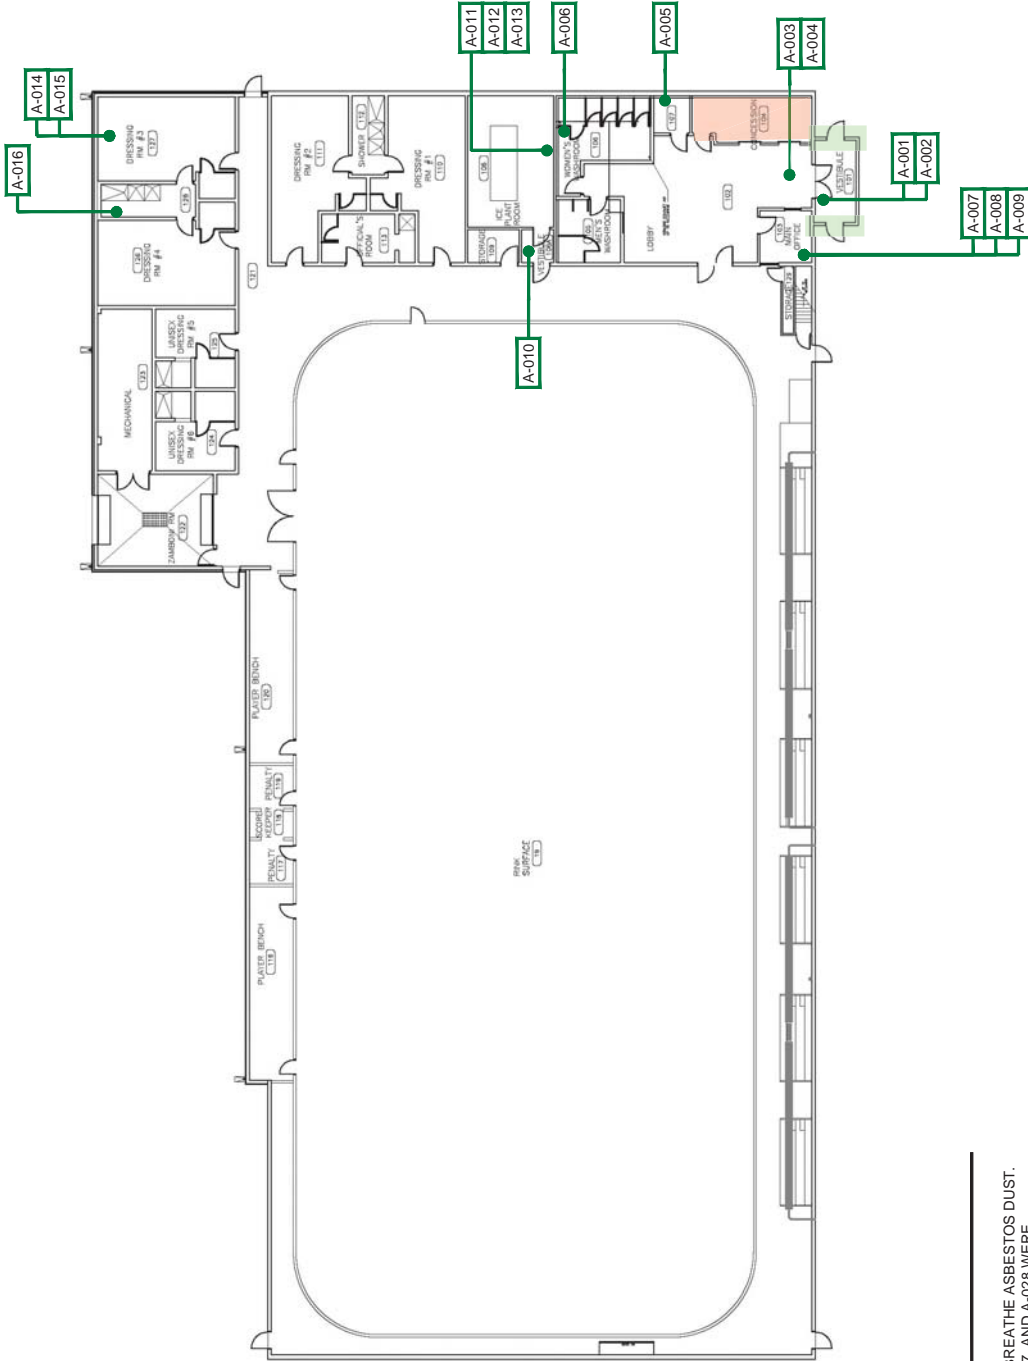
PROJECT NO. 1667963
CONTROL 1000-HM-0001
REV. 0
FIGURE 1

- NOTE(S)**
1. ASBESTOS IS A CARCINOGEN. DO NOT BREATHE ASBESTOS DUST.
 2. SAMPLES A-023, A-024, A-025, A-026, A-027, AND A-028 WERE COLLECTED ALONG THE EXTERIOR OF THE BUILDING.
 3. ASBESTOS-CONTAINING BLACK DOOR WINDOW CAULKING IS LOCATED ON THE EXTERIOR WINDOWS OF THE EXTERIOR DOORS OF ROOM 101.

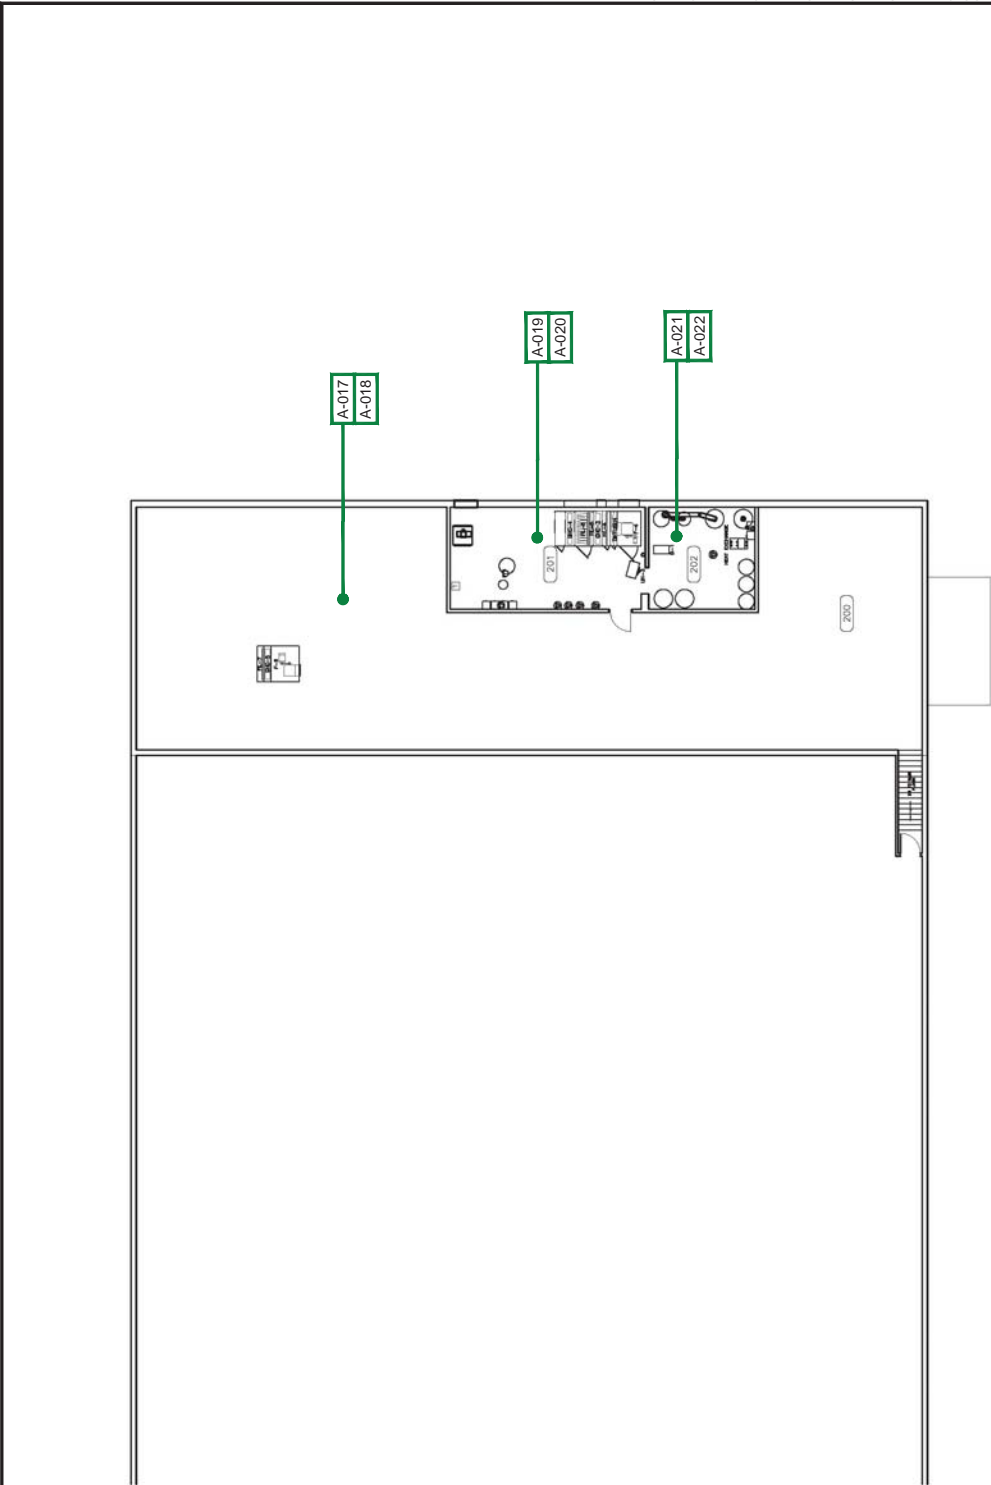
1. ASBESTOS IS A CARCINOGEN. DO NOT BREATHE ASBESTOS DUST.
2. SAMPLES A-023, A-024, A-025, A-026, A-027, AND A-028 WERE COLLECTED ALONG THE EXTERIOR OF THE BUILDING.
3. ASBESTOS-CONTAINING BLACK DOOR WINDOW CAULKING IS LOCATED ON THE EXTERIOR WINDOWS OF THE EXTERIOR DOORS OF ROOM 101.
