July 10, 2017

CITY OF SASKATOON

Asbestos-Containing Building Materials Assessment Report - Archibald Arena

Report Number: 1667963

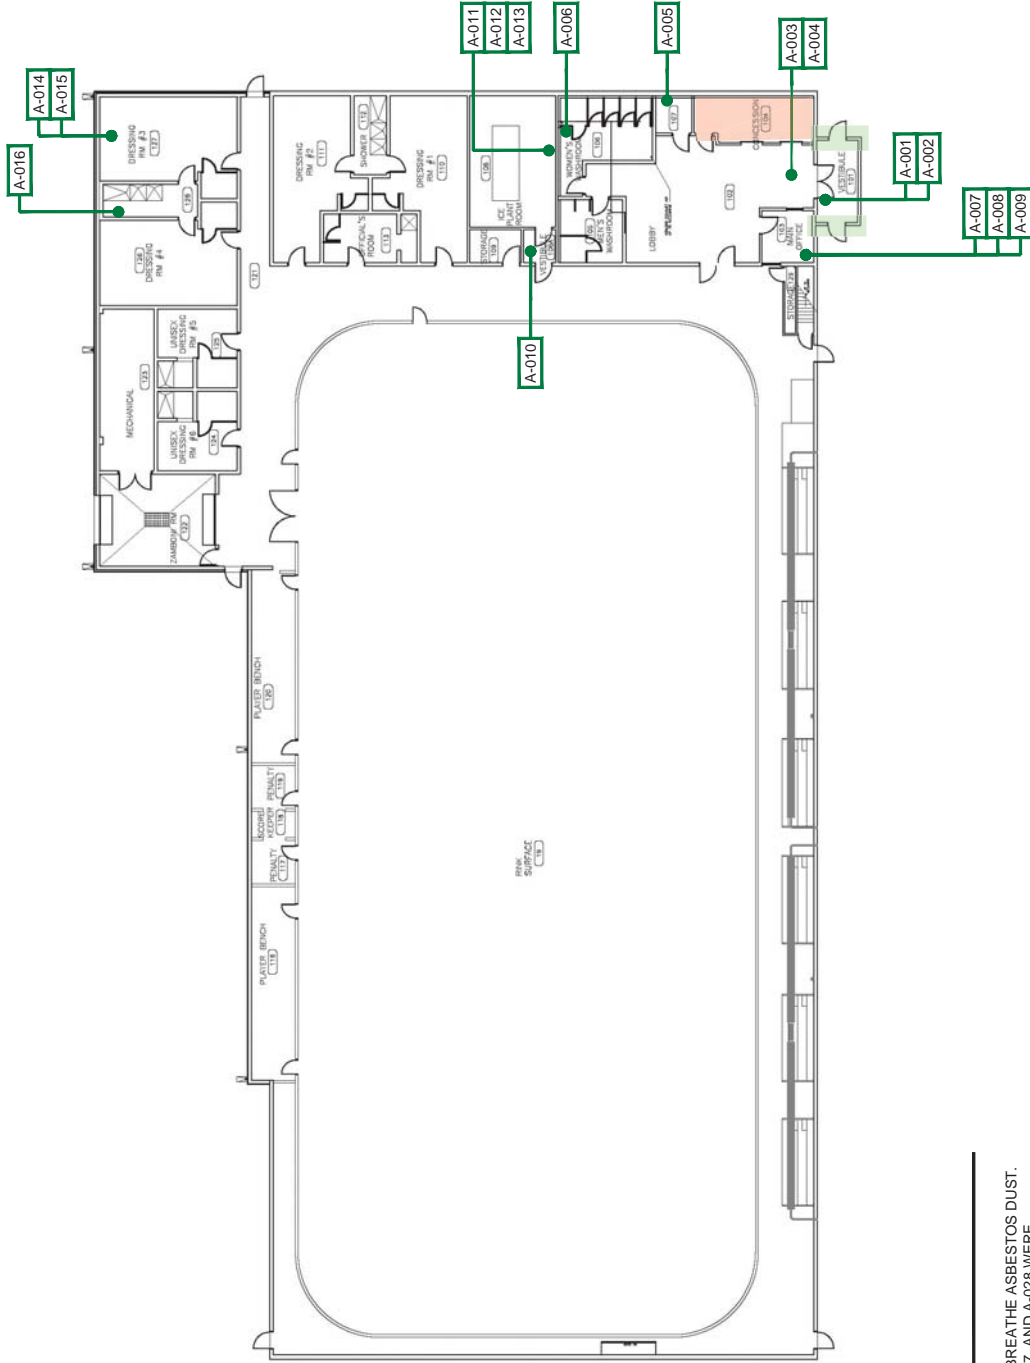
FIGURE 1

- NOTE(S)**
- ASBESTOS IS A CARCINOGEN. DO NOT BREATHE ASBESTOS DUST.
 - SAMPLES A-023, A-024, A-025, A-026, A-027, AND A-028 WERE COLLECTED ALONG THE EXTERIOR OF THE BUILDING.
 - ASBESTOS-CONTAINING BLACK DOOR WINDOW CAULKING IS LOCATED ON THE EXTERIOR WINDOWS OF THE EXTERIOR DOORS OF ROOM 101.

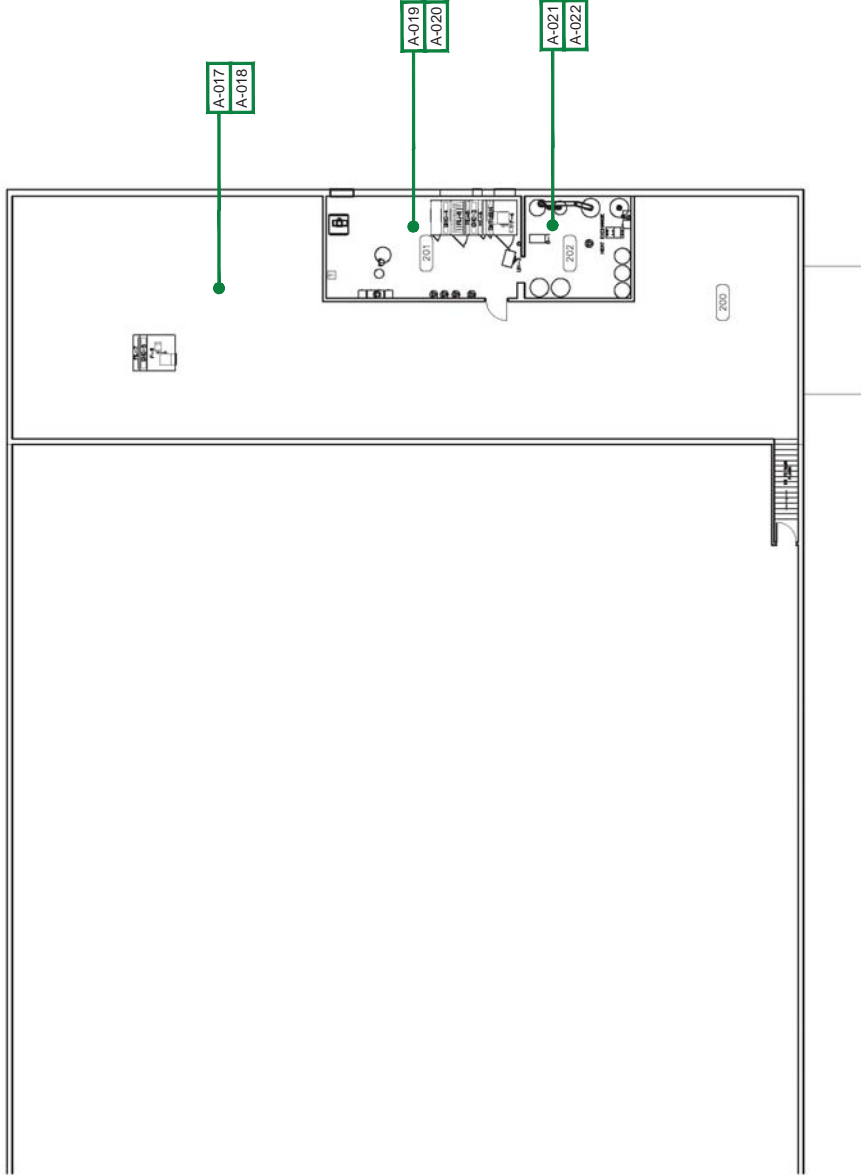
1. ASBESTOS IS A CARCINOGEN. DO NOT BREATHE ASBESTOS DUST.
2. SAMPLES A-023, A-024, A-025, A-026, A-027, AND A-028 WERE COLLECTED ALONG THE EXTERIOR OF THE BUILDING.
3. ASBESTOS-CONTAINING BLACK DOOR WINDOW CALKING IS LOCATED ON THE EXTERIOR WINDOWS OF THE EXTERIOR DOORS OF ROOM 101.
