December 7, 2017

CITY OF SASKATOON

# Asbestos-Containing Building Materials Assessment Report - Fire Station No. 7

**Report Number: 1667963**

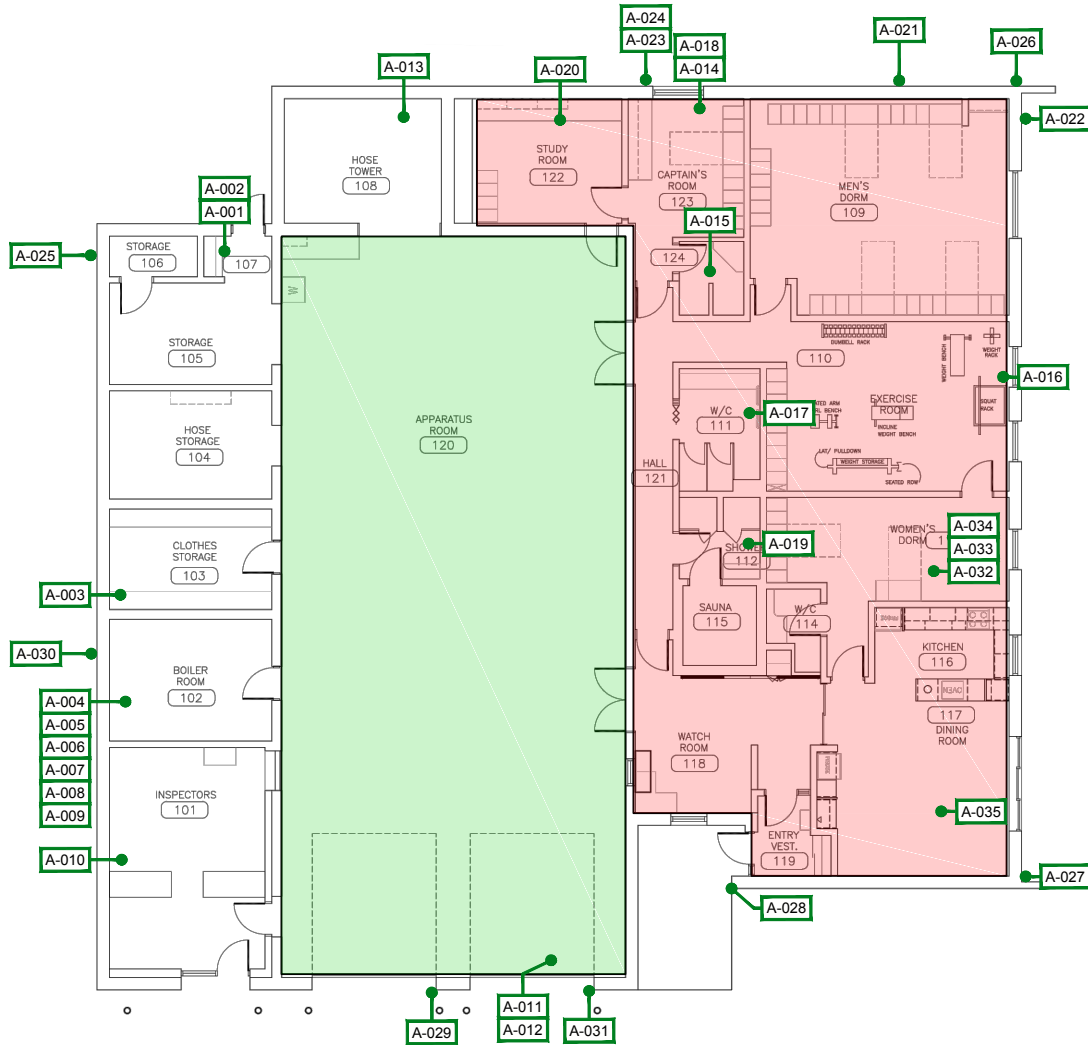
## **Floor Plan**

Two (2) samples of black window caulking were collected during the assessment. One of the samples collected was found to contain 3.8% Chrysotile asbestos. Asbestos-containing black window caulking (see Photograph 1 in Appendix B) was observed in the following location:

One (1) sample of red/brown duct mastic was collected during the assessment. The sample collected was found to contain 3.4% Chrysotile asbestos. Asbestos-containing red/brown duct mastic (see Photograph 2 in Appendix B) was observed in the following locations:
