**CITY OF SASKATOON – FIRE MAINTENANCE BUILDING  
ASBESTOS SURVEY REPORT**

**MAY 2013**

**Prepared By: Bersch & Associates Ltd.**  
**Project No. : B67SRE01FM**

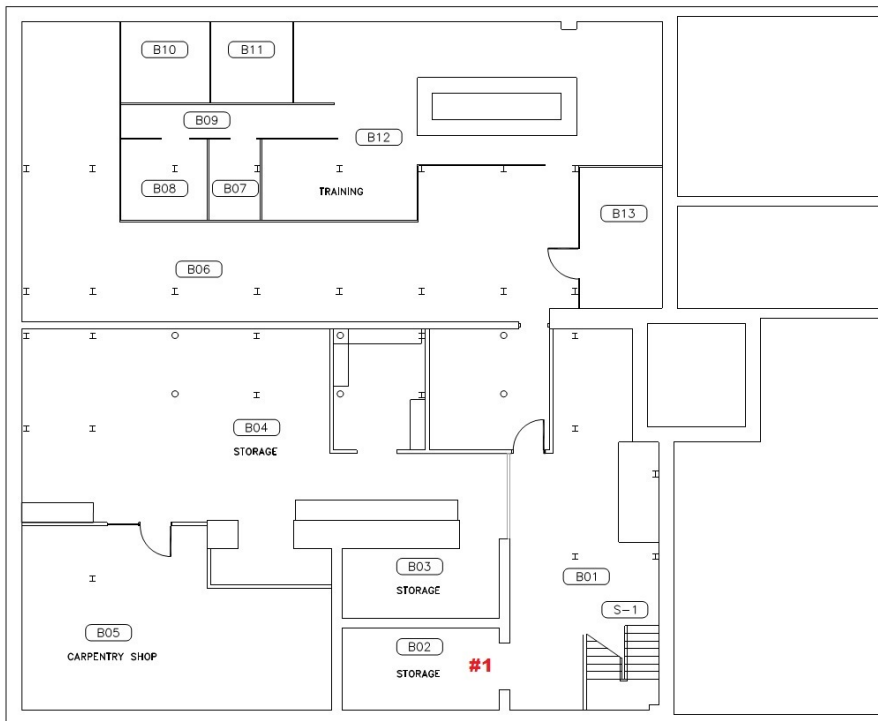
- Asbestos containing **transite board** has been identified as ACM on the exterior west side of the building. This material has been identified on the floor plans in appendix II.
- **Any material located within ceilings, wall cavities, pipe chases or other inaccessible areas or areas of limited access shall be considered asbestos-containing until testing of the material can determine the presence or absence of asbestos.**

**Transite asbestos board** was identified as containing asbestos. This material was observed to be in good condition with a low potential for disturbance. The material is the black board surrounding the overhead doors on the exterior wall surface. The material may be managed.

<b>PRIORITY:</b>	<b>THREE</b>
<b>CONDITION:</b>	<b>GOOD</b>
<b>POTENTIAL FOR DISTURBANCE:</b>	<b>LOW</b>
<b>ACTION:</b>	<b>MANAGE</b>

For the specifics of this report Management of the asbestos containing materials is the recommended planned activity. In the event of renovations or maintenance to areas containing asbestos materials, written procedures must be developed to conduct the activity or prior removal if the situation warrants.
