December 7, 2017

CITY OF SASKATOON

Asbestos-Containing Building Materials Assessment Report - Inventory and Disposal Services Building

Report Number: 1667963

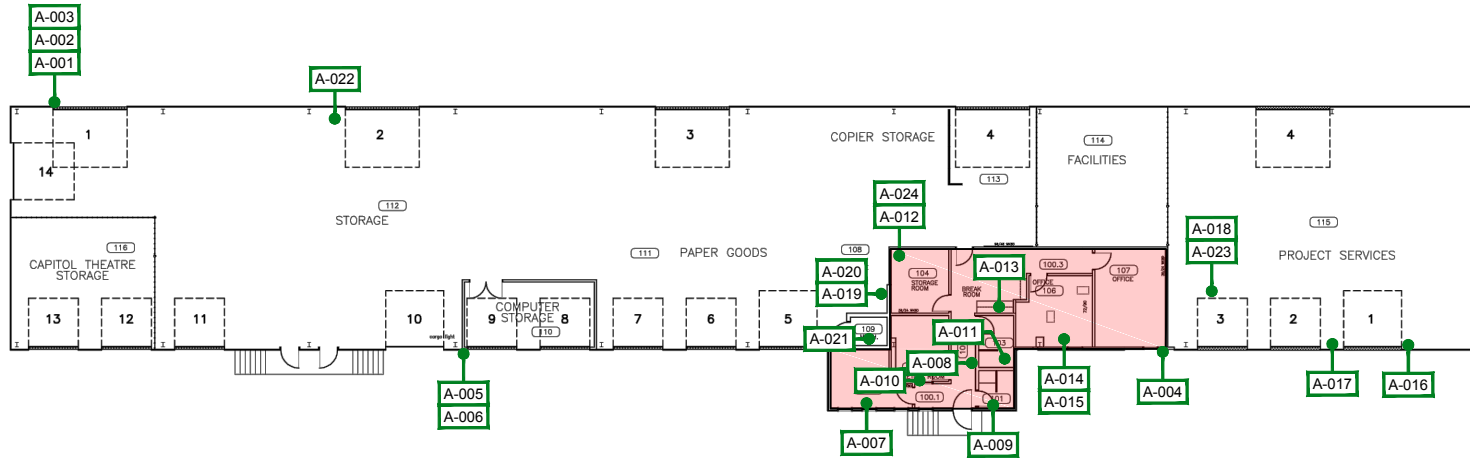
Floor Plan

Five (5) samples of drywall joint compound were collected during the assessment. One of the samples collected was found to contain 3.1% Chrysotile asbestos. Asbestos-containing drywall joint compound (see Photograph 3 in Appendix B) was observed in the following locations:
