**J.S. Wood Library  
Asbestos Survey Report**

**December 2014**

**Prepared For: City Of Saskatoon- Infrastructure Services Department**  
1101 Avenue P North, Saskatoon, SK.  
Attn: Brent Anderson

**Prepared By: Bersch & Associates Ltd.**  
**Project No. : B67SRL04**

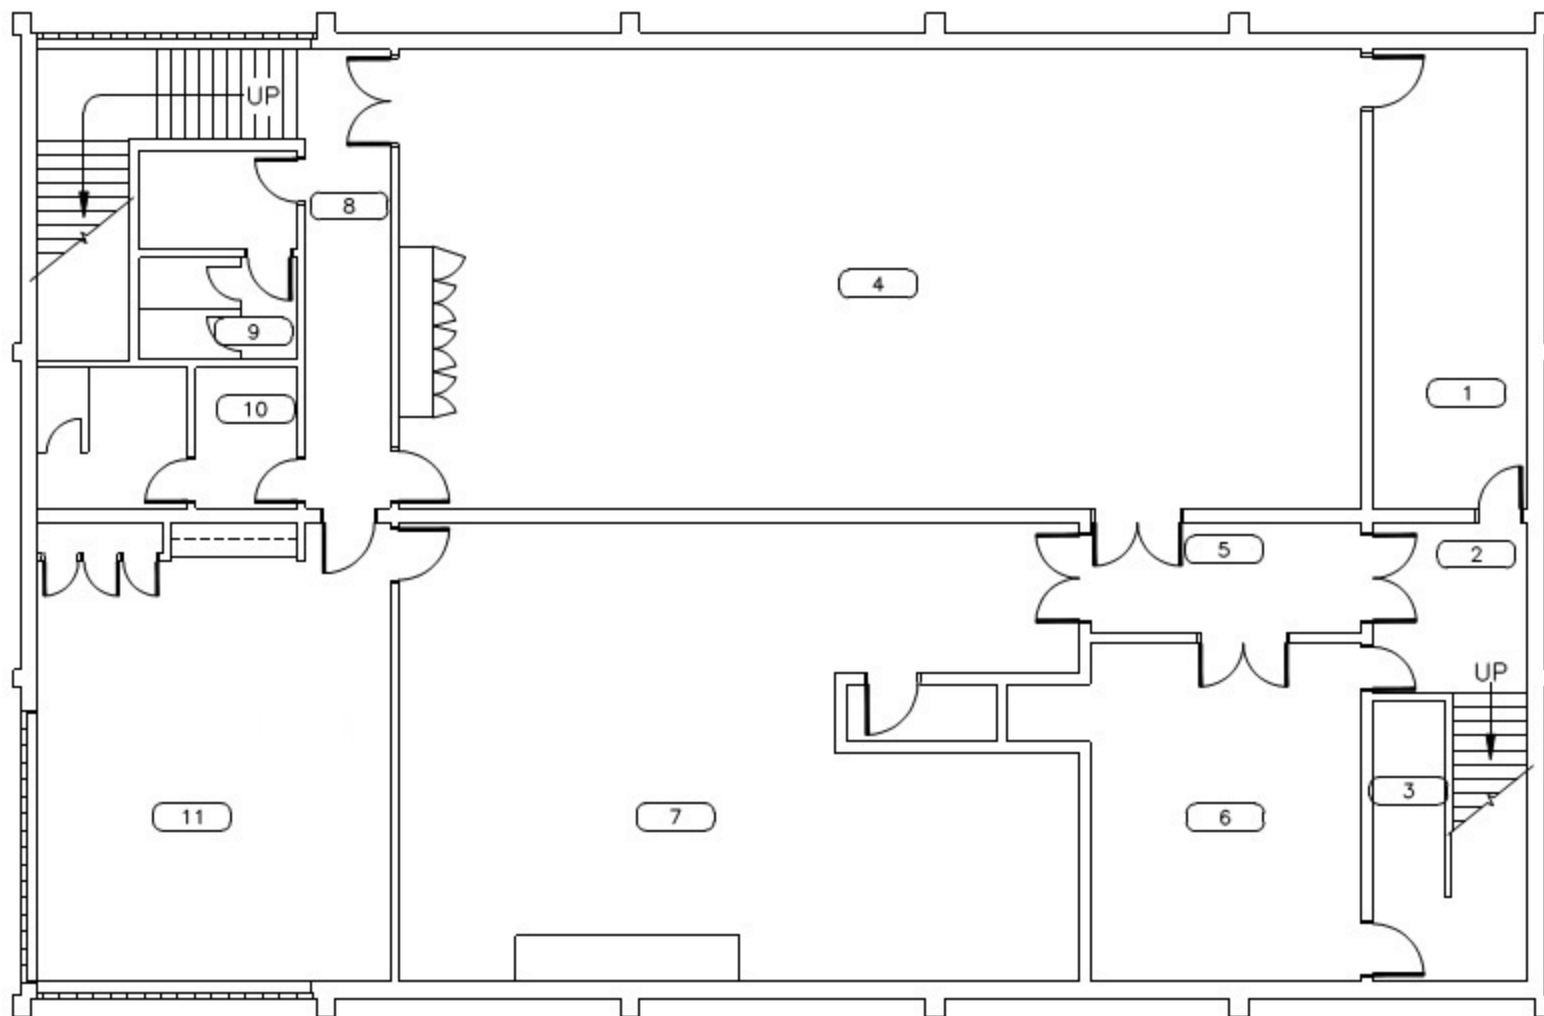
**FLOOR PLANS**

- **Vinyl Asbestos Floor Tile** is located on the Main Floor Library and Offices. The Asbestos Floor Tile is identified on the **Floor Plans** in **Appendix III** of this report.
