## John Deere Building Saskatoon, SK.

## Asbestos Survey Report February 2015

**Prepared By:** Bersch & Associates Ltd.  
**Project No. :** B67SRB05

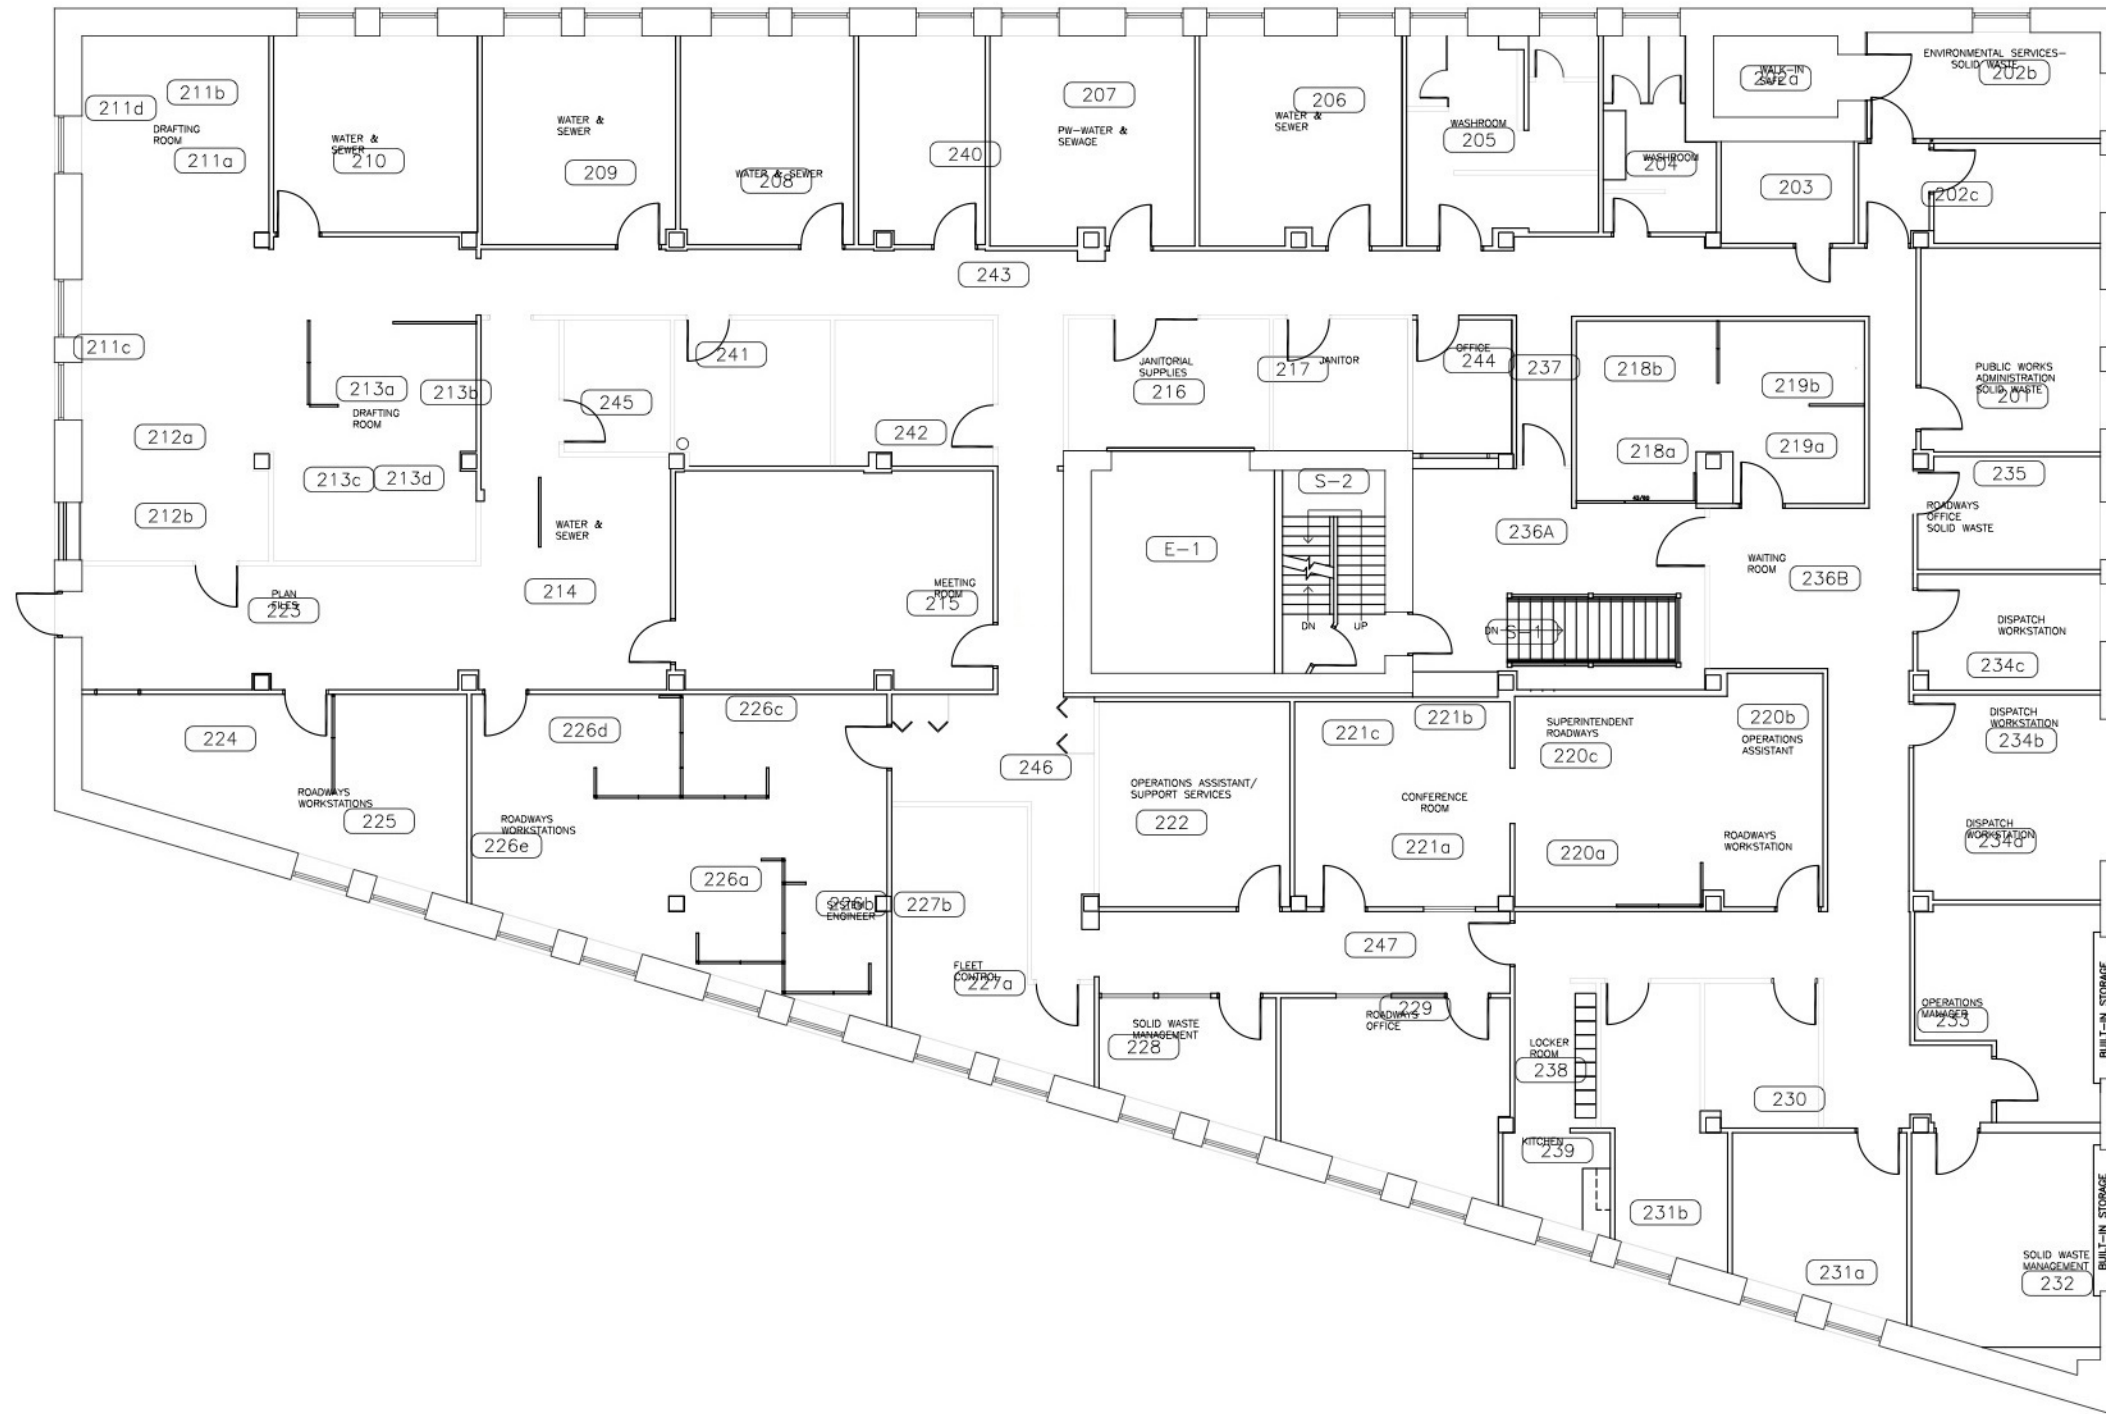
- **Vinyl Asbestos Sheet Flooring** is located on the Main Floor of the facility. Due to the poor condition of the sheet flooring in several areas, remediation is required. Please refer to Appendix III for the locations on the floor plans.

- **9" x 9" Vinyl Asbestos Floor Tile** was identified within Storage Room 114. The flooring was observed in good condition with no further action required. Please refer to Appendix III for the location on the floor plans.

- ASBESTOS SHEET FLOORING**
- ASBESTOS FLOOR TILE**
