December 4, 2017

CITY OF SASKATOON

Asbestos-Containing Building Materials Assessment Report - Mayfair Lawn Bowling Clubhouse

Report Number: 1667963

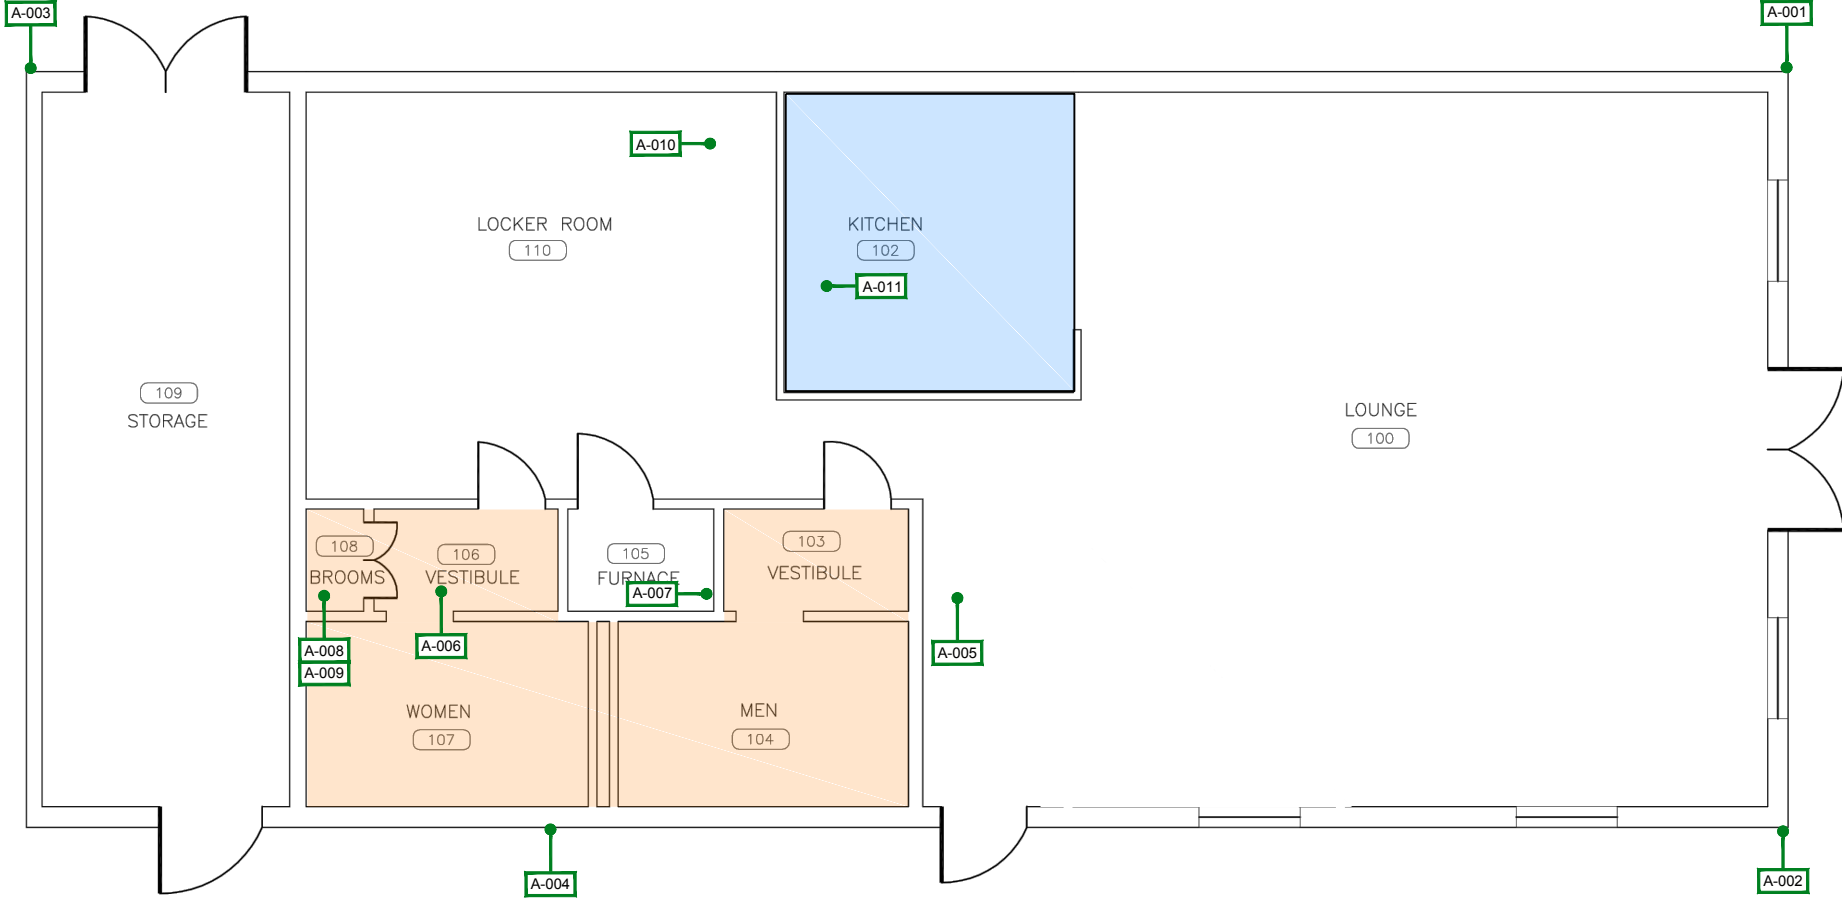
Floor Plan

One (1) sample of 12"x12" beige floor tile with brown streaks was collected during the assessment. The sample collected was found to contain 2.3% Chrysotile asbestos. Asbestos-containing 12"x12" beige floor tile with brown streaks (see Photograph 1 in Appendix B) was observed in the following locations:

One (1) sample of silver sink undercoat was collected during the assessment. The sample collected was found to contain 1.7% Chrysotile asbestos. Asbestos-containing silver sink undercoat (see Photograph 2 in Appendix B) was observed in the following location:
