July 12, 2017

CITY OF SASKATOON

# Asbestos-Containing Building Materials Assessment Report - Mayfair Library

**Report Number: 1667963**

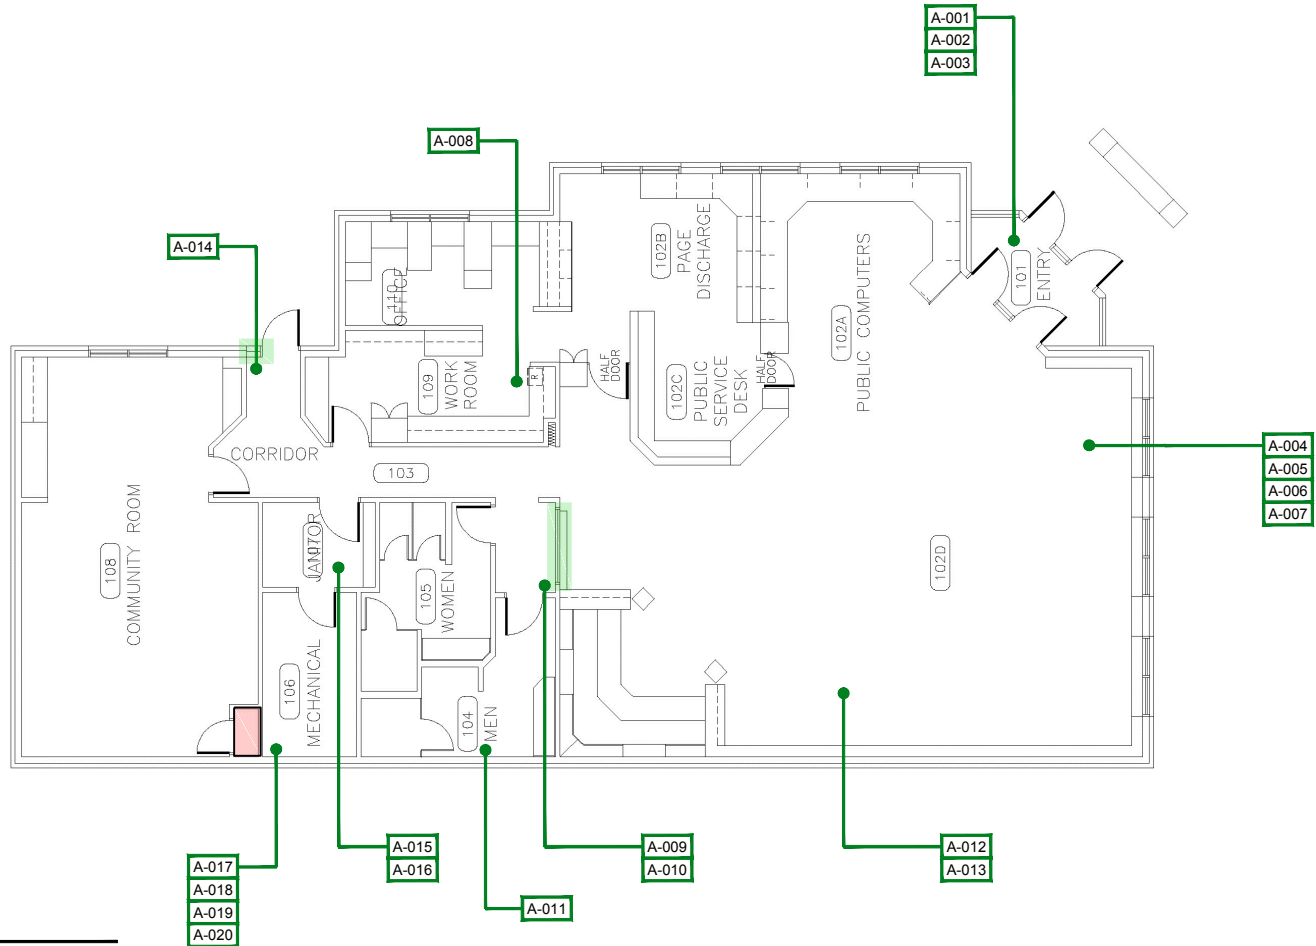
## **Floor Plans**

1. ASBESTOS IS A CARCINOGEN. DO NOT BREATHE ASBESTOS DUST.
2. SAMPLES A-021 TO A-027 WERE COLLECTED ALONG THE EXTERIOR OF THE BUILDING.
3. NON-ASBESTOS-CONTAINING LOOSE FILL INSULATION IS LOCATED WITHIN THE CEILING SPACE THROUGHOUT THE BUILDING.
