August 25, 2017

CITY OF SASKATOON

# Asbestos-Containing Building Materials Assessment Report - North Central Substation/Electrical Transformer Building

**Report Number: 1667963**

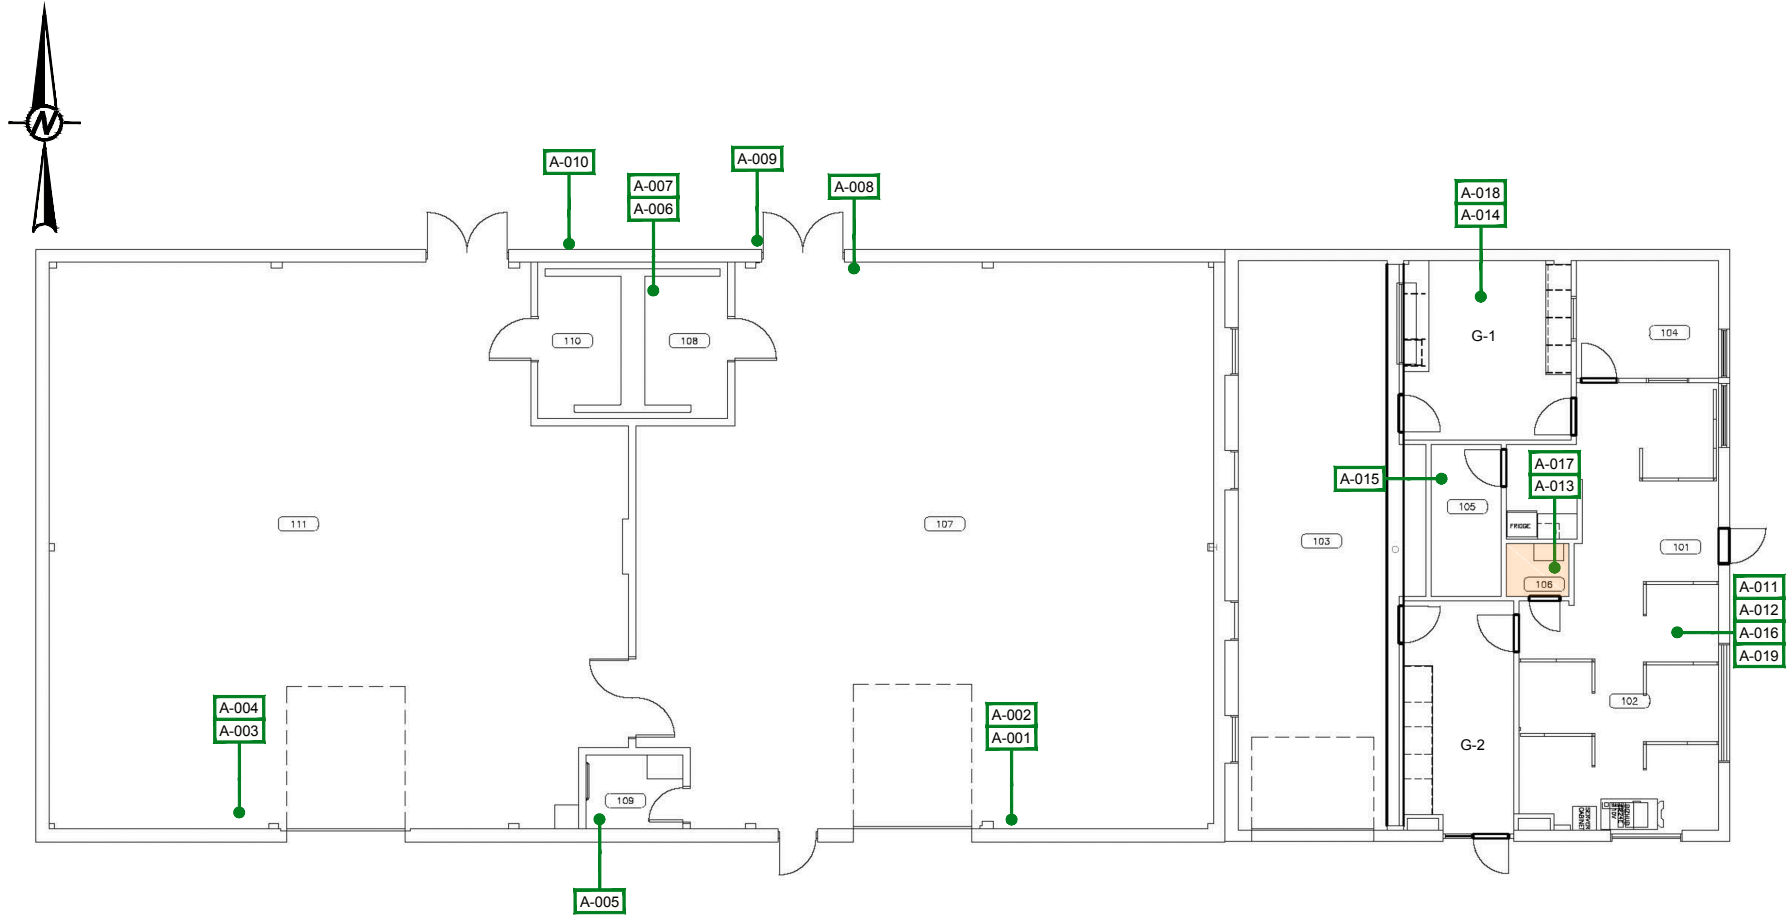
## **Floor Plans**

One (1) sample of 1'x1' off-white floor tile with black flecks was collected during the assessment. The sample collected was found to contain trace Chrysotile asbestos. Asbestos-containing 1'x1' off-white floor tile with black flecks (see Photograph 1 in Appendix B) was observed in the following locations:

ASBESTOS SAMPLE LOCATION
	ASBESTOS - CONTAINING FLOOR TILE
