## CITY OF SASKATOON

# Asbestos-Containing Building Materials Assessment Report - Nutana Lawn Bowling Clubhouse

**Report Number: 1667963**

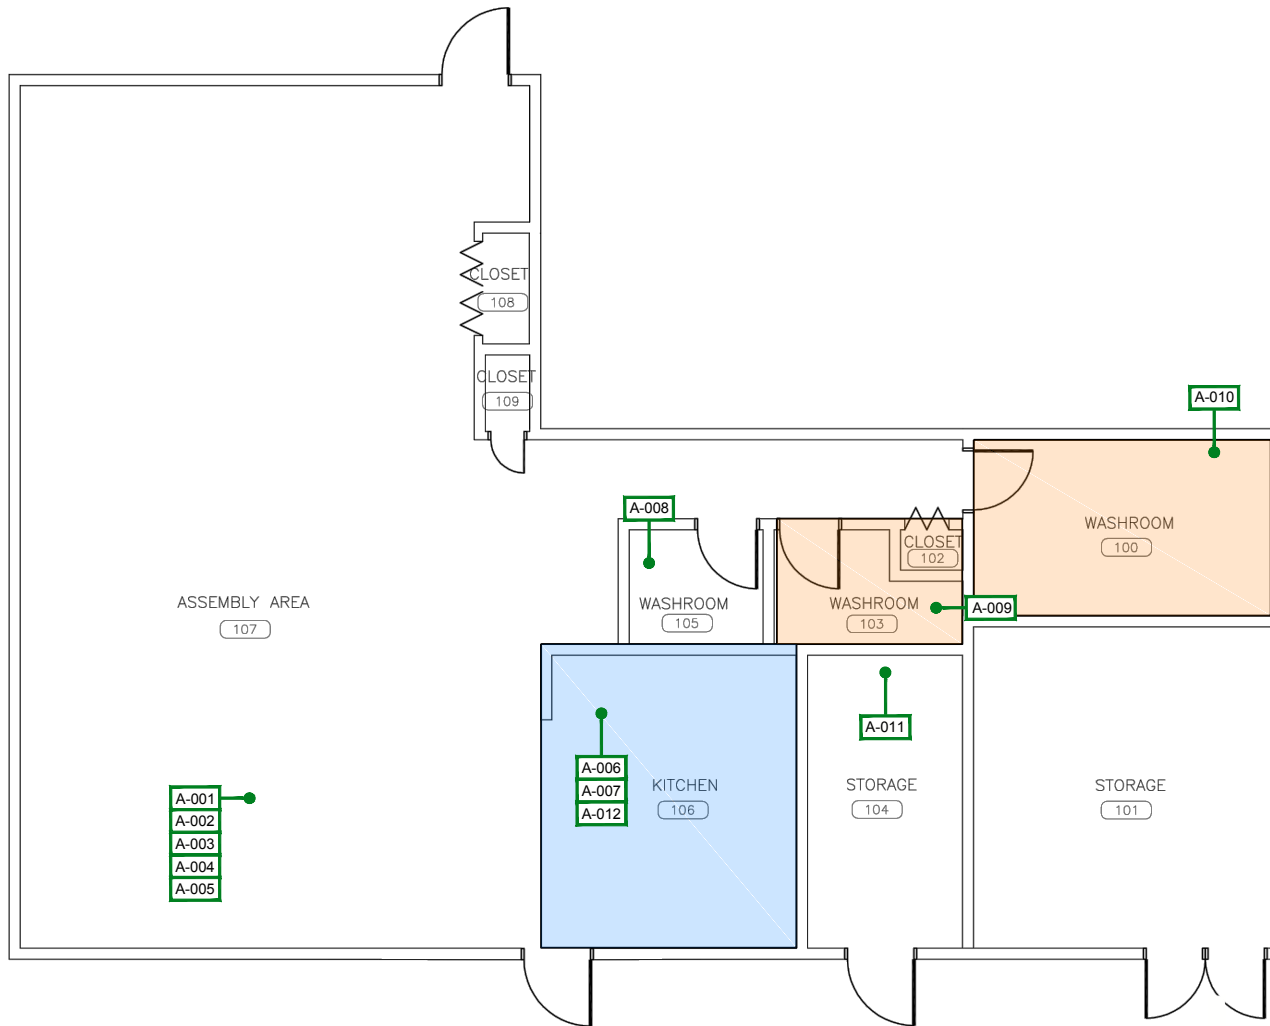
## **Floor Plan**

One (1) sample of 12"x12" beige floor tile with black and white streaks was collected during the assessment. The sample collected was found to contain 0.75% Chrysotile asbestos. Asbestos-containing 12"x12" beige floor tile with black and white streaks (see Photograph 1 in Appendix B) was observed in the following locations:

Additional asbestos-containing 12"x12" beige floor tile with black and white streaks may be located below the carpet in other areas of the Site. Please note the asbestos-containing 12"x12" beige floor tile with black and white streaks was observed to be in poor condition within Room 103.

One (1) sample of silver sink undercoat was collected during the assessment. The sample collected was found to contain 1.6% Chrysotile asbestos. Asbestos-containing silver sink undercoat (see Photograph 2 in Appendix B) was observed in the following location:
