CITY OF SASKATOON

Asbestos-Containing Building Materials Assessment Report - Victoria Park Riversdale Badminton and Tennis Club

Report Number: 1667963

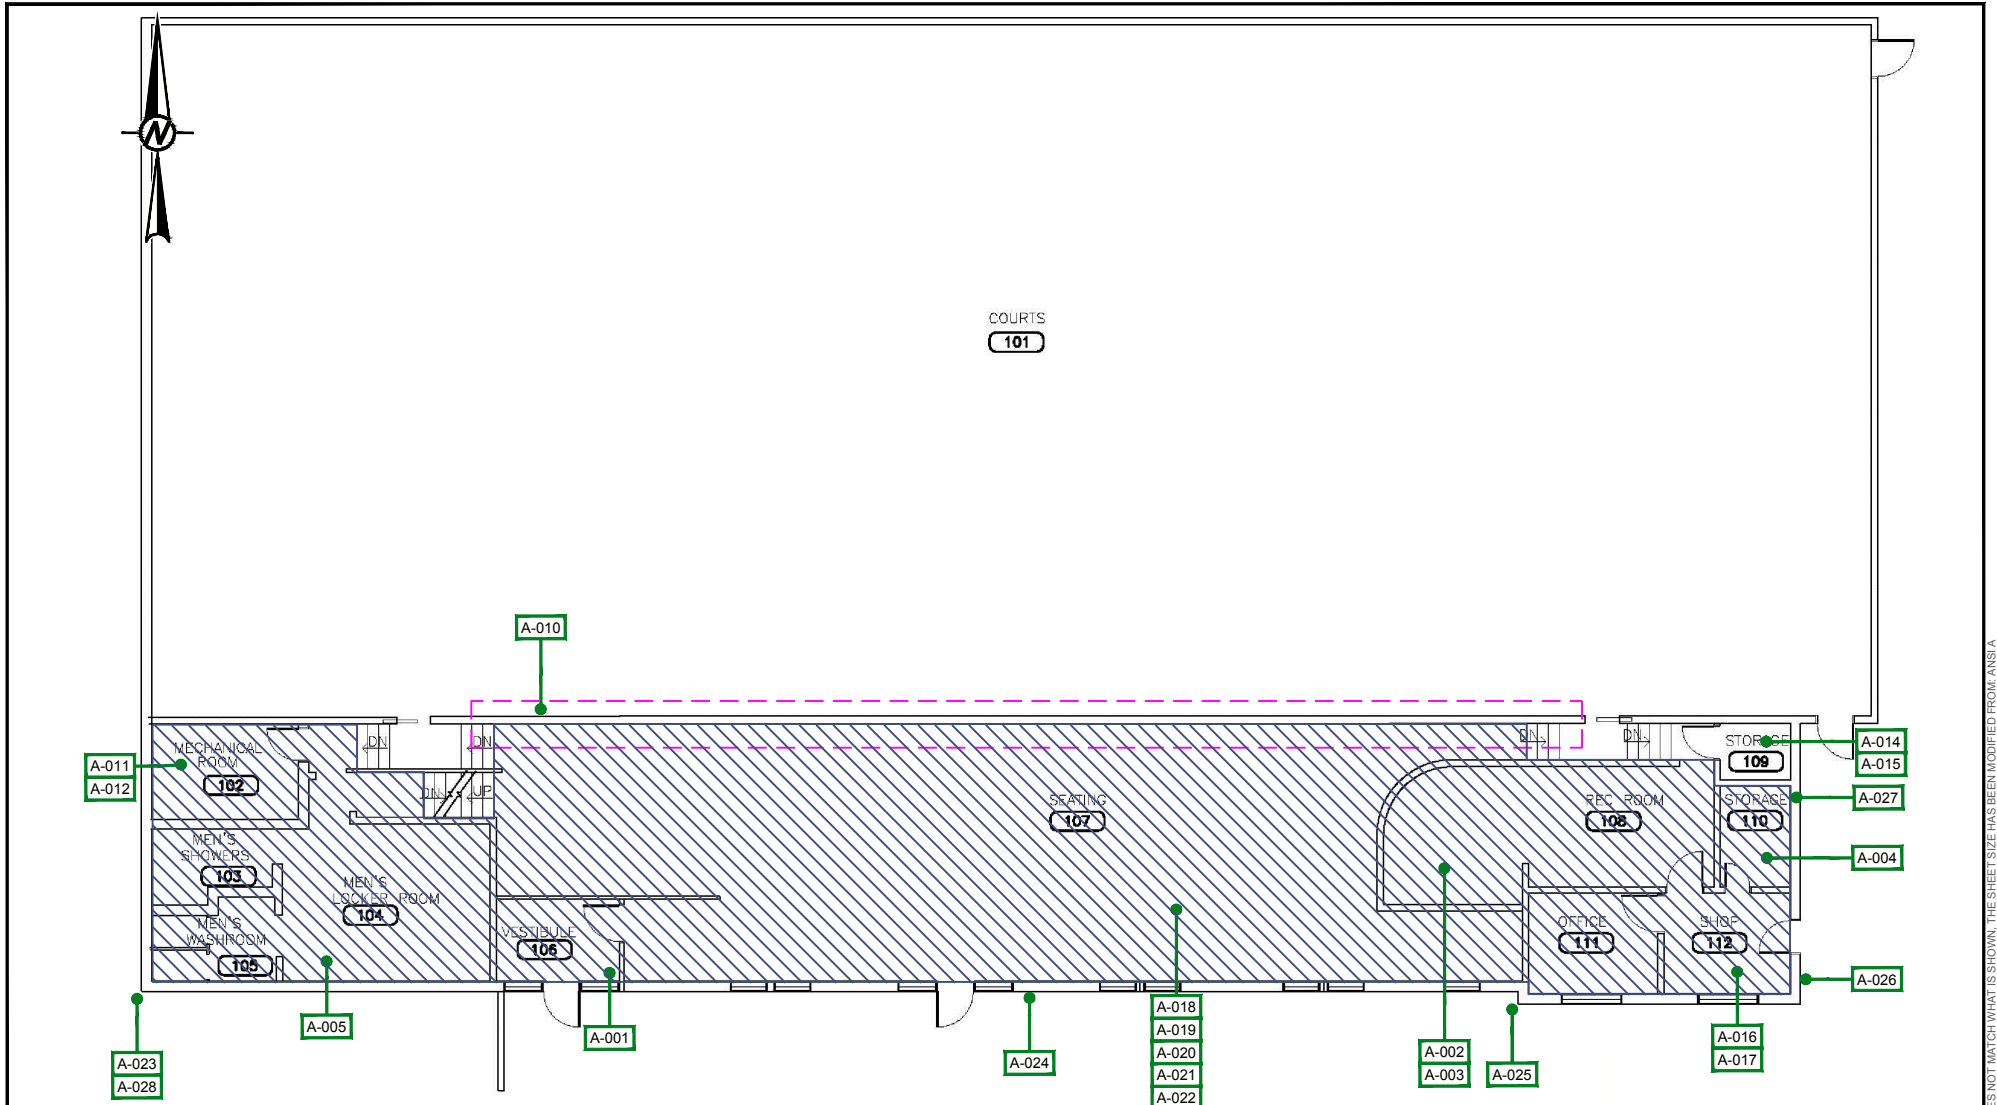
Seven (7) samples of drywall joint compound were collected during the assessment. Three of the samples collected were found to contain 2.1% to 2.8% Chrysotile asbestos. Asbestos-containing drywall joint compound (see Photograph 1 in Appendix B) was observed in the following location:

Two (2) samples of black window caulking were collected during the assessment. One of the samples collected was found to contain 1.6% Chrysotile asbestos. Asbestos-containing black window caulking (see Photograph 2 in Appendix B) was observed in the following location:
