**SPCA ANIMAL SHELTER  
ASBESTOS SURVEY REPORT**

**May 2013**

**Prepared For: City of Saskatoon – Infrastructure Services Department**  
1101 Avenue P North, Saskatoon SK, Canada S7L 7K6  
Attn: Brent Anderson

**Prepared By: Bersch & Associates Ltd.**  
**Project No. : B67.13**

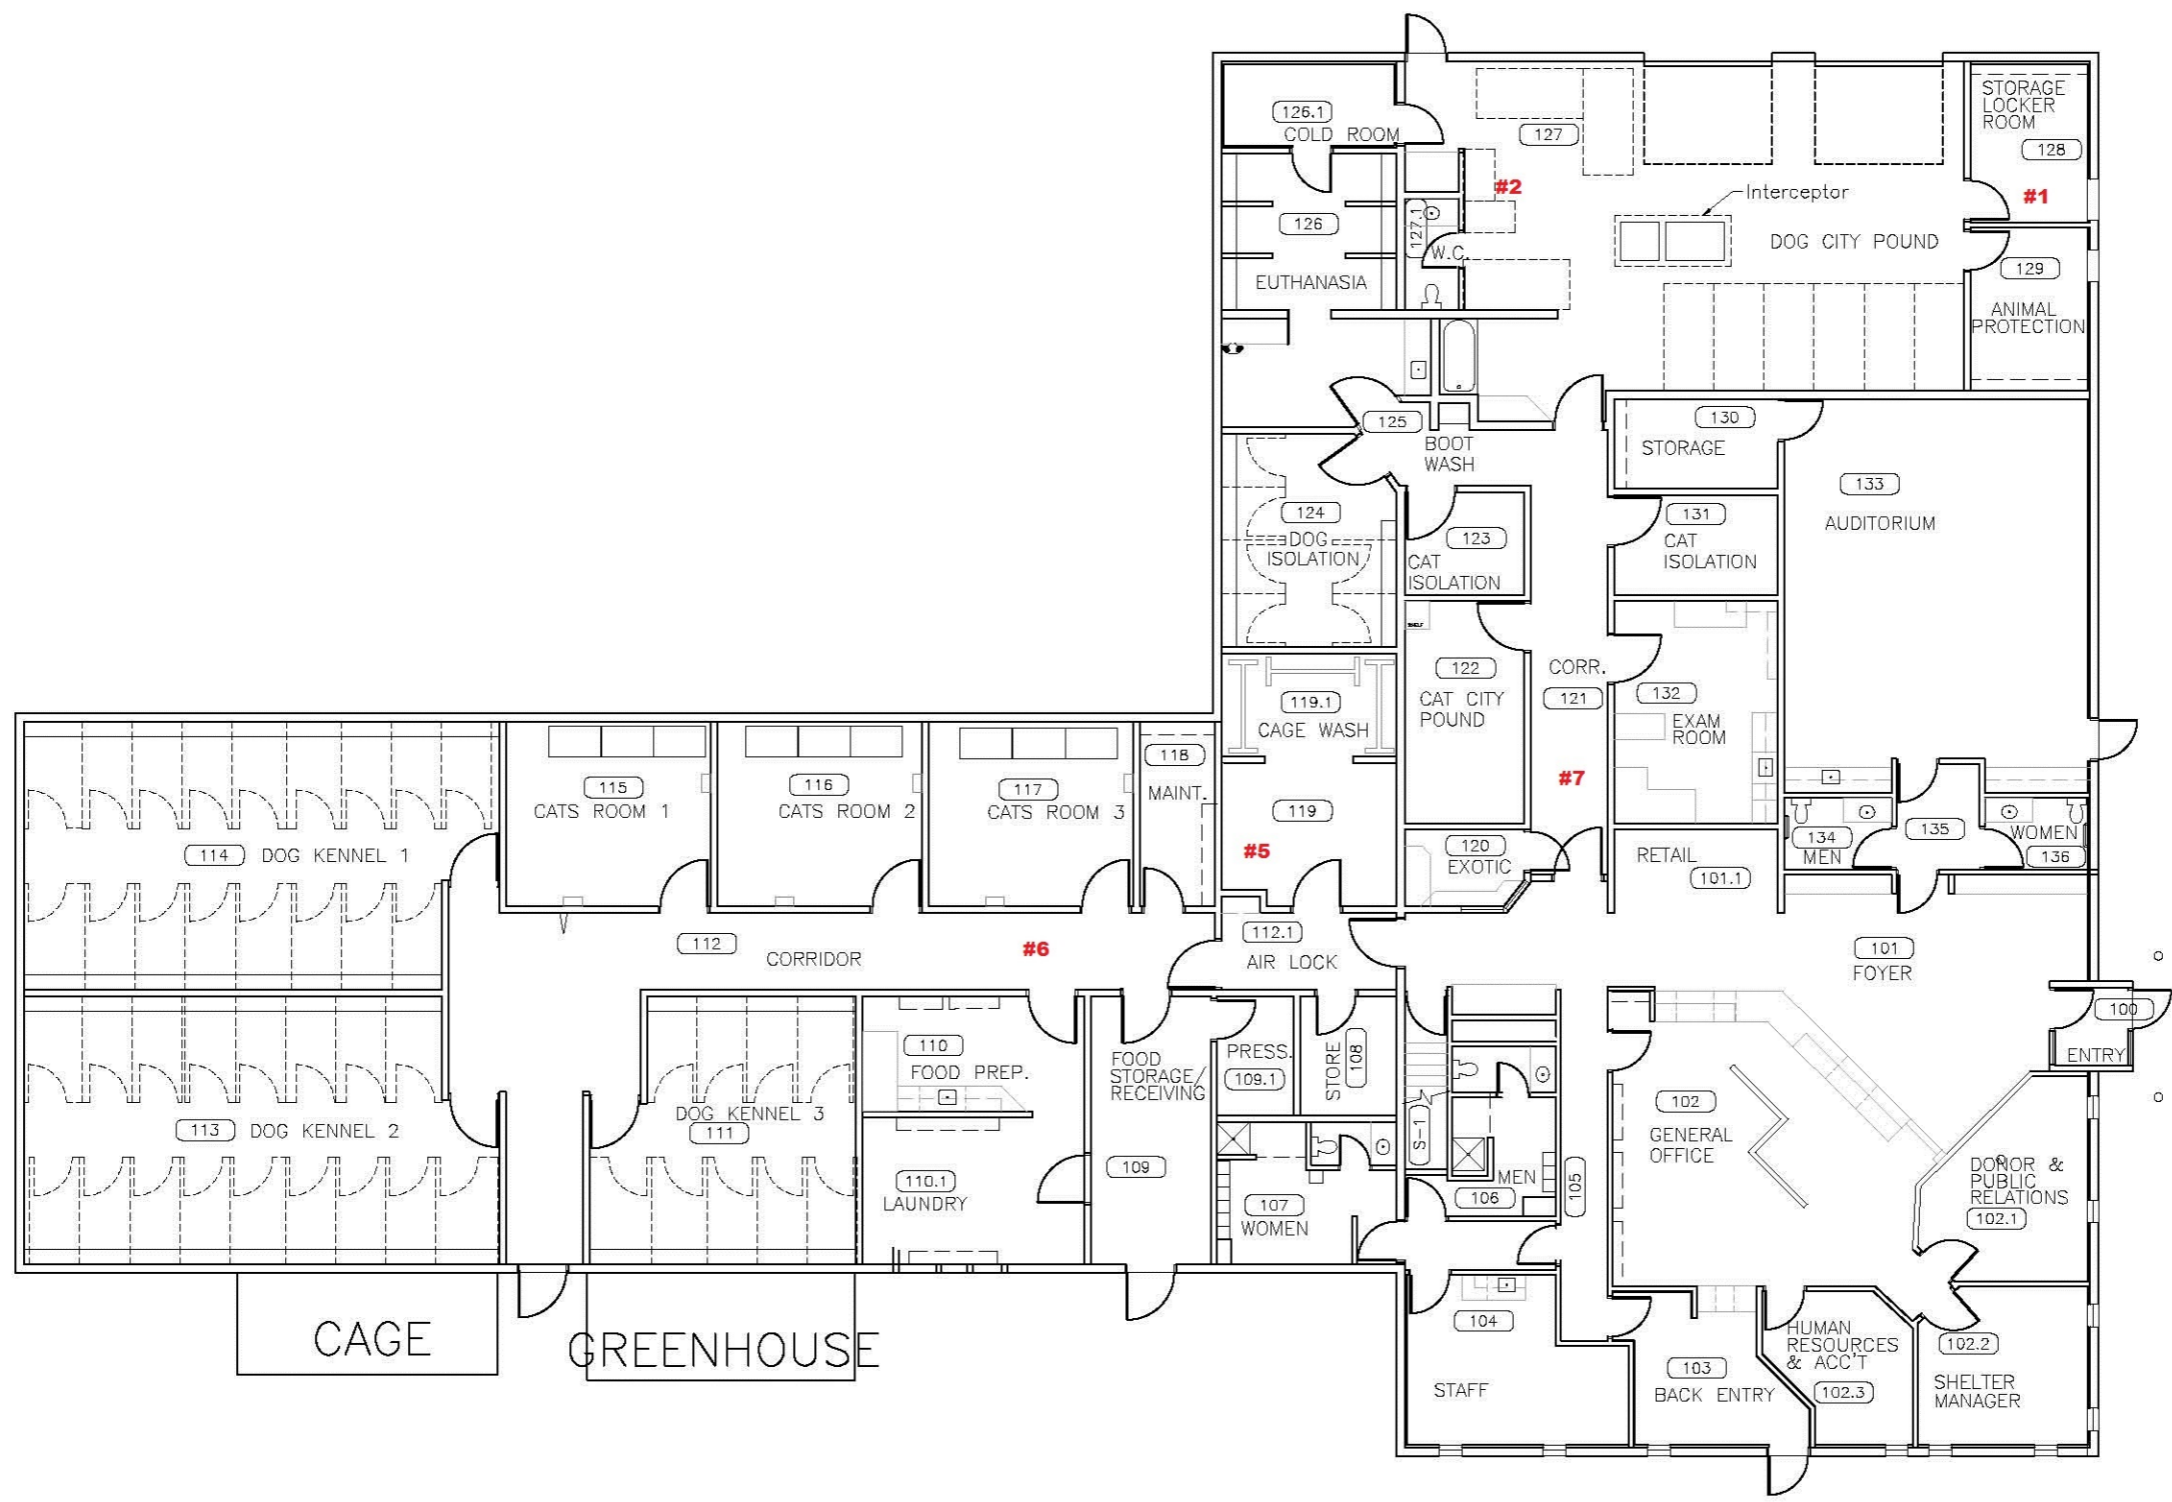
**FLOOR PLANS**

Included in *Appendix II* of this report is a **Floor Plan** of the facility identifying the bulk sample locations. **Photos** of suspect materials sampled are also included in *Appendix III*.
