**Field House  
Asbestos Survey Report**

**January 2015**

**Prepared For: City of Saskatoon Infrastructure Services - Facilities Branch**  
3130 Laurier Drive, Saskatoon, SK.  
Attn: Brent Anderson

**Prepared By: Bersch & Associates Ltd.**  
**Project No. : B67SRJ08**

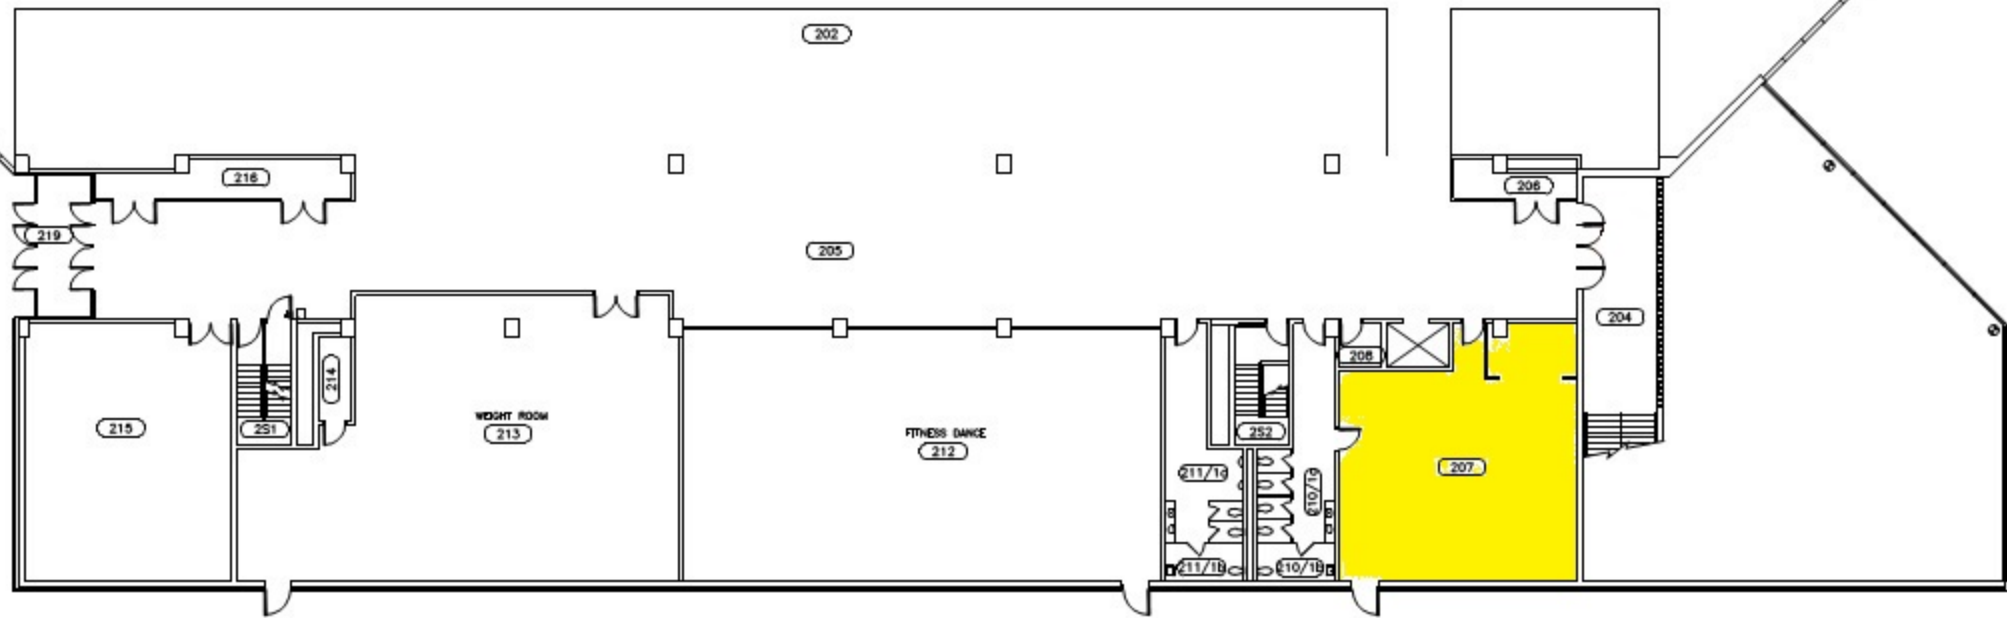
**ASBESTOS FLOOR TILE**

- **Vinyl Asbestos Floor Tile** is located in Meeting Room 151(walkway to track area) and Meeting Room 207. The Asbestos Floor Tile is identified on the **Floor Plans** in **Appendix III** of this report. It is suspected that the vinyl asbestos tile is present beneath the new layer of flooring throughout the facility. ***Further testing of any flooring beneath the top layer is recommended prior to renovations.***
