December 1, 2017

CITY OF SASKATOON

# Asbestos-Containing Building Materials Assessment Report - Silverwood Golf Course Maintenance Storage Building

**Report Number: 1667963**

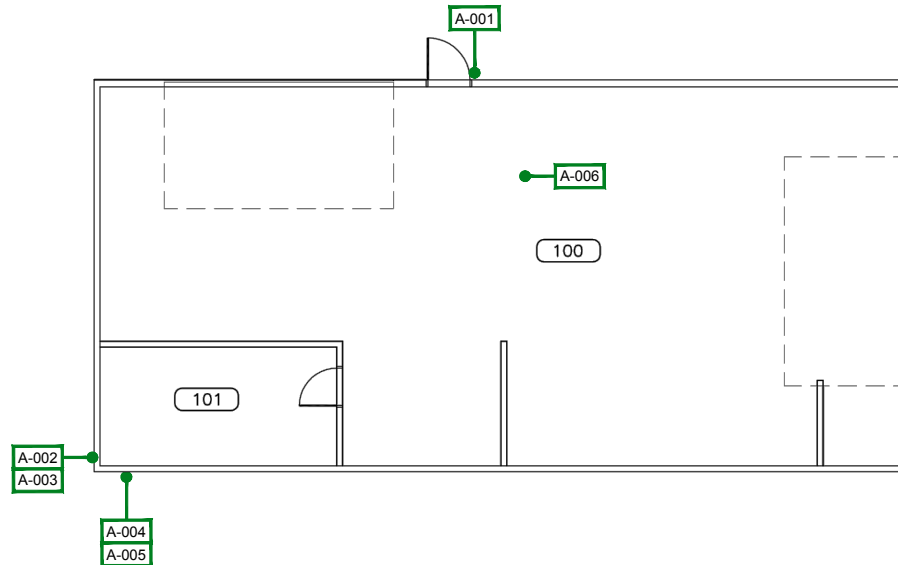
## **Floor Plans**

**NOTE(S)**  
 1. ASBESTOS IS A CARCINOGEN. DO NOT BREATHE ASBESTOS DUST.  
 2. ASBESTOS-CONTAINING BLACK DOOR CAULKING IS LOCATED ON THE BUILDING EXTERIOR.
