November 28, 2017

CITY OF SASKATOON

Asbestos-Containing Building Materials Assessment Report - Supernatant Pump Station (North 40 Sludge)

Report Number: 1667963

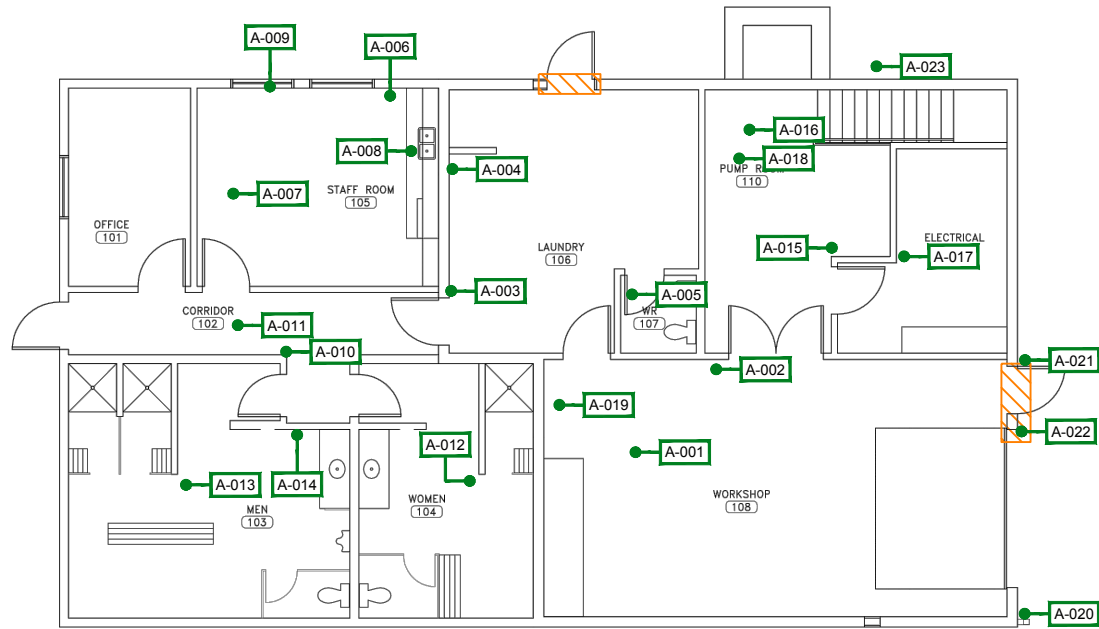
Floor Plans

One (1) sample of grey caulking was collected during the assessment. The sample collected was found to contain 0.25% Chrysotile asbestos. Asbestos-containing grey caulking (see Photograph 1 in Appendix B) was observed in the following locations:

If scheduled for impact, asbestos-containing exterior grey caulking should be abated following low-risk abatement work procedures as outlined in the *Saskatchewan Asbestos Abatement Manual (2017)*. Alternatively, as the caulking was observed in good condition, and with a priority rating of 5 (please see the room by room spreadsheet provided in Appendix C for a description of the priority ratings), the caulking can be managed in place if not scheduled for impact.
