**Trades Offices
Asbestos Survey Report**

January 2014

Prepared For: City Of Saskatoon- Infrastructure Services Department
1101 Avenue P North, Saskatoon, SK.
Attn: Brent Anderson

Prepared By: Bersch & Associates Ltd.
Project No. : B67SRD30

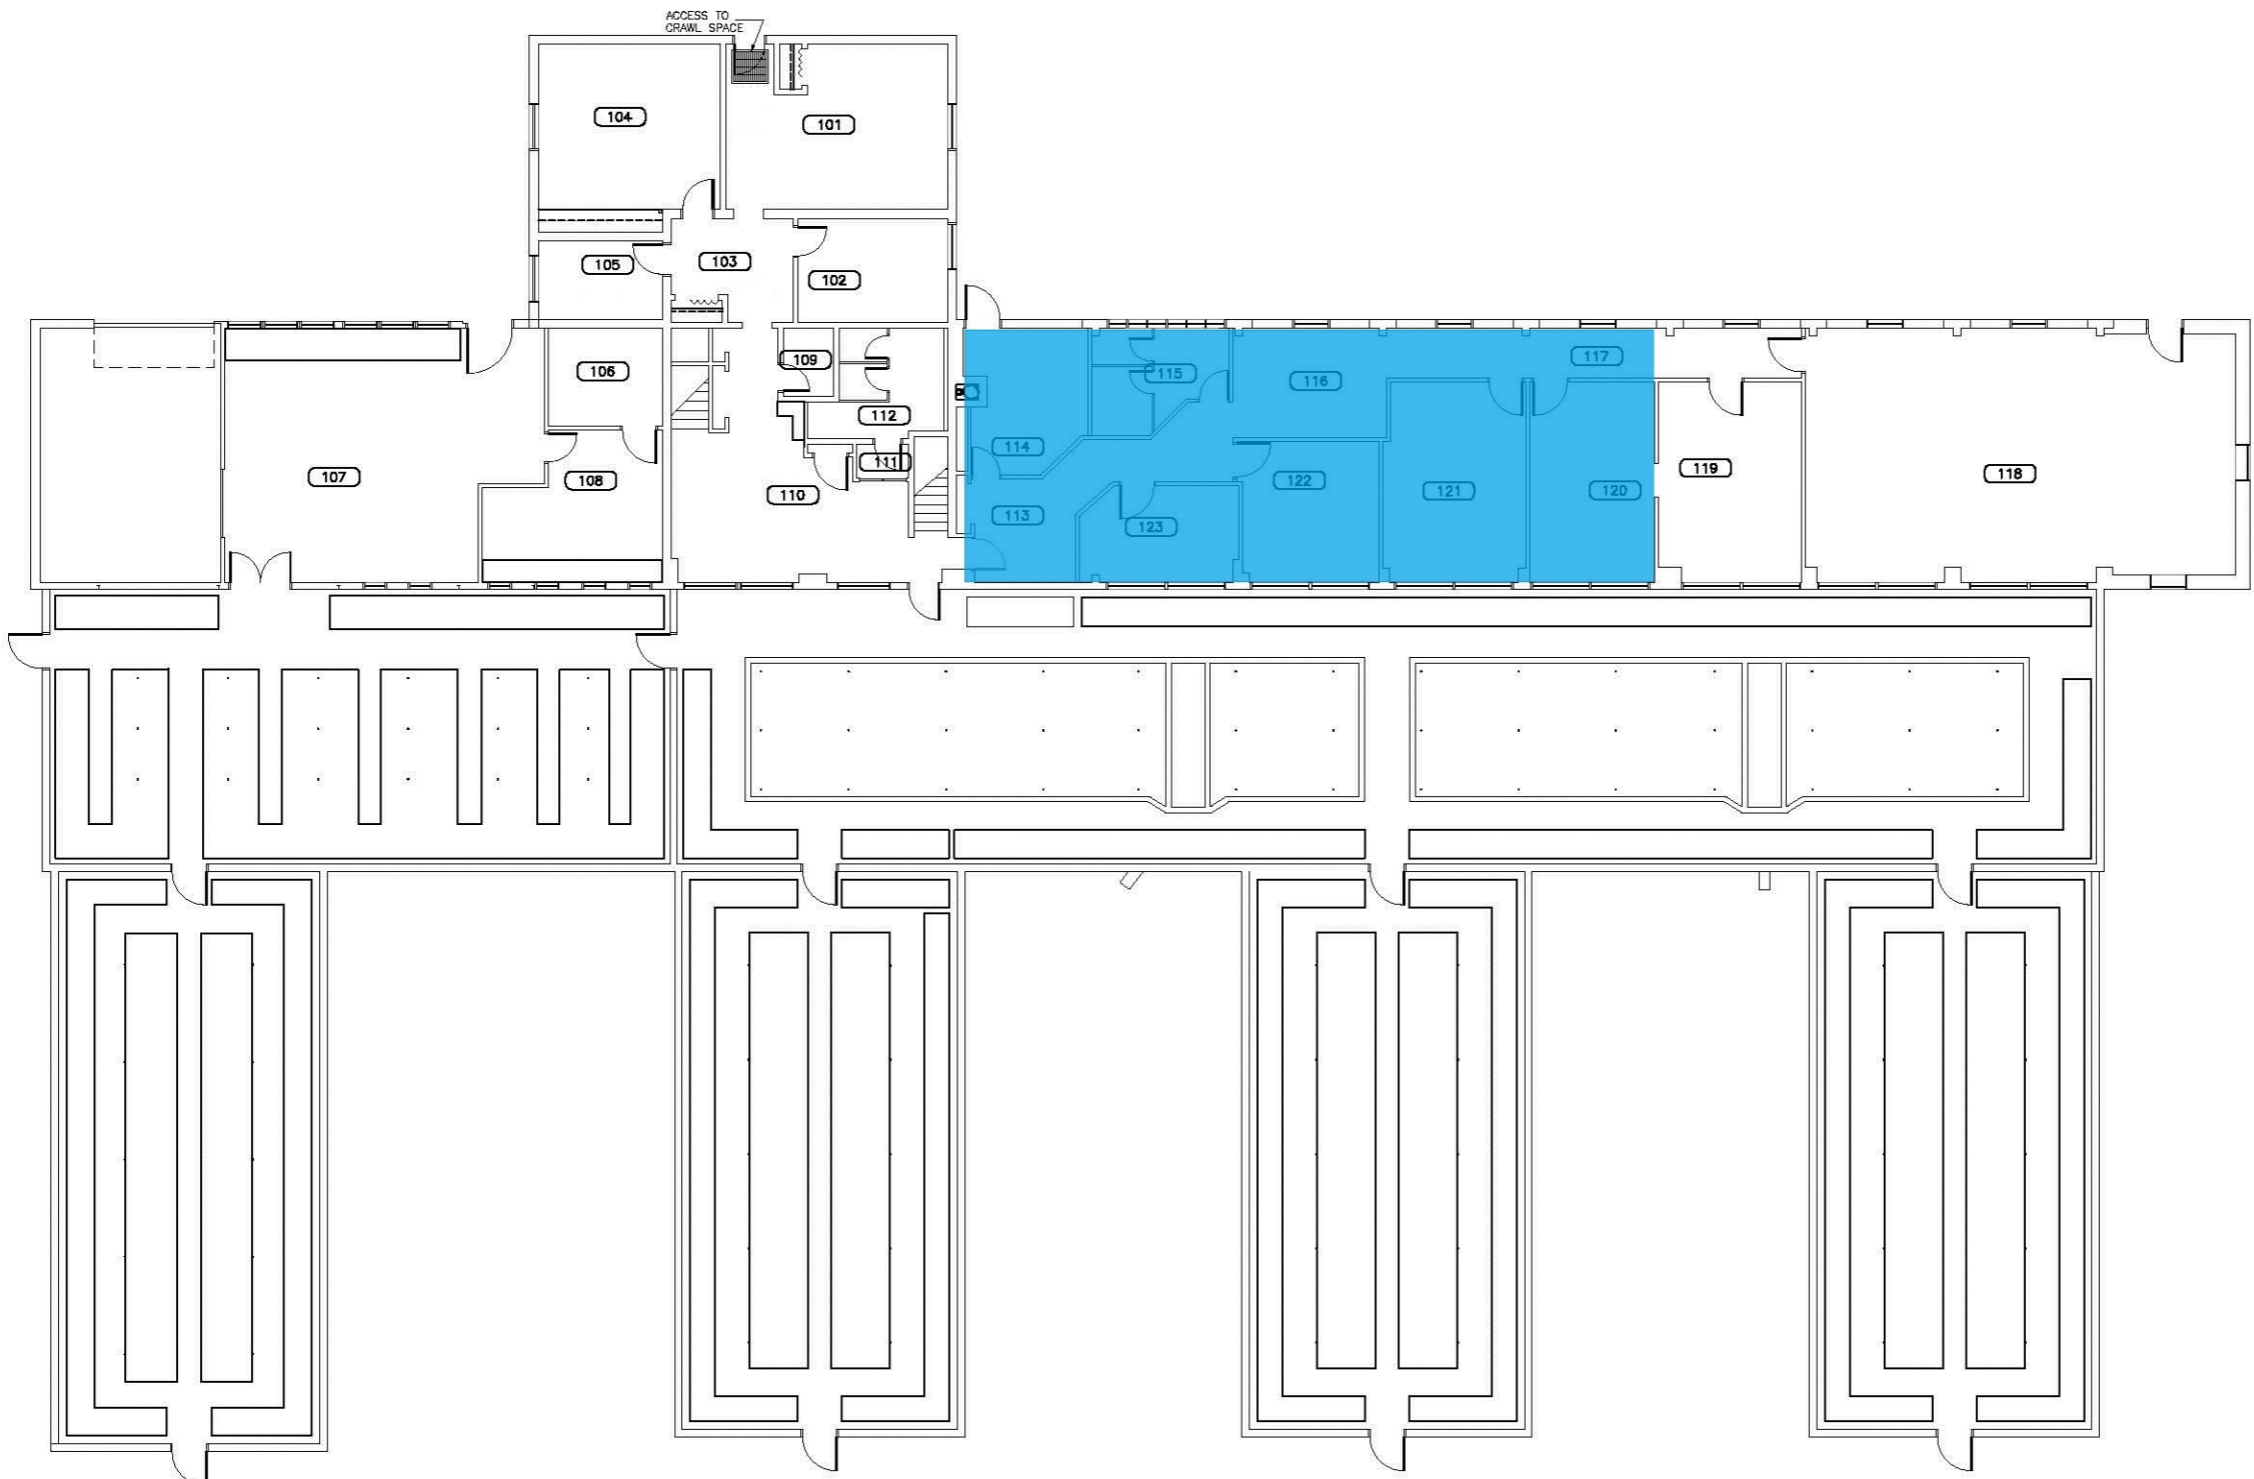
FLOOR PLANS

- **Transite Board** is located above the windows and on the ceiling above the suspended ceiling of various rooms on the ground floor.
- **Heat Shield Material** is located within the incandescent light fixture within 101 Main Entry.
