February 5, 2018

CITY OF SASKATOON

Asbestos-Containing Building Materials Assessment Report - Trailer 708

Report Number: 1667963

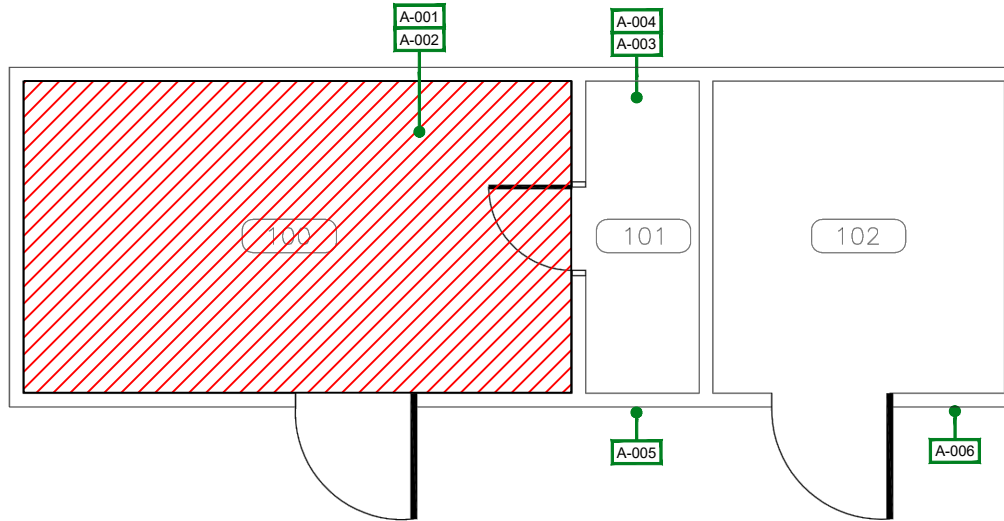
Floor Plan

One (1) sample of gold sink undercoat was collected during the assessment. The sample collected was found to contain 2.3% Chrysotile asbestos. Asbestos-containing gold sink undercoat (see Photograph 1 in Appendix B) was observed in the following location:

Removal work should be completed by workers that are adequately trained in the hazards and proper methods of working with asbestos. Throughout the abatement activities, appropriate air monitoring and inspections should be conducted by a competent person to document that contamination is contained and that ACM are disposed of appropriately. Ensure asbestos waste is disposed of in accordance with the requirements of the Government of Saskatchewan.
