CITY OF SASKATOON

Asbestos-Containing Building Materials Assessment Report - Transit Body Shop

Report Number: 1667963

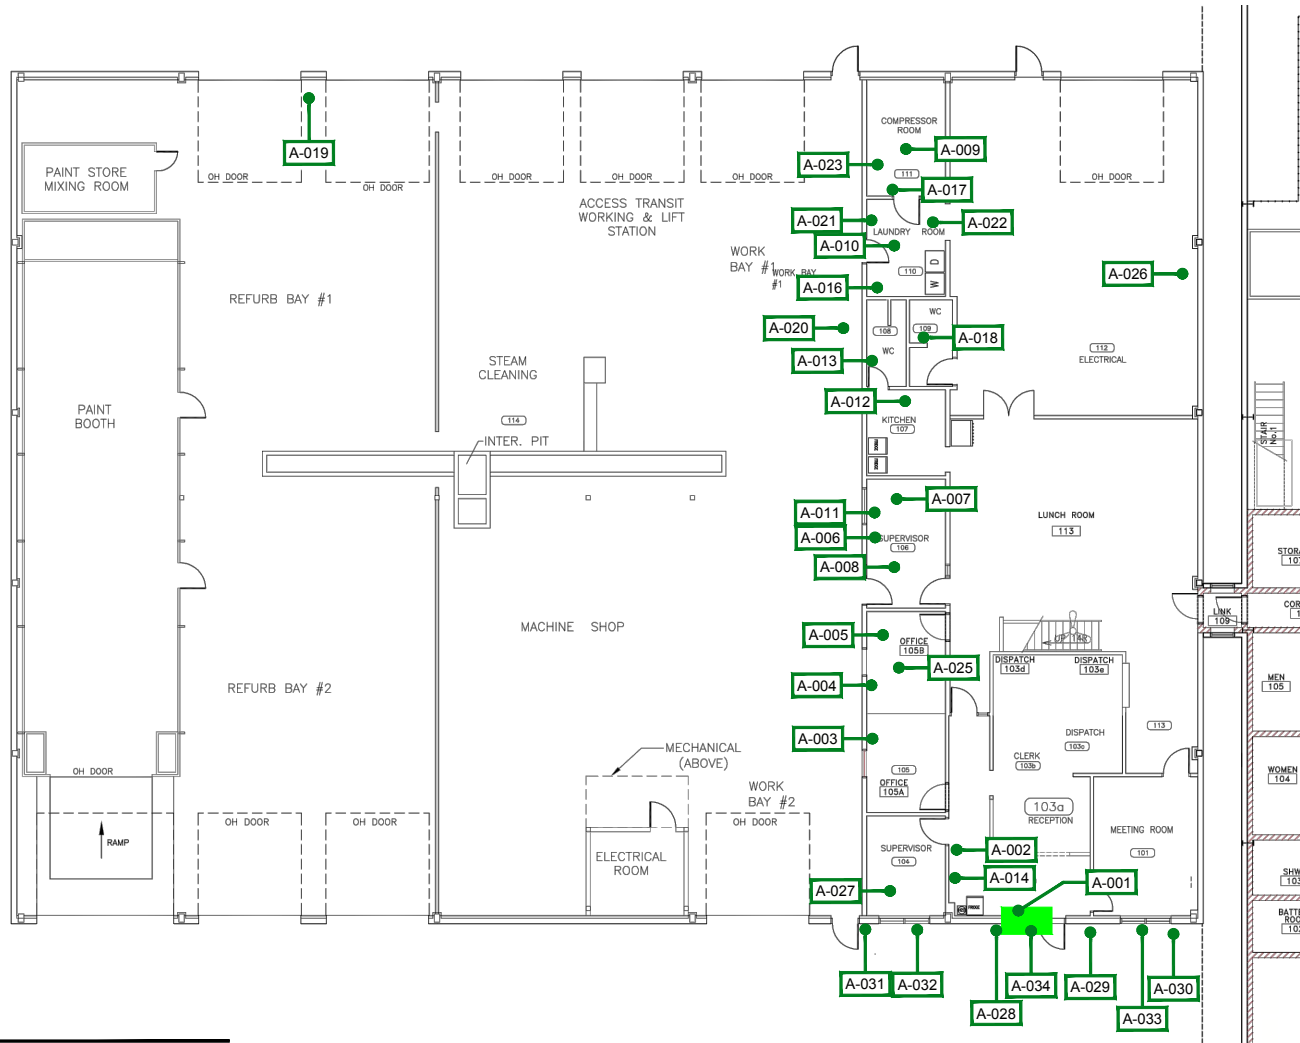
Floor Plans

One (1) sample of black window caulking was collected during the assessment. The sample collected was found to contain 5.6% Chrysotile asbestos. Asbestos-containing black window caulking (see Photograph 1 in Appendix B) was observed in the following locations:
