December 7, 2017

## CITY OF SASKATOON

# Asbestos-Containing Building Materials Assessment Report - Water Meter Shop

**Report Number: 1667963**

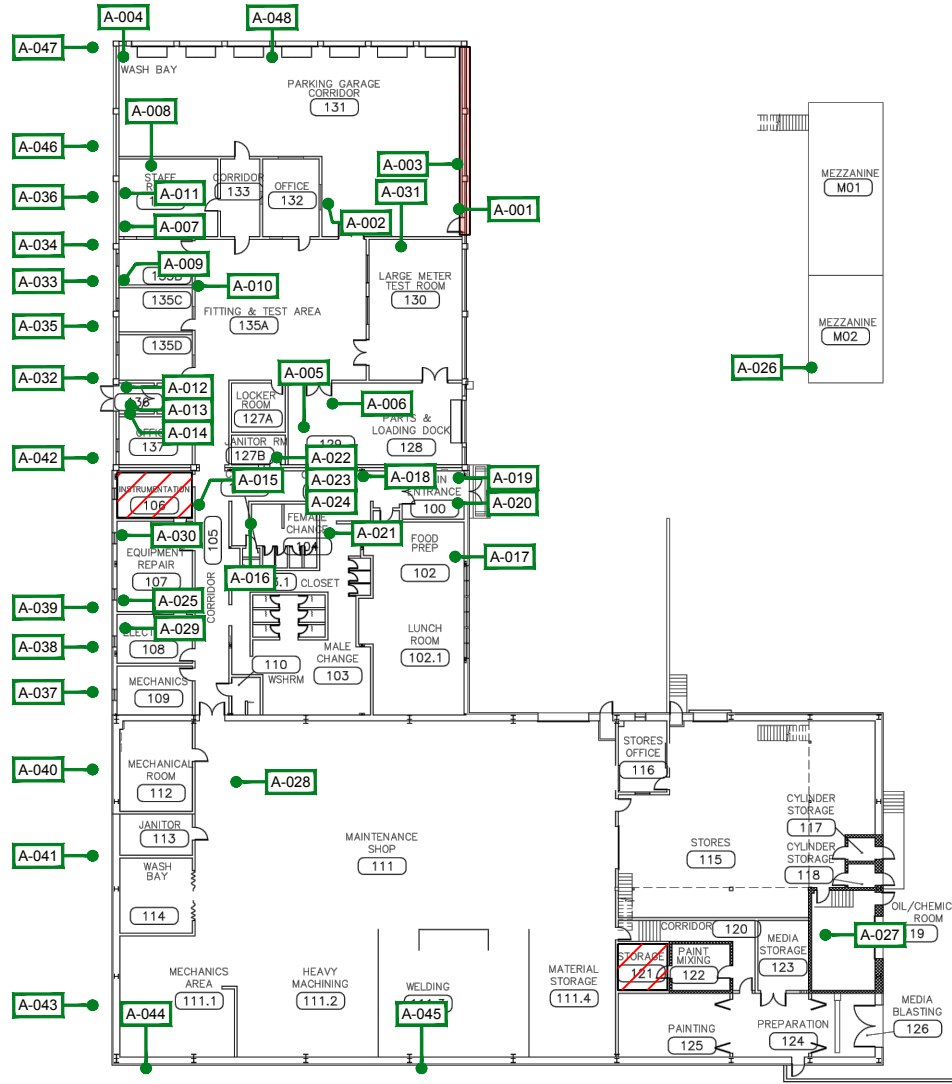
## **Floor Plan**

One (1) sample of loose-fill vermiculite insulation was collected during the assessment. The sample collected was found to contain trace amount of Actinolite asbestos. Asbestos-containing loose-fill vermiculite insulation (see Photograph 1 in Appendix B) was observed to have leaked from the wall cavity in Room 131. The loose vermiculite was subsequently cleaned by the Client following its identification.

- NOTE(S)**
1. ASBESTOS IS A CARCINOGEN. DO NOT BREATHE ASBESTOS DUST.
  2. ADDITIONAL ASBESTOS-CONTAINING VERMICULITE INSULATION MAY BE LOCATED IN OTHER CINDERBLOCK WALLS THROUGHOUT THE SITE.

Removal work should be completed by workers that are adequately trained in the hazards and proper methods of working with asbestos. Throughout the abatement activities, appropriate air monitoring and inspections should be conducted by a competent person to document that contamination is contained and that ACM are disposed of appropriately. Ensure asbestos waste is disposed of in accordance with the requirements of the Government of Saskatchewan.
