CITY OF SASKATOON

Asbestos-Containing Building Materials Assessment Report - Avenue C Substation

Report Number: 1667963

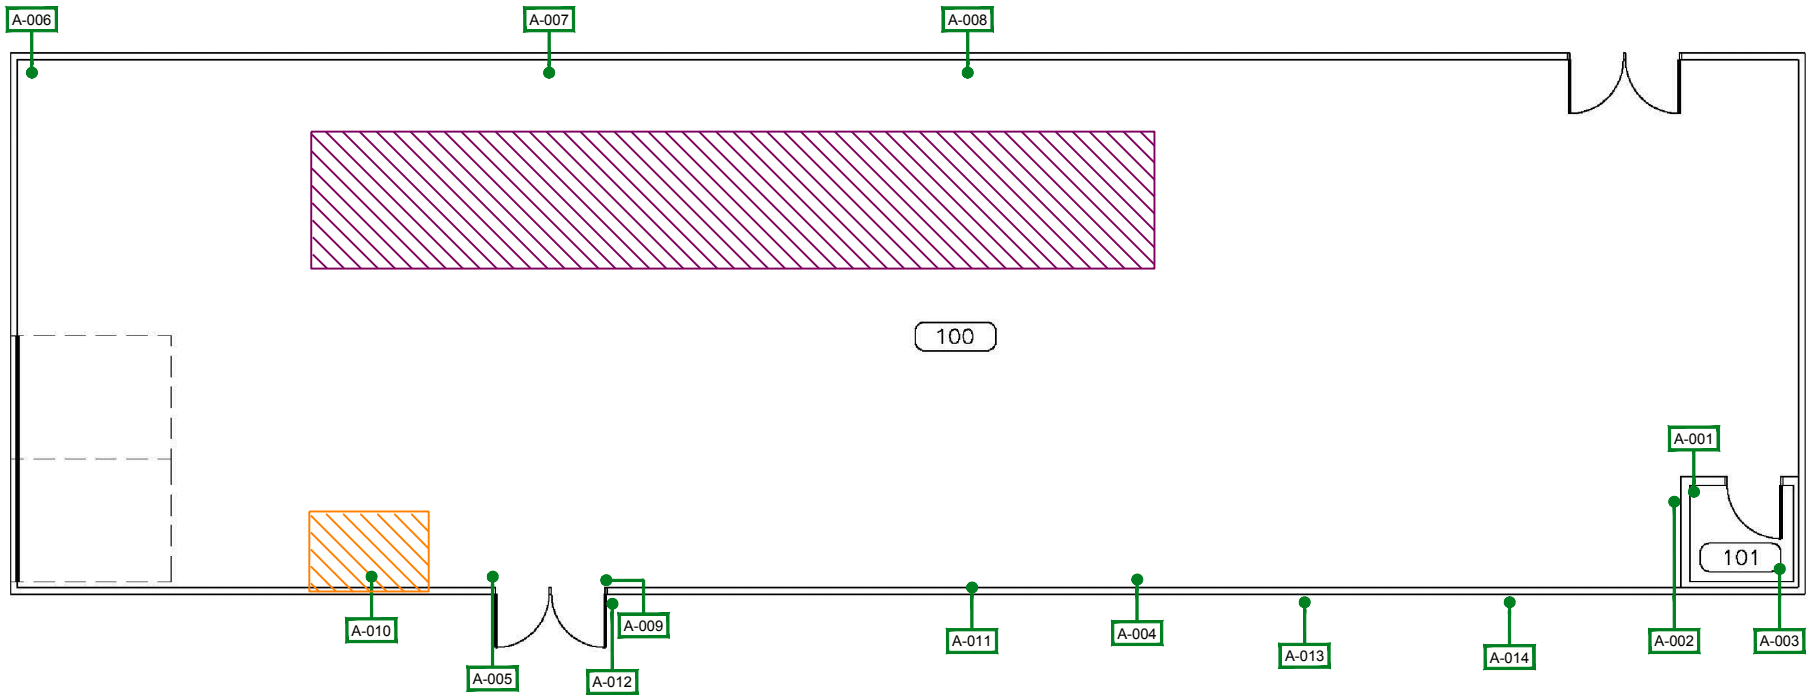
Floor Plan

One (1) sample of grey firestop was collected during the assessment. The sample was found to contain 2.4% Chrysotile asbestos. The asbestos-containing grey firestop was observed to be in good condition at the time of the assessment and in a non-friable form. Asbestos-containing grey firestop (see Photograph 1) was observed in the following locations:
