**City Hall
Asbestos Survey Report**

January 2015

Prepared For: City of Saskatoon Infrastructure Services - Facilities Branch
3130 Laurier Drive, Saskatoon, SK.
Attn: Brent Anderson

Prepared By: Bersch & Associates Ltd.
Project No. : B67SRA14

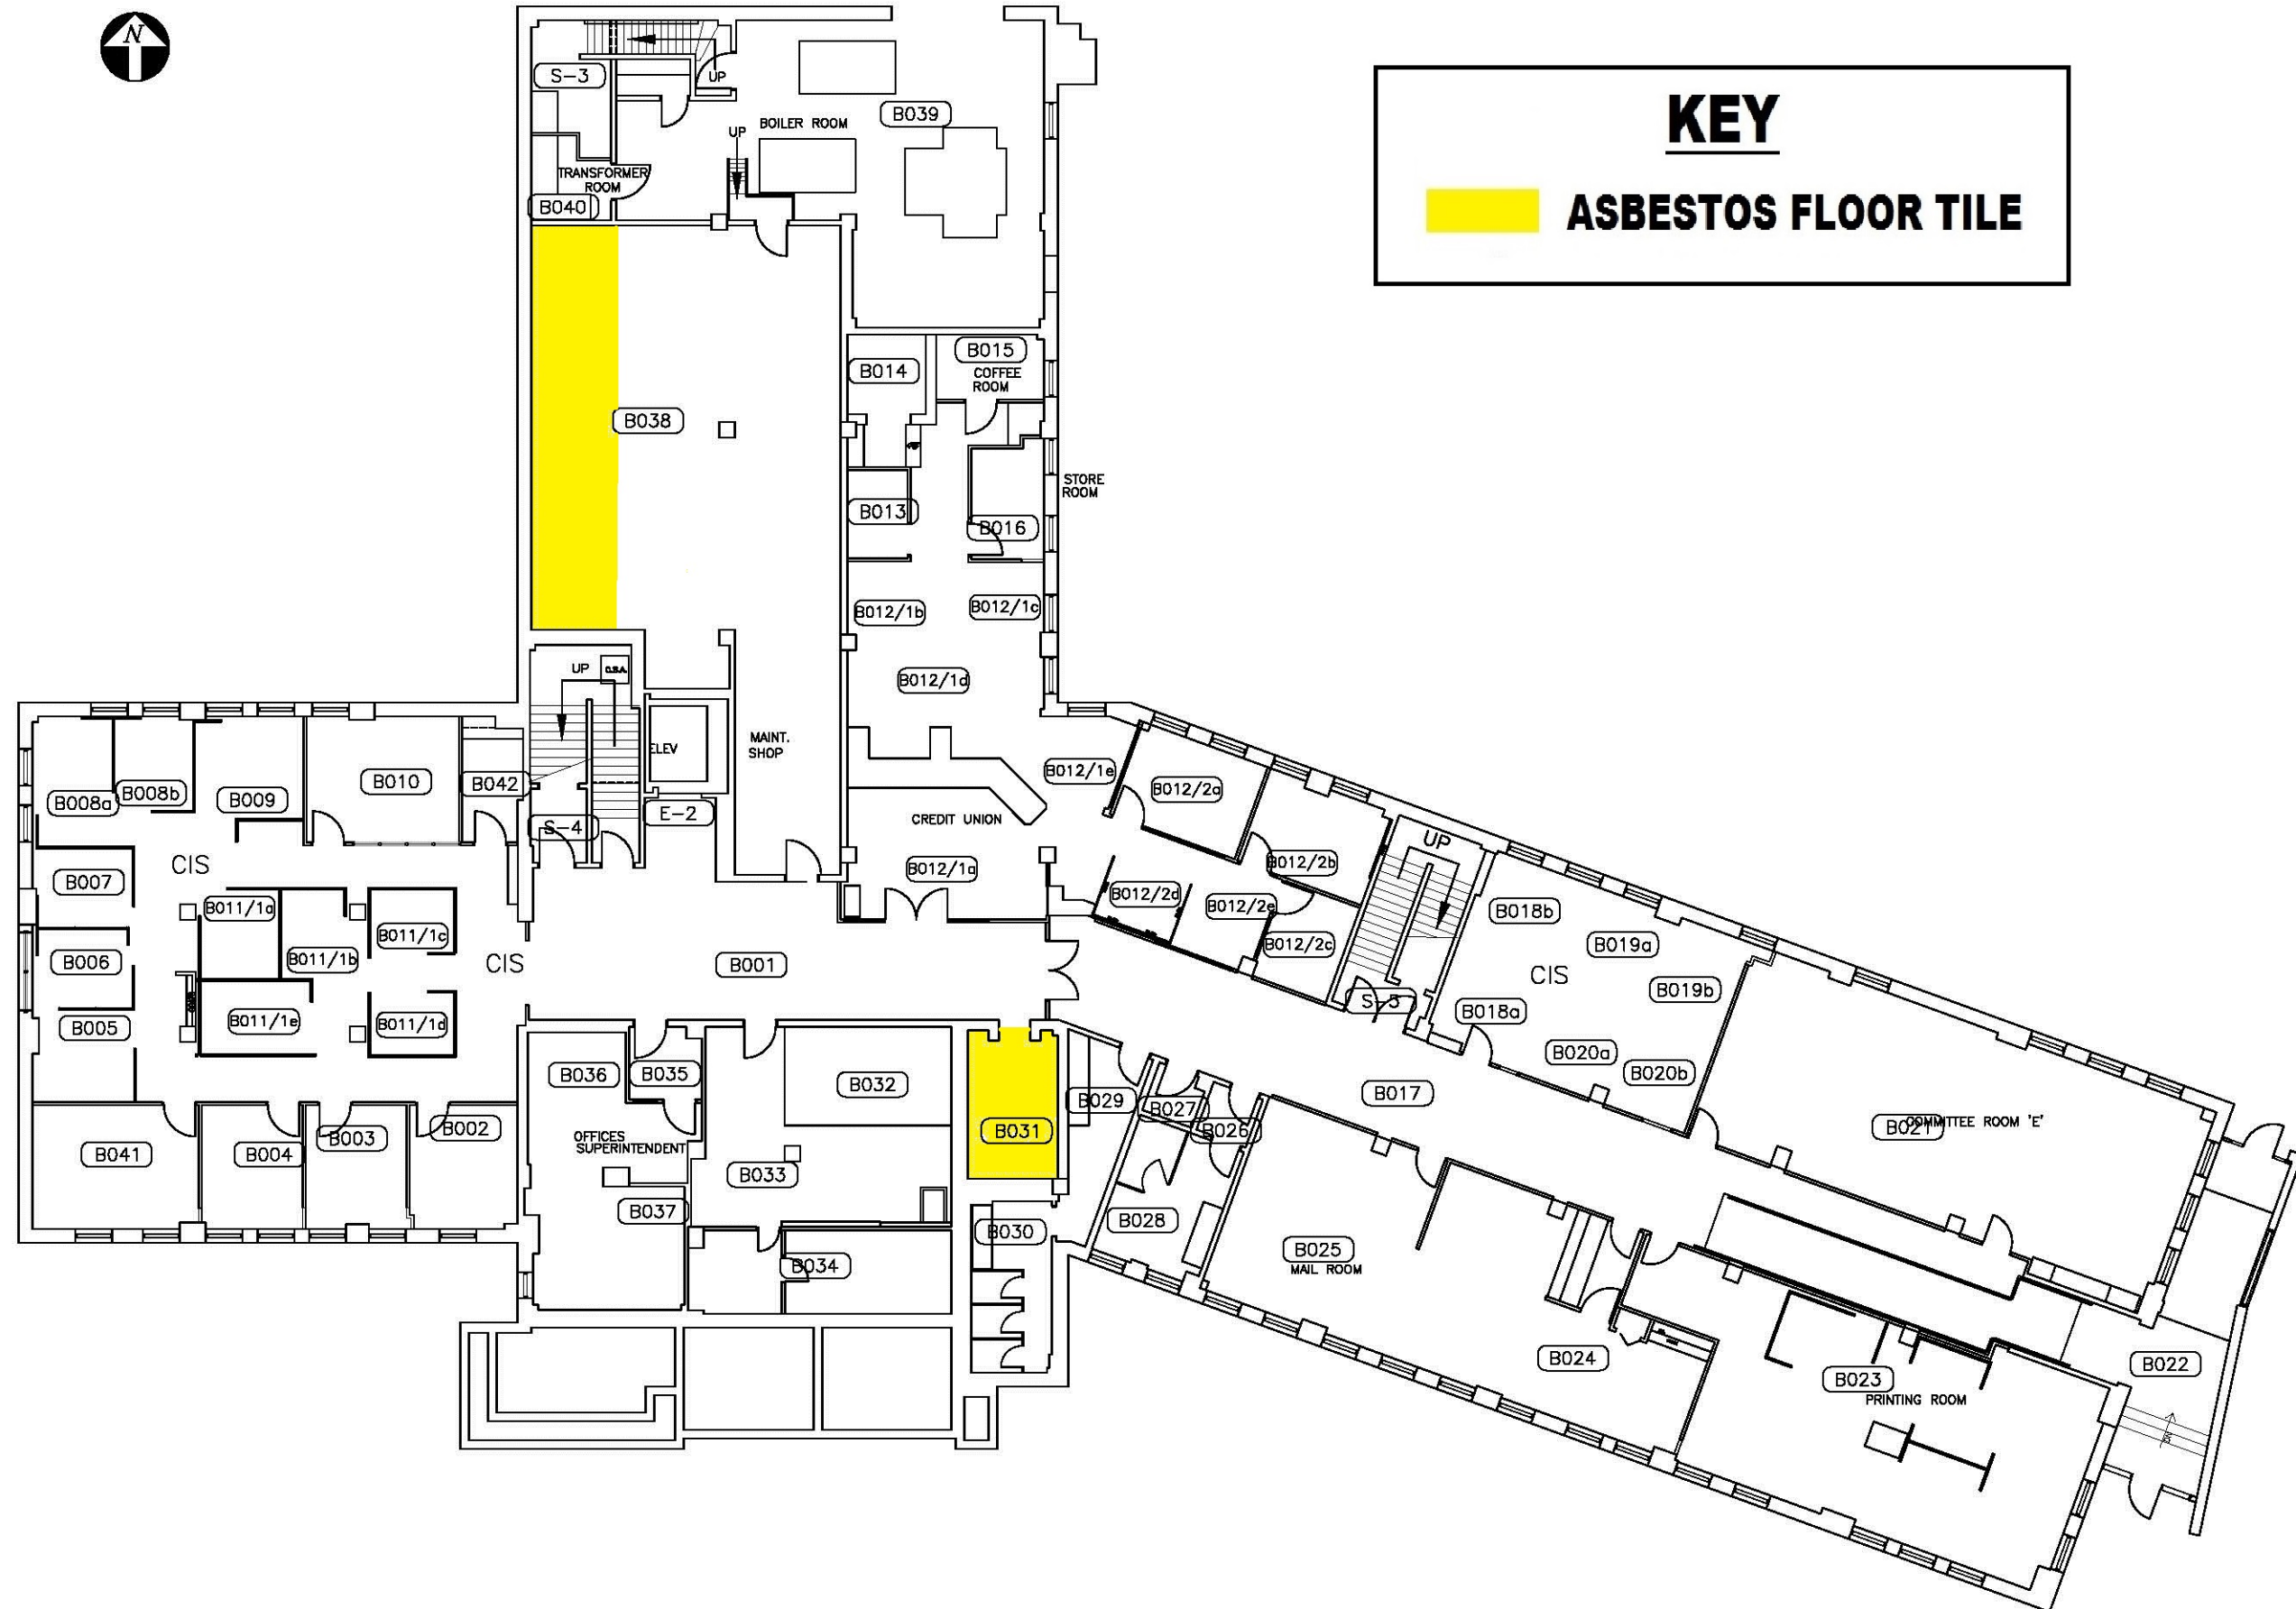
- **Vinyl Asbestos Floor Tile** is located in various rooms throughout the City Hall Building. The Asbestos Floor Tile is identified on the **Floor Plans** in **Appendix III** of this report.

- **Vinyl Asbestos Sheet Flooring** is located in various rooms throughout the City Hall Building. The Asbestos Floor Tile is identified on the **Floor Plans** in **Appendix III** of this report.

ASBESTOS FLOOR TILE
