**City of Saskatoon
Civic Square East
202 4th Ave North, Saskatoon, Sk.**

**Asbestos Survey Report
November 2016**

**Prepared By: Bersch & Associates Ltd.
Project No.: B40SRH29F**

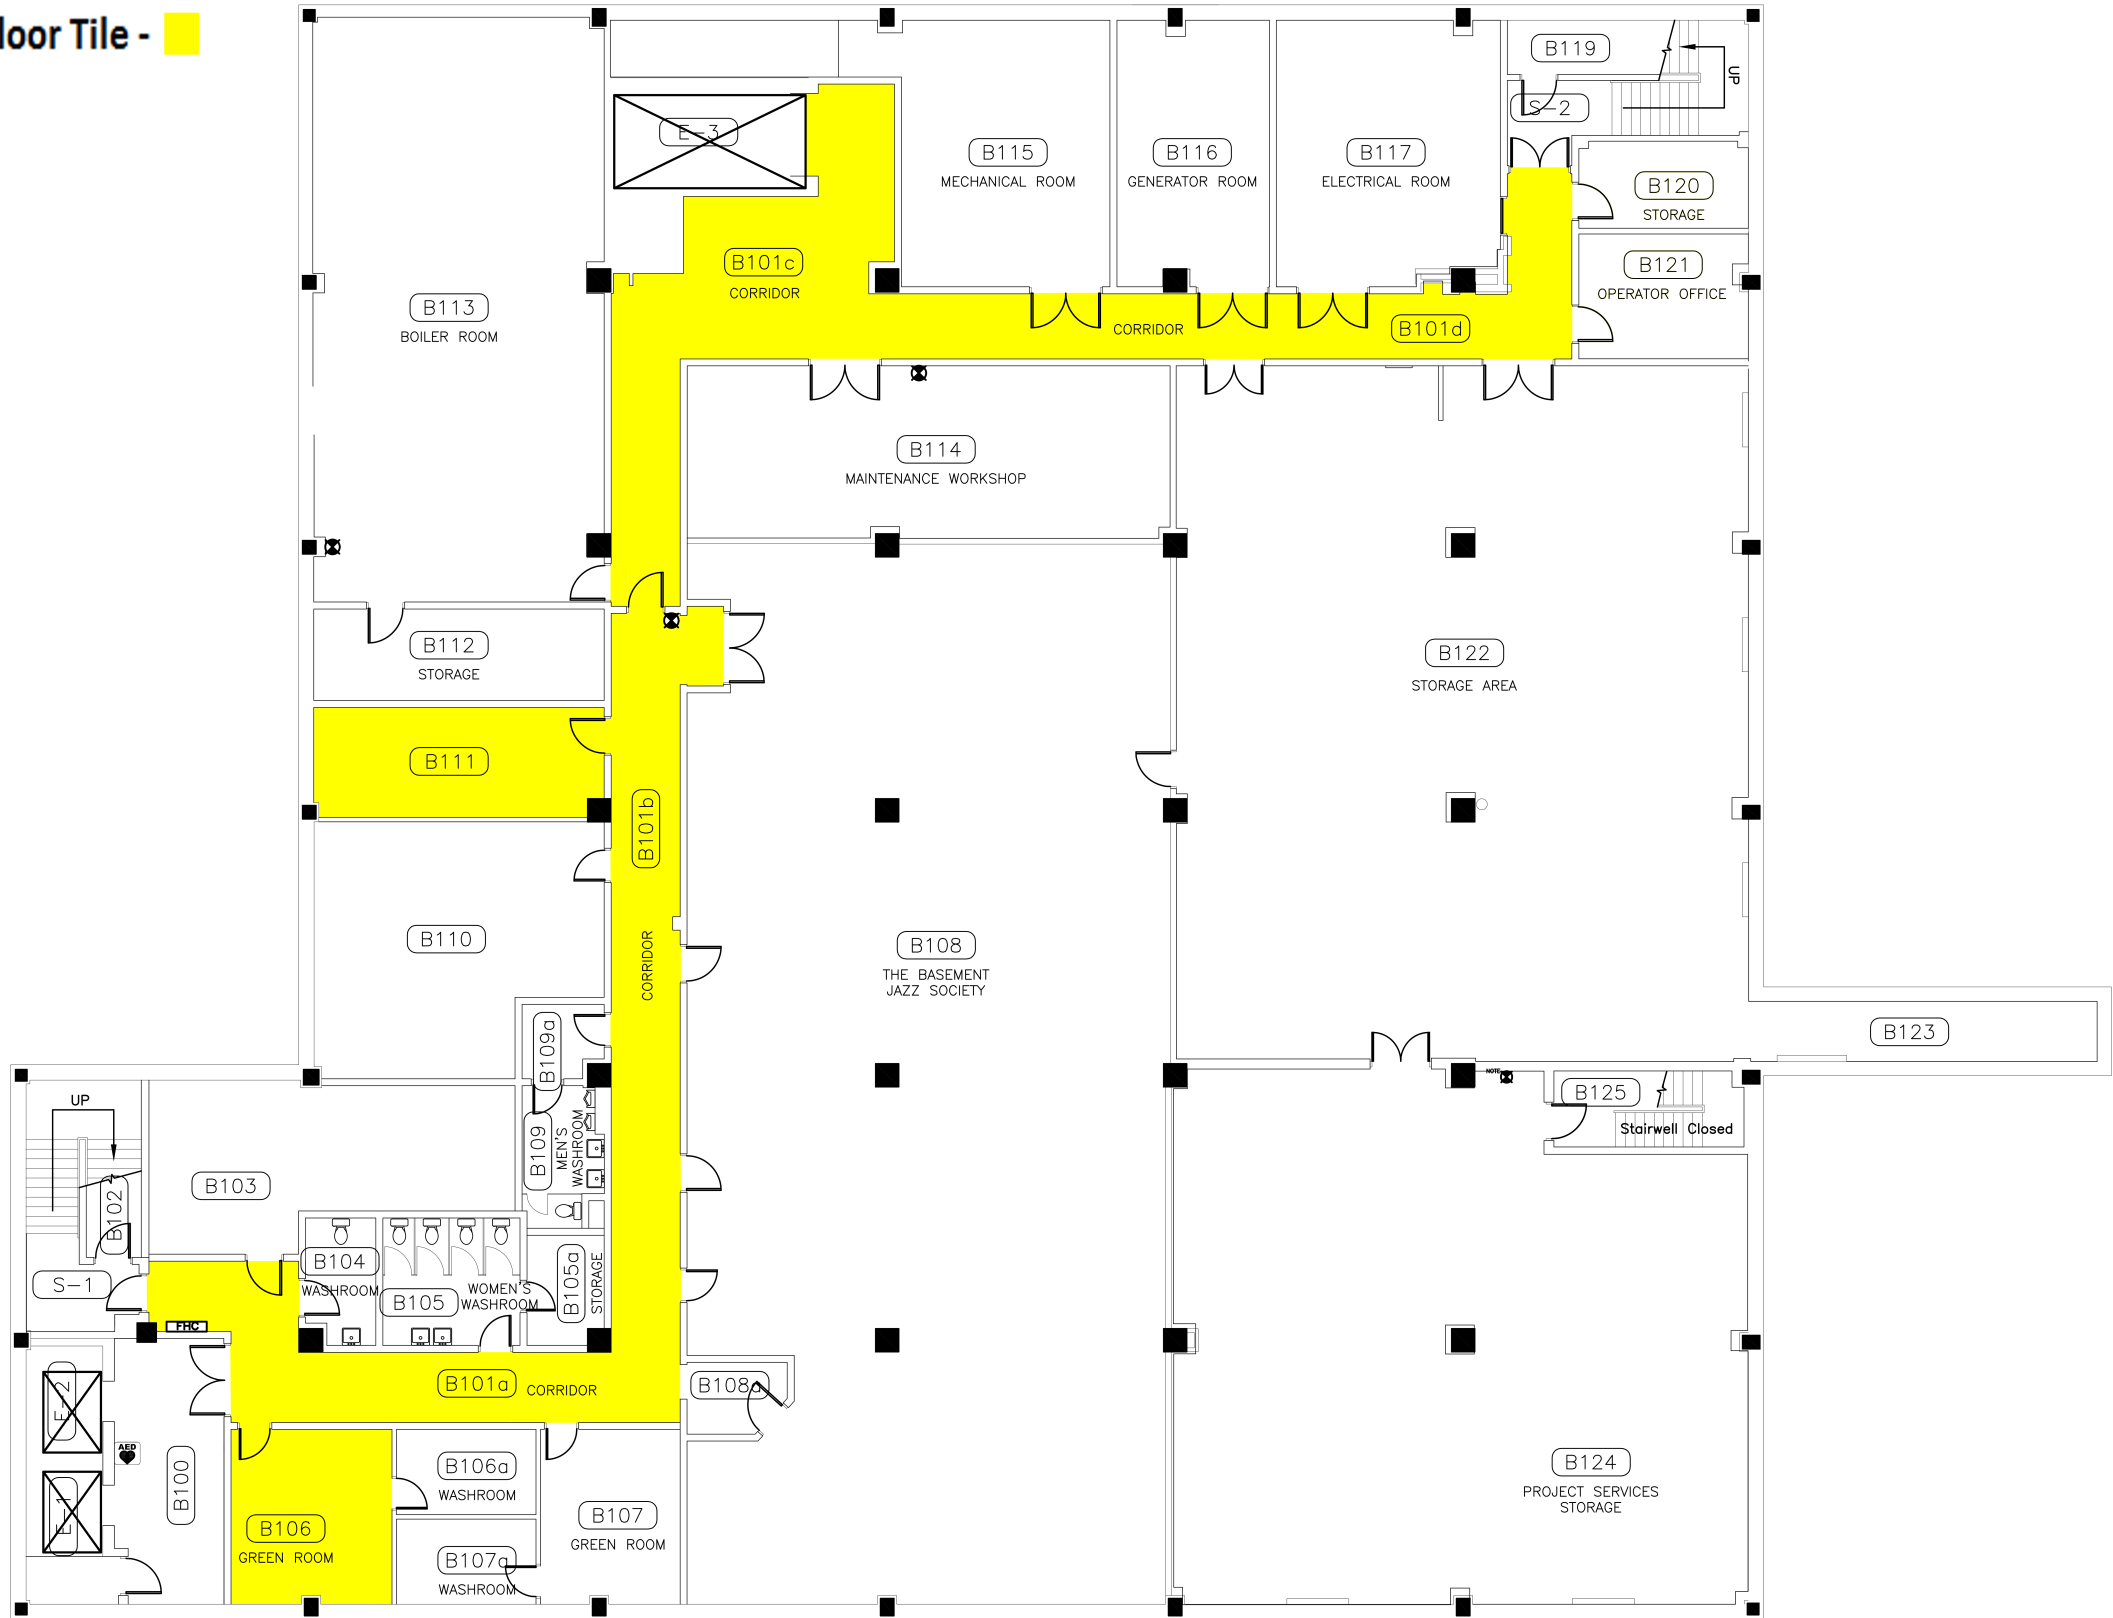
- **Vinyl Asbestos Floor Tile (VAT)** was observed in various areas throughout the basement level of the building. Please refer to **Appendix II & Appendix III** of this report. The VAT is identified on the Floor Plans located in **Appendix III** of this report.
