October 4, 2017

## CITY OF SASKATOON AND GENERAL MANAGEMENT SERVICES

# Asbestos-Containing Building Materials Assessment Report - Essex Plaza

**Report Number: 1779656**

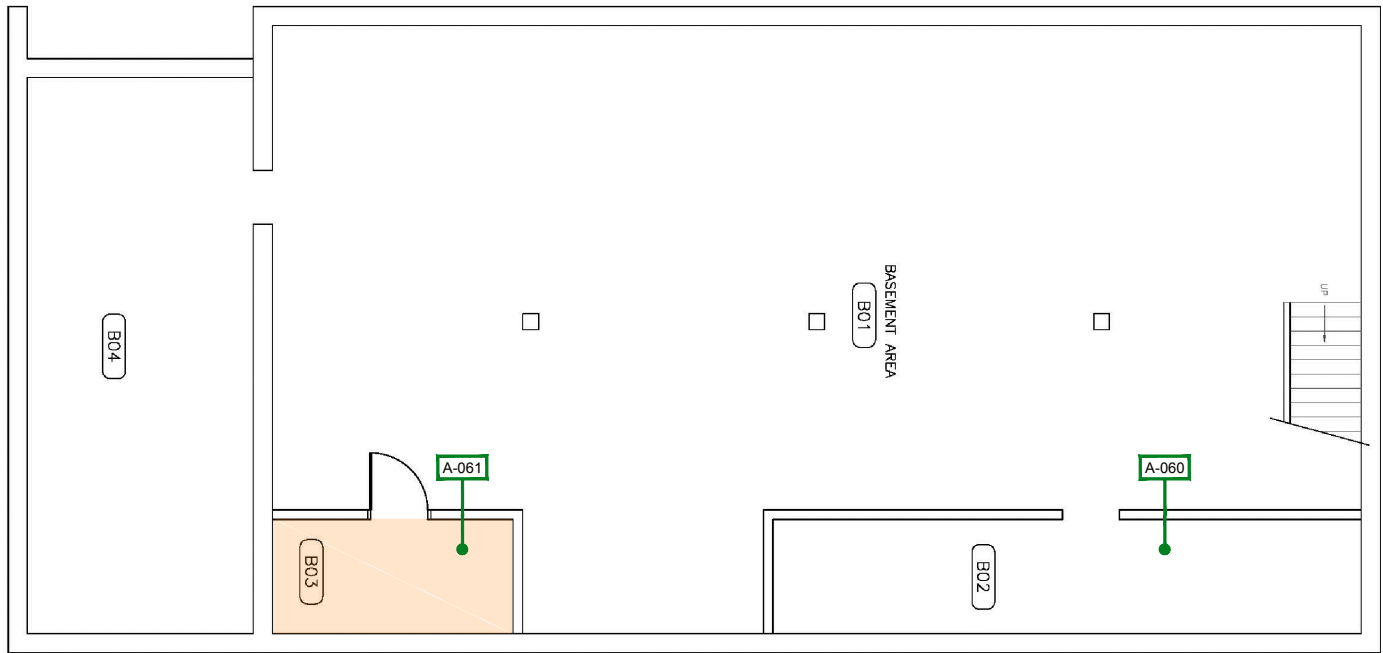
FIGURE 1

- ASBESTOS SAMPLE LOCATION
- ASBESTOS - CONTAINING DRYWALL JOINT COMPOUND

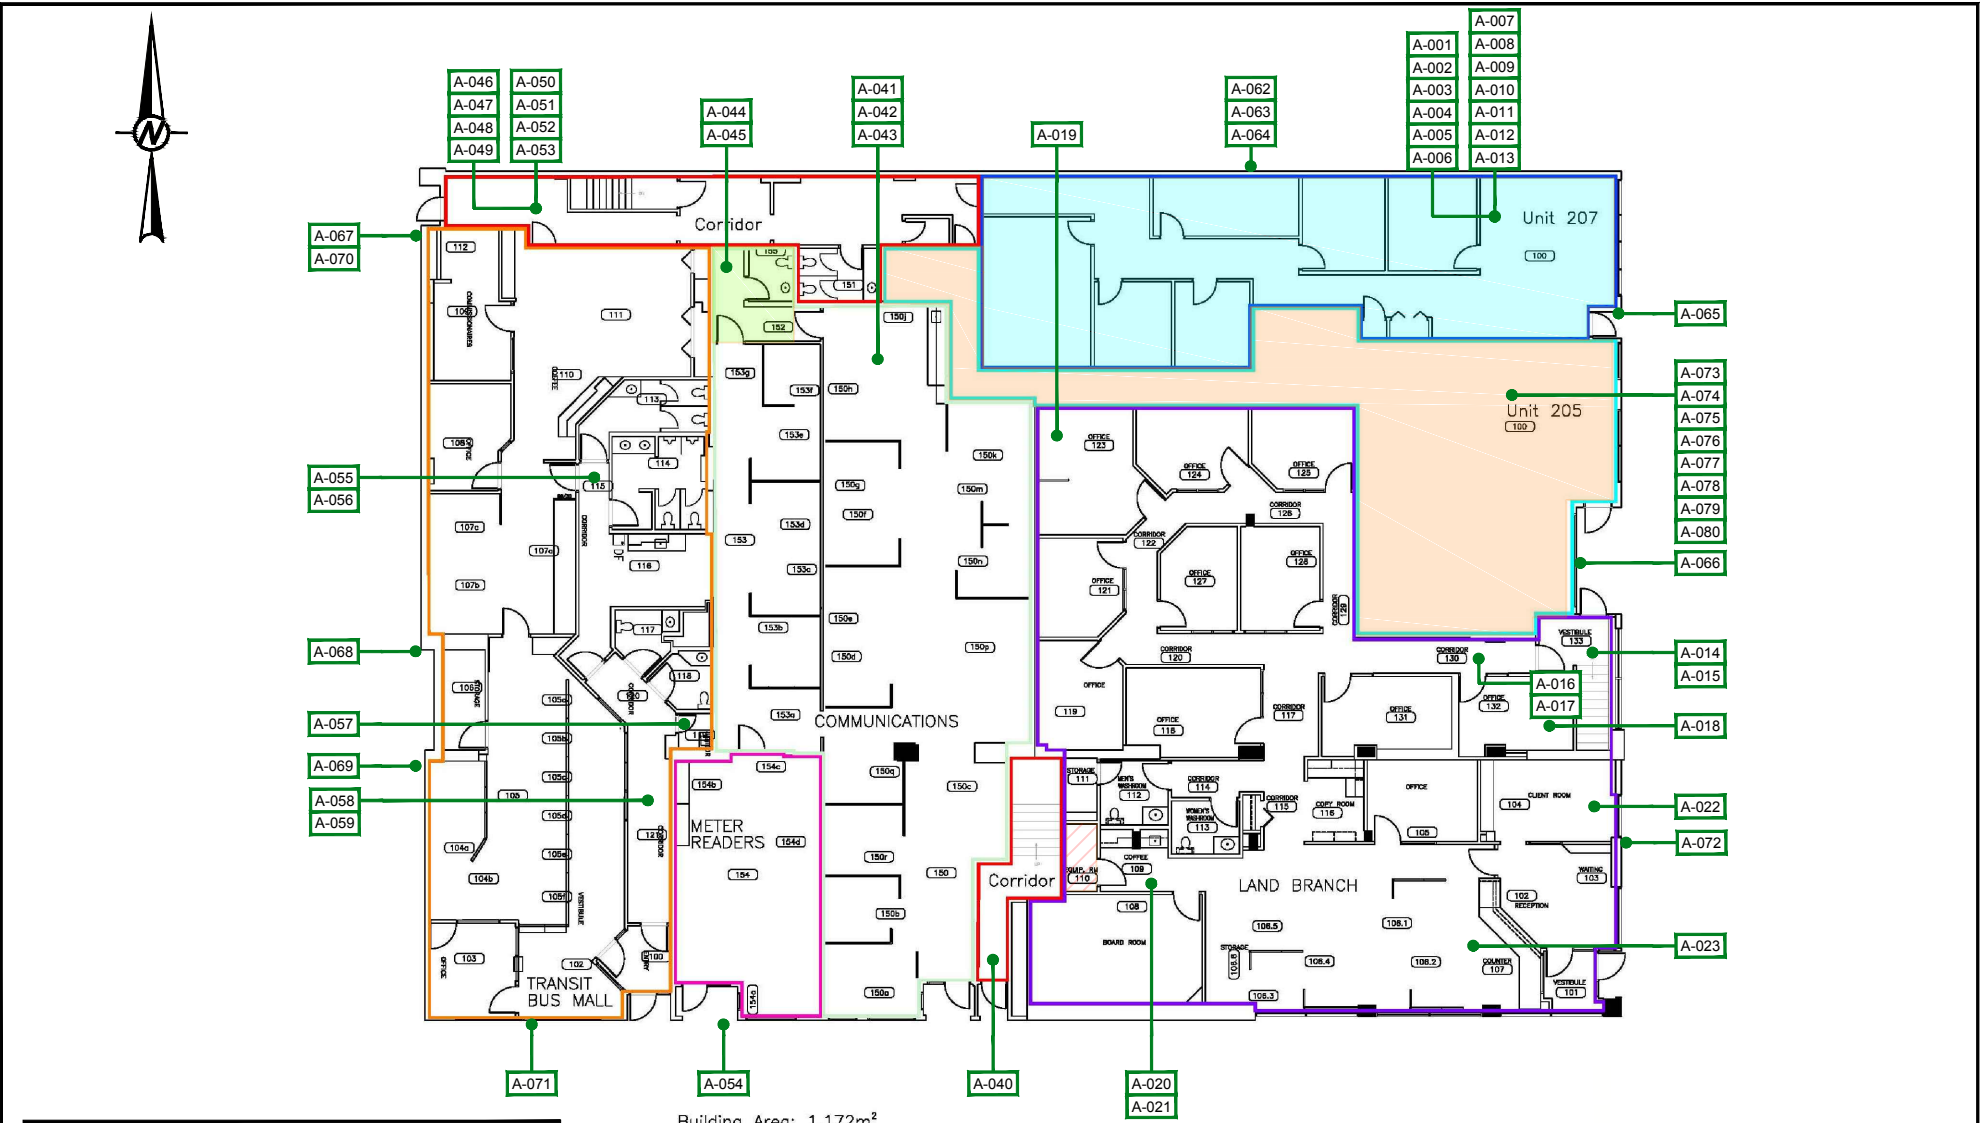
PROJECT NO.	CONTROL	REV.	FIGURE
1667963	1000-HM-0001	0	2

- ASBESTOS SAMPLE LOCATION
- ASBESTOS-CONTAINING FLOOR TILE
- ASBESTOS-CONTAINING FLOOR TILE, FLOOR TILE ON PLYWOOD CEILING AND WINDOW CAULKING
- ASBESTOS - CONTAINING DRYWALL JOINT COMPOUND, WINDOW CAULKING AND FLOOR TILE
- NO ACCESS
