SUBJECT: Fire Hall #6 - Asbestos Registry Report

FINAL
**Limited Asbestos
Building Materials
Assessment**

Fire Hall #6 Cable Drop Project
3309 Taylor Street East,
Saskatoon, Saskatchewan

April 4, 2017

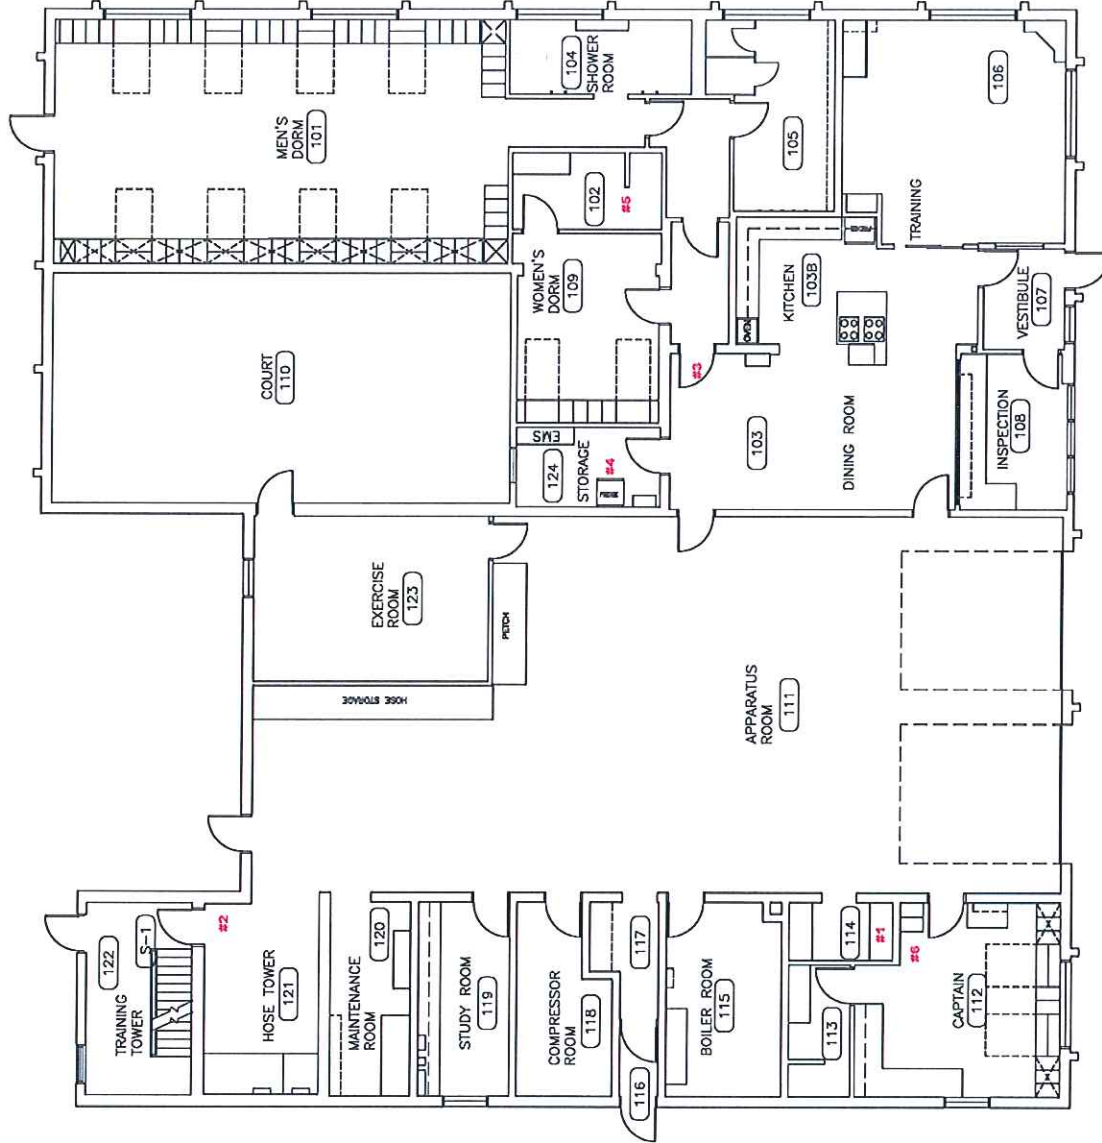
SHEET 1

Also included is a floor plan of the facility identifying the bulk sample locations. Photos of suspect materials sampled are also included following the floor plans.
