CITY OF SASKATOON

Asbestos-Containing Building Materials Assessment Report - Holiday Park Golf Course Maintenance Building

Report Number: 1667963

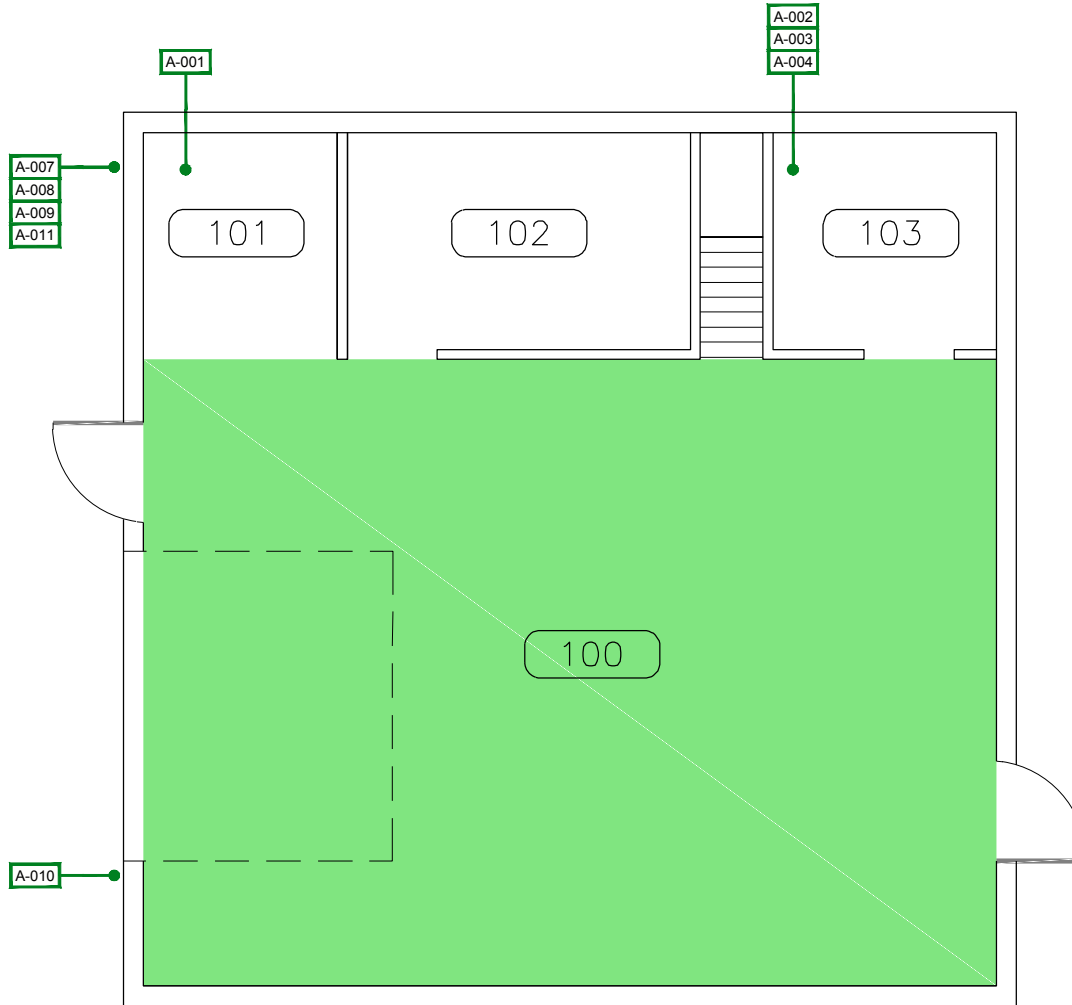
PROJECT NO. 1667963	CONTROL 1001-HM-0001	REV. 0	FIGURE 1
-------------------------------	--------------------------------	------------------	--------------------

TITLE
MAIN FLOOR
