CITY OF SASKATOON

Asbestos-Containing Building Materials Assessment Report - Low Lift Station

Report Number: 1667963

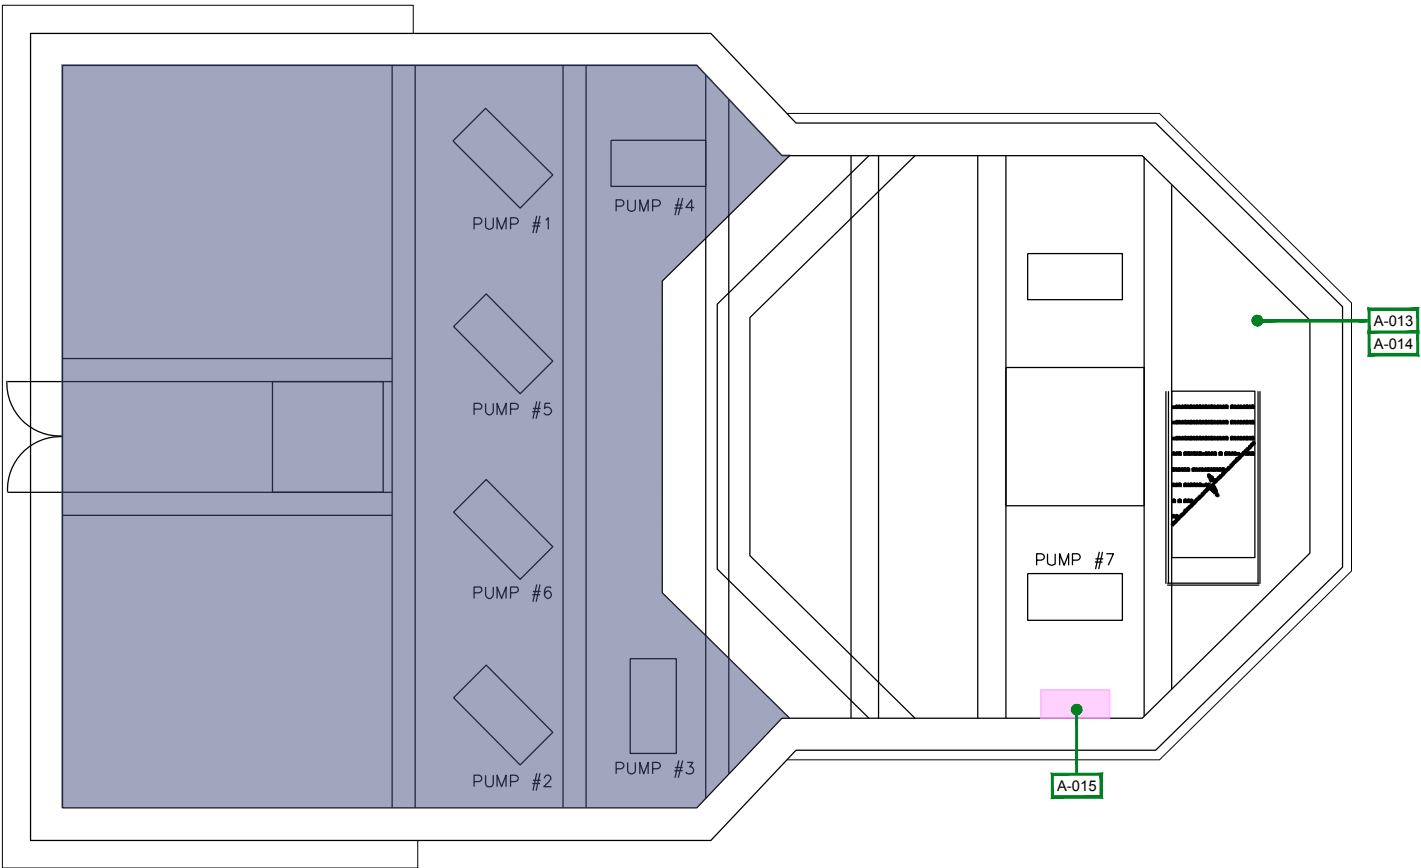
PROJECT NO.	CONTROL	REV.	FIGURE
1667963	1000-HM-0002	0	2

- ASBESTOS SAMPLE LOCATION
- ASBESTOS-CONTAINING INSULATION
- NO ACCESS
