December 1, 2017

CITY OF SASKATOON

Asbestos-Containing Building Materials Assessment Report - Nutana Lawn Bowling Clubhouse

Report Number: 1667963

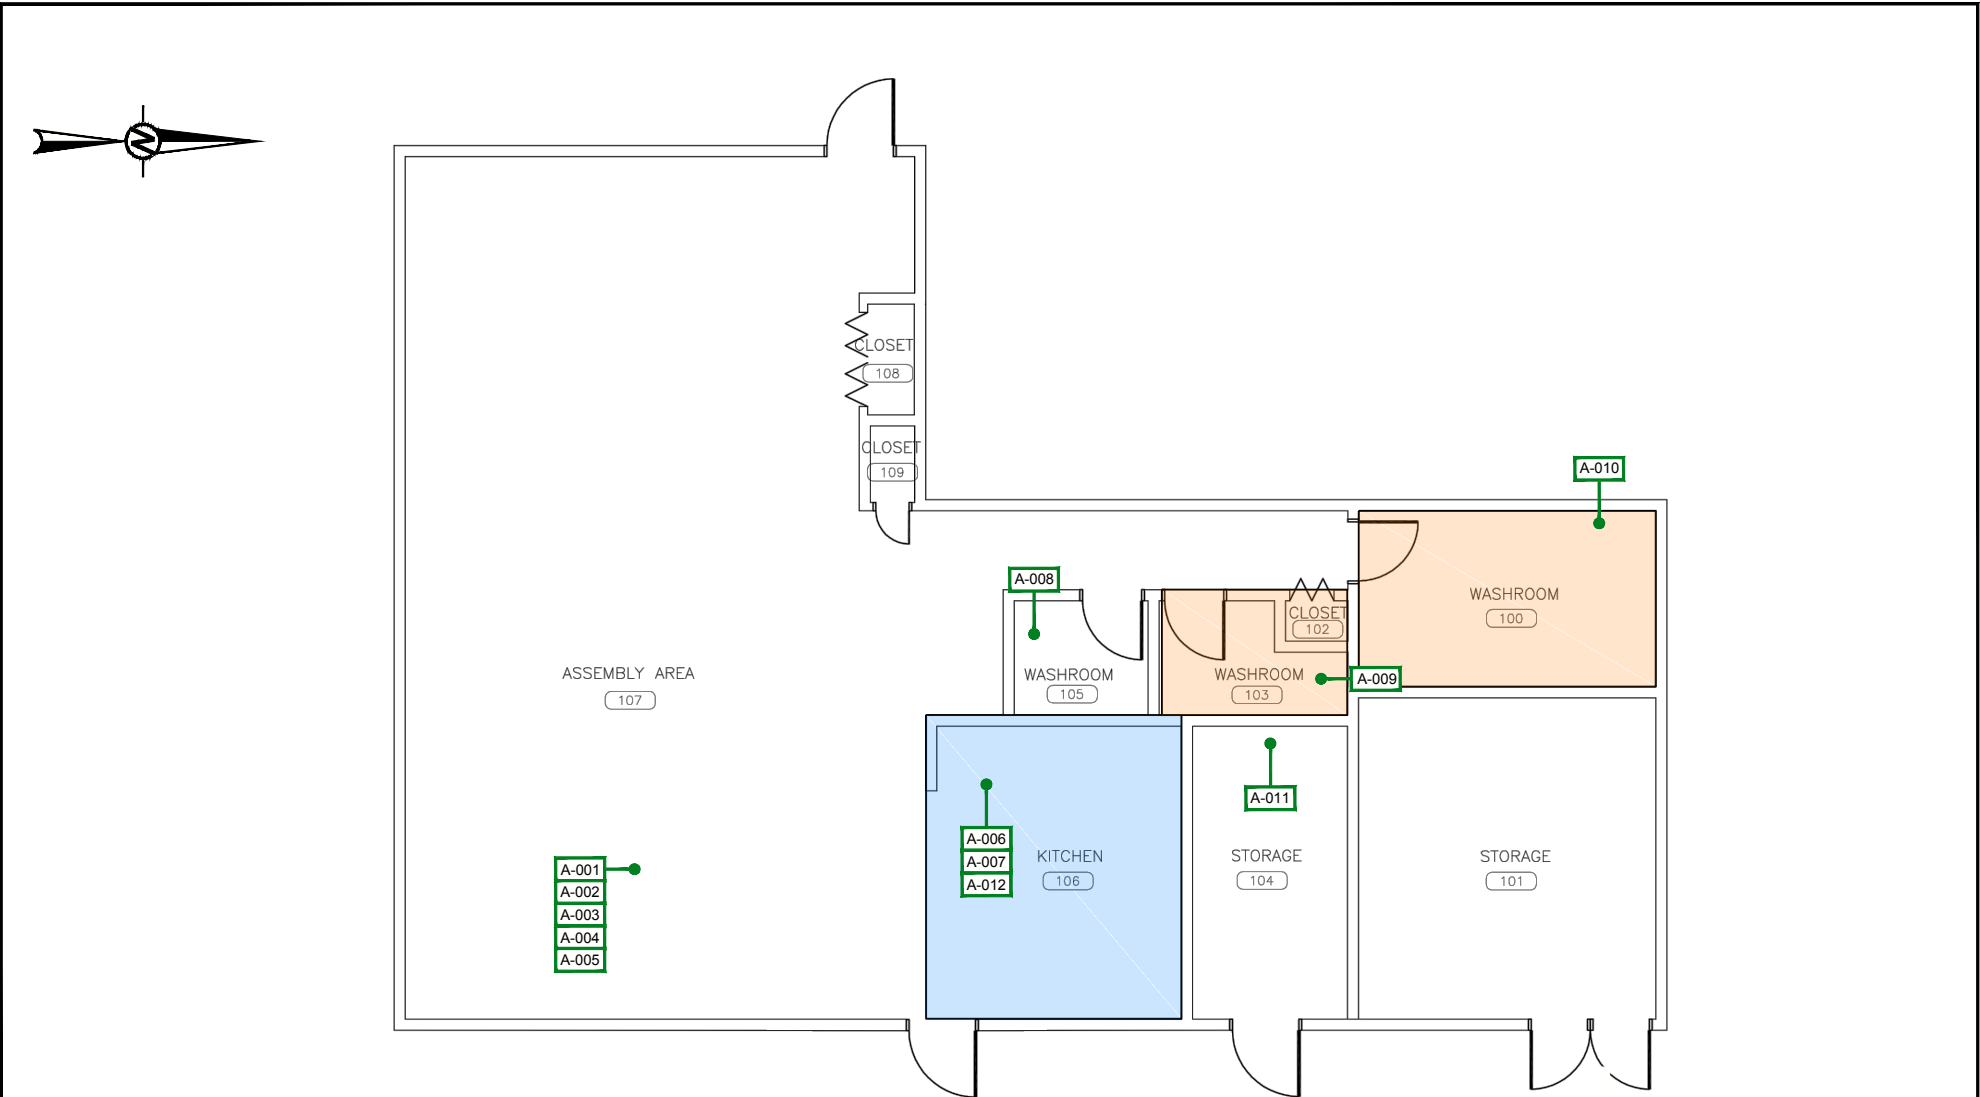
Floor Plan

One (1) sample of 12"x12" beige floor tile with black and white streaks was collected during the assessment. The sample collected was found to contain 0.75% Chrysotile asbestos. Asbestos-containing 12"x12" beige floor tile with black and white streaks (see Photograph 1 in Appendix B) was observed in the following locations:

Additional asbestos-containing 12"x12" beige floor tile with black and white streaks may be located below the carpet in other areas of the Site. Please note the asbestos-containing 12"x12" beige floor tile with black and white streaks was observed to be in poor condition within Room 103.

One (1) sample of silver sink undercoat was collected during the assessment. The sample collected was found to contain 1.6% Chrysotile asbestos. Asbestos-containing silver sink undercoat (see Photograph 2 in Appendix B) was observed in the following location:

Removal work should be completed by workers that are adequately trained in the hazards and proper methods of working with asbestos. Throughout the abatement activities, appropriate air monitoring and inspections should be conducted by a competent person to document that contamination is contained and that ACM are disposed of appropriately. Ensure asbestos waste is disposed of in accordance with the requirements of the Government of Saskatchewan.
