August 8, 2017

## CITY OF SASKATOON

# Asbestos-Containing Building Materials Assessment Report - City Yards Patrol Shed

**Report Number: 1667963**

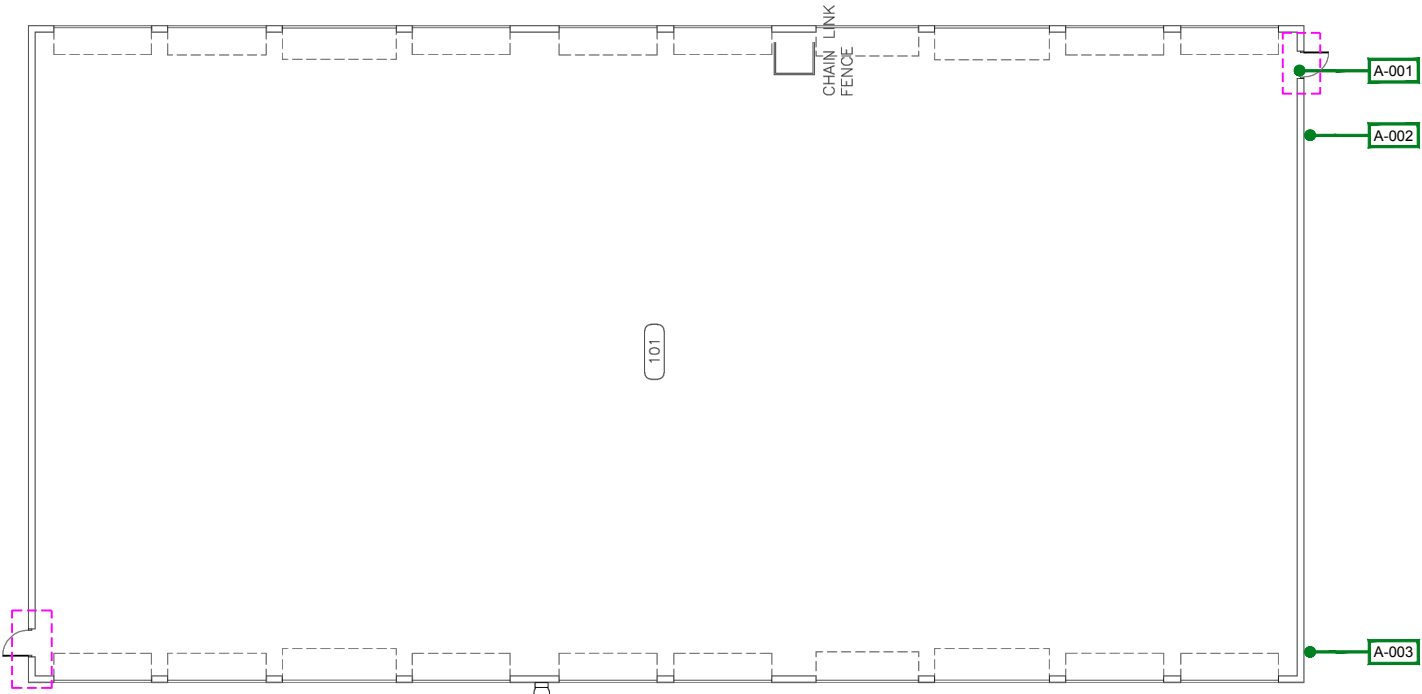
## **Floor Plans**

One (1) sample of black window caulking was collected during the assessment. The sample collected was found to contain 3.3% Chrysotile asbestos. Asbestos-containing black window caulking (see Photograph 1 in Appendix B) was observed in the following locations:

Removal work should be completed by workers that are adequately trained in the hazards and proper methods of working with asbestos. Throughout the abatement activities, appropriate air monitoring and inspections should be conducted by a competent person to document that contamination is contained and that ACM are disposed of appropriately. Ensure asbestos waste is disposed of in accordance with the requirements of the Government of Saskatchewan.
