## **Field House Asbestos Survey Report**

**January 2015**

**Prepared For: City of Saskatoon Infrastructure Services - Facilities Branch**  
3130 Laurier Drive, Saskatoon, SK.  
Attn: Brent Anderson

**Prepared By: Bersch & Associates Ltd.**  
**Project No. : B67SRJ08**

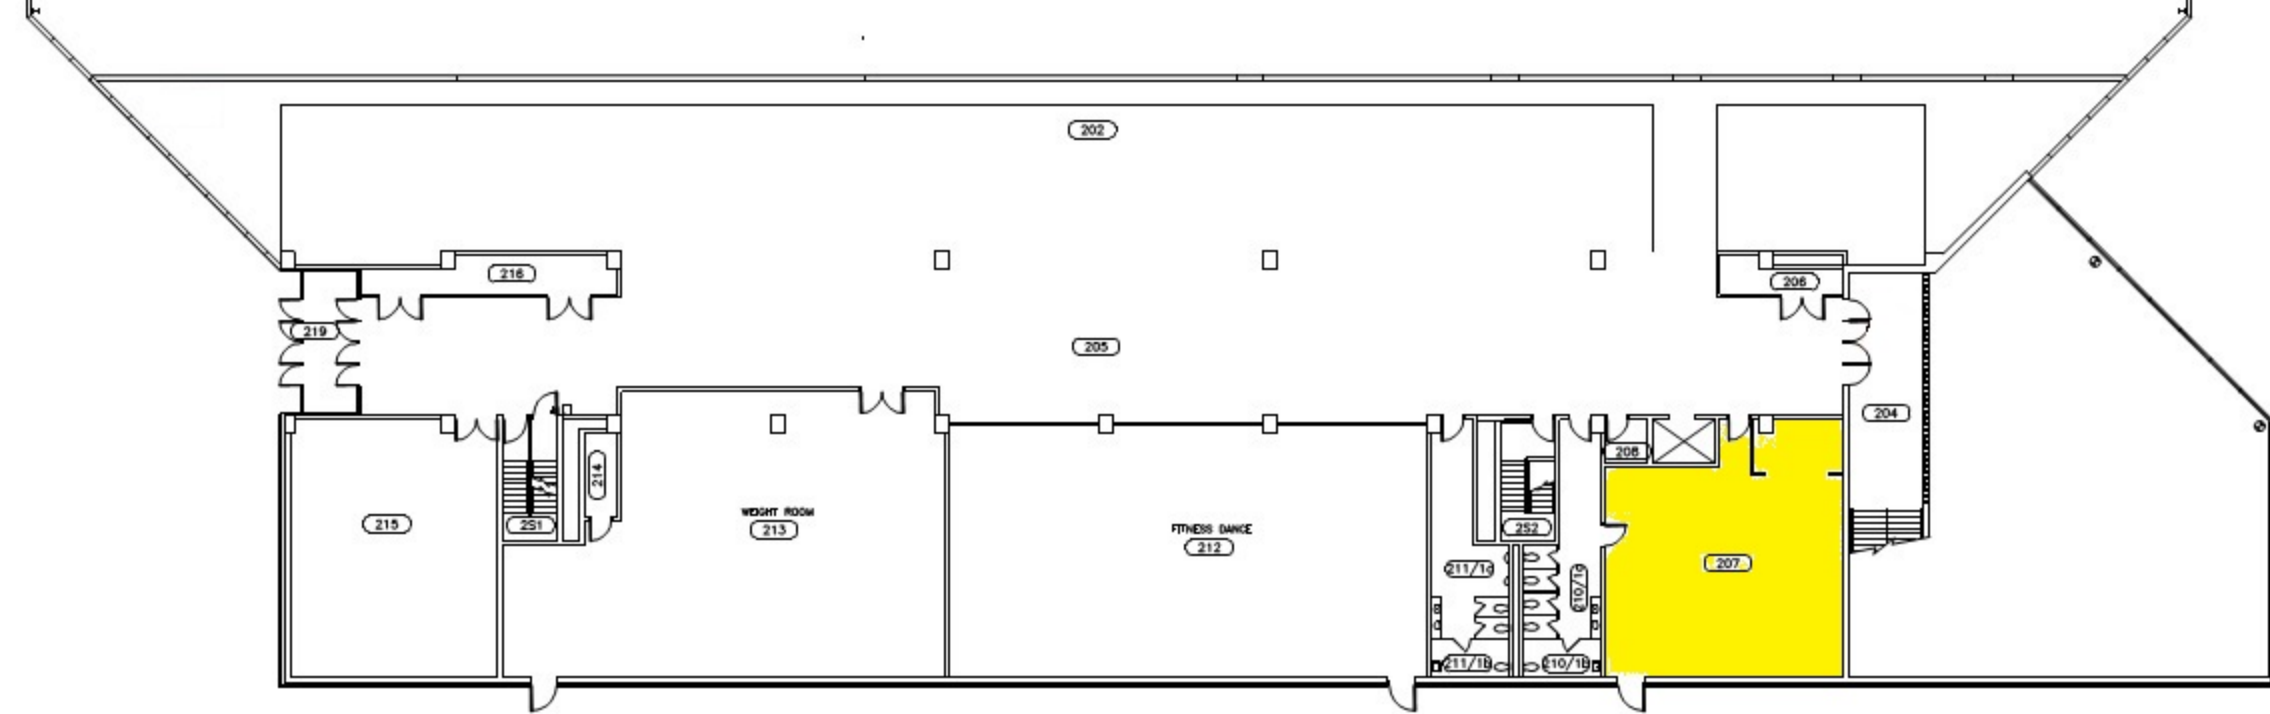
- **Vinyl Asbestos Floor Tile** is located in Meeting Room 151(walkway to track area) and Meeting Room 207. The Asbestos Floor Tile is identified on the **Floor Plans** in **Appendix III** of this report. It is suspected that the vinyl asbestos tile is present beneath the new layer of flooring throughout the facility. ***Further testing of any flooring beneath the top layer is recommended prior to renovations.***

**ASBESTOS FLOOR TILE**
