**SPCA ANIMAL SHELTER
ASBESTOS SURVEY REPORT**

May 2013

Prepared By: Bersch & Associates Ltd.
Project No. : B67.13

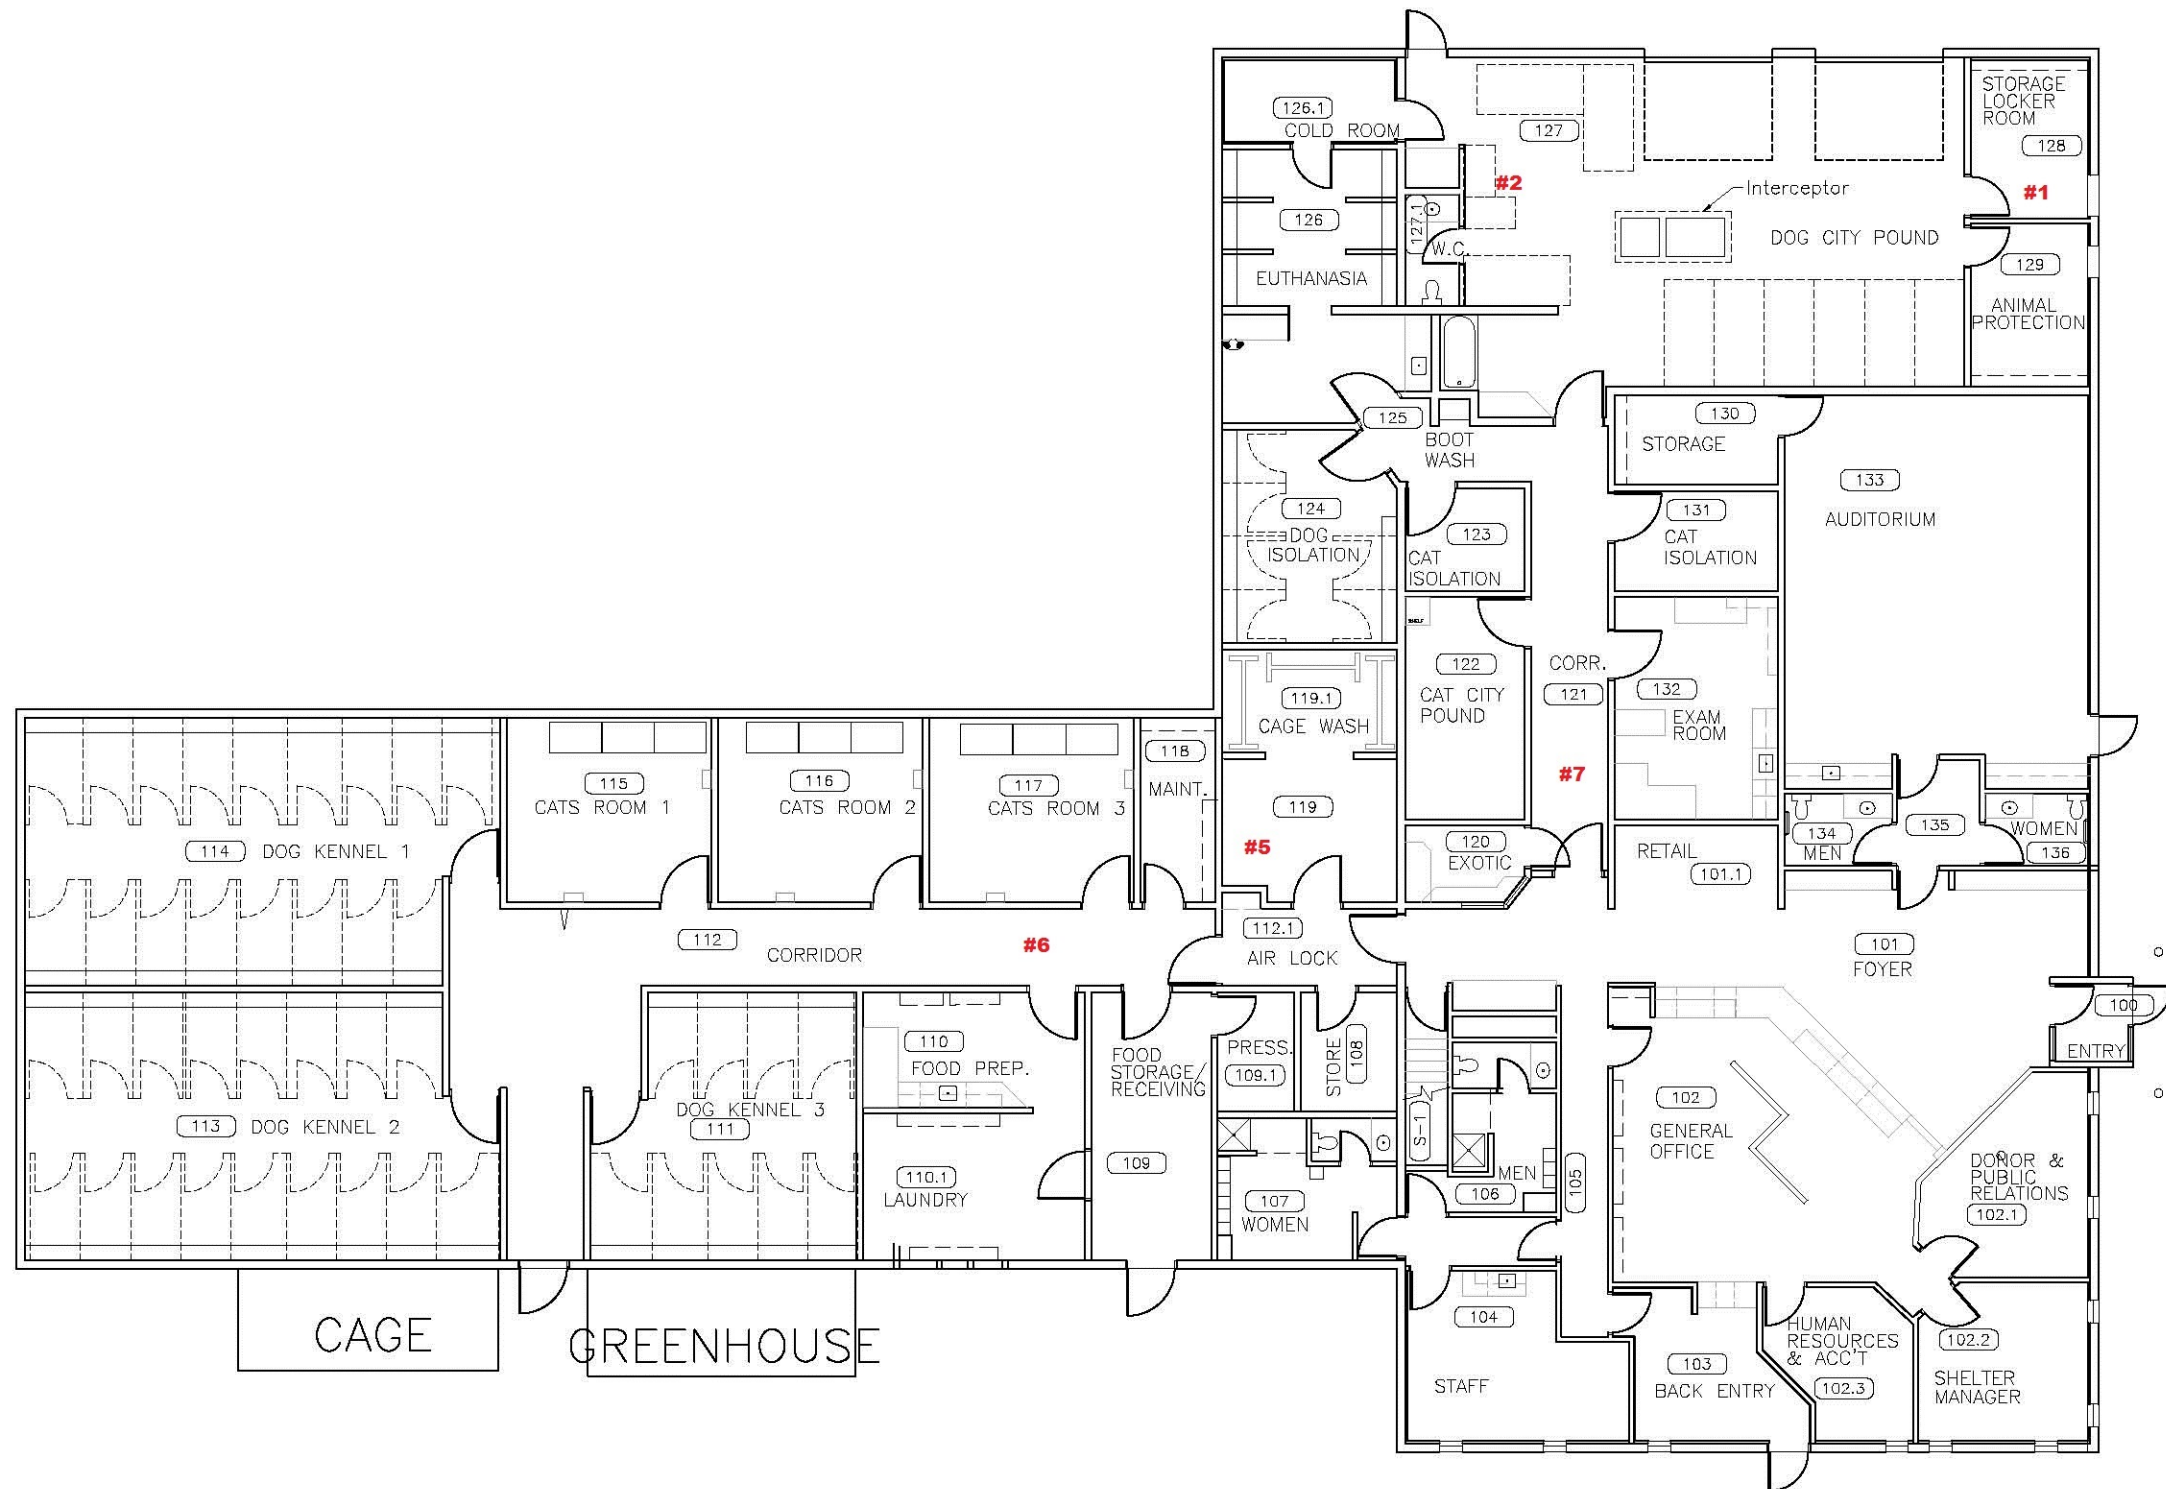
FLOOR PLANS

Included in **Appendix II** of this report is a **Floor Plan** of the facility identifying the bulk sample locations. **Photos** of suspect materials sampled are also included in **Appendix III**.
