## **Trades Offices Asbestos Survey Report**

**January 2014**

**Prepared For: City Of Saskatoon- Infrastructure Services Department**  
1101 Avenue P North, Saskatoon, SK.  
Attn: Brent Anderson

**Prepared By: Bersch & Associates Ltd.**  
**Project No. : B67SRD30**

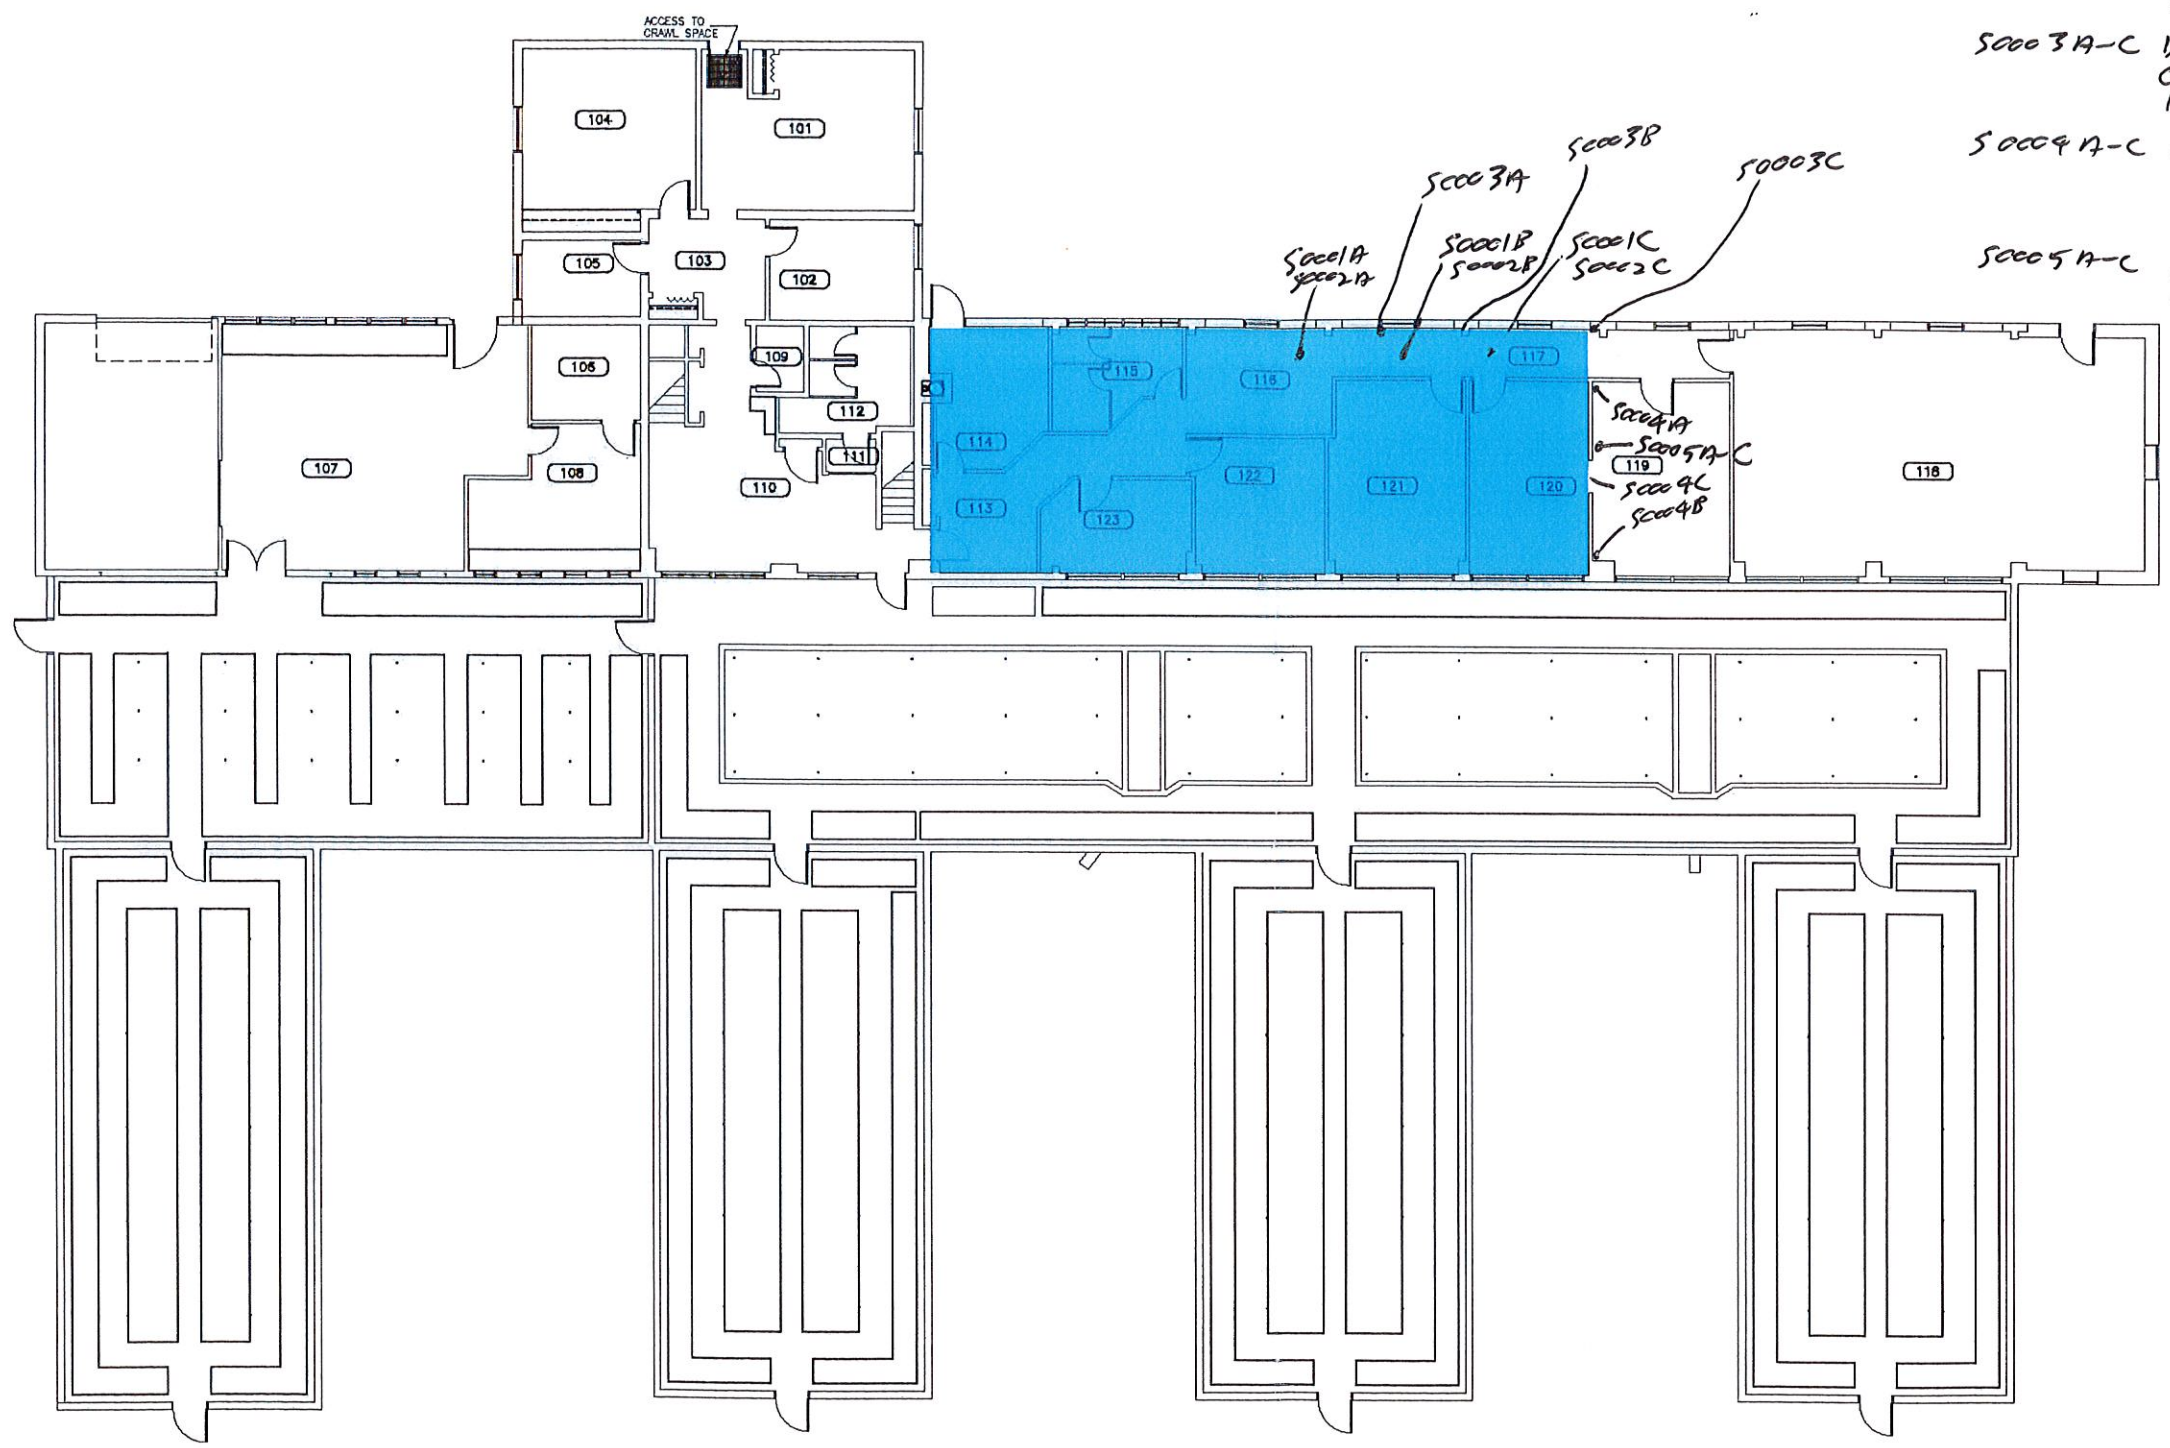
7141A0-001

- S0001A-C ACOUSTIC CEILING TILE
- S0002A-C ACOUSTIC CEILING TILE
- S0003A-C DRYWALL JOINT COMPOUND EXTERIOR WALL
- S0004A-C DRYWALL JOINT COMPOUND INTERIOR WALL
- S0005A-C ACOUSTIC CEILING TILE
