CITY OF SASKATOON

Asbestos-Containing Building Materials Assessment Report - Trailer 709

Report Number: 1667963

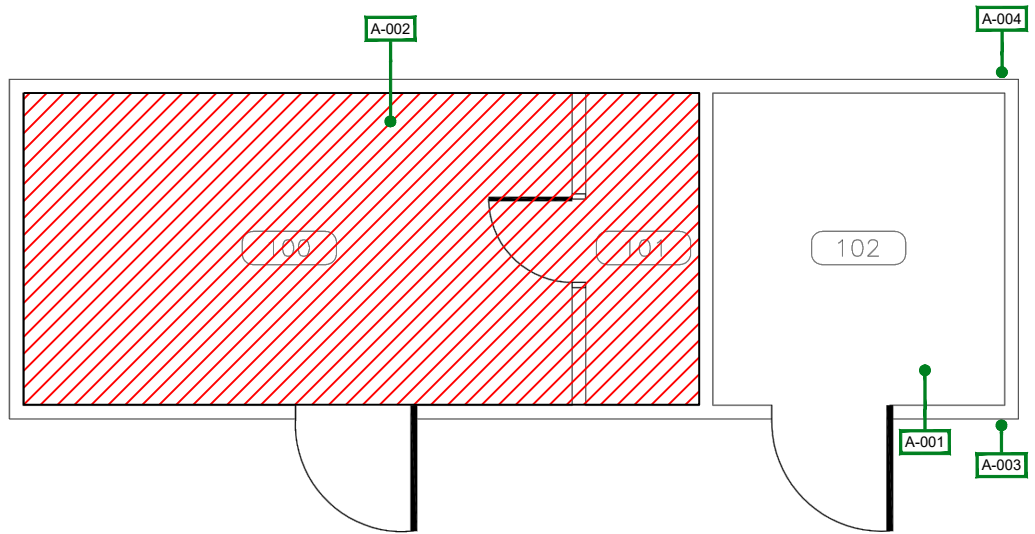
Floor Plan

One (1) sample of silver sink undercoat was collected during the assessment. The sample collected was found to contain 1.3% Chrysotile asbestos. Asbestos-containing silver sink undercoat (see Photograph 1 in Appendix B) was observed in the following location:

If scheduled for impact, sinks with asbestos-containing silver undercoat should be abated following low-risk abatement work procedures as outlined in the *Saskatchewan Asbestos Abatement Manual (2017)*. Alternatively, as the silver sink undercoat was observed in good condition, and with a priority rating of 5 (please see the room by room spreadsheet provided in Appendix C for a description of the priority ratings), it can be managed in place if not scheduled for impact.
