**TRANSIT STORAGE & ADMINISTRATION  
BUILDING  
ASBESTOS SURVEY REPORT**

**April 2014**

**Prepared For: City of Saskatoon – Infrastructure Services Department**  
1101 Avenue P North, Saskatoon SK, Canada S7L 7K6  
Attn: Brent Anderson

**Prepared By: Bersch & Associates Ltd.**  
**Project No. : B67SRD23**

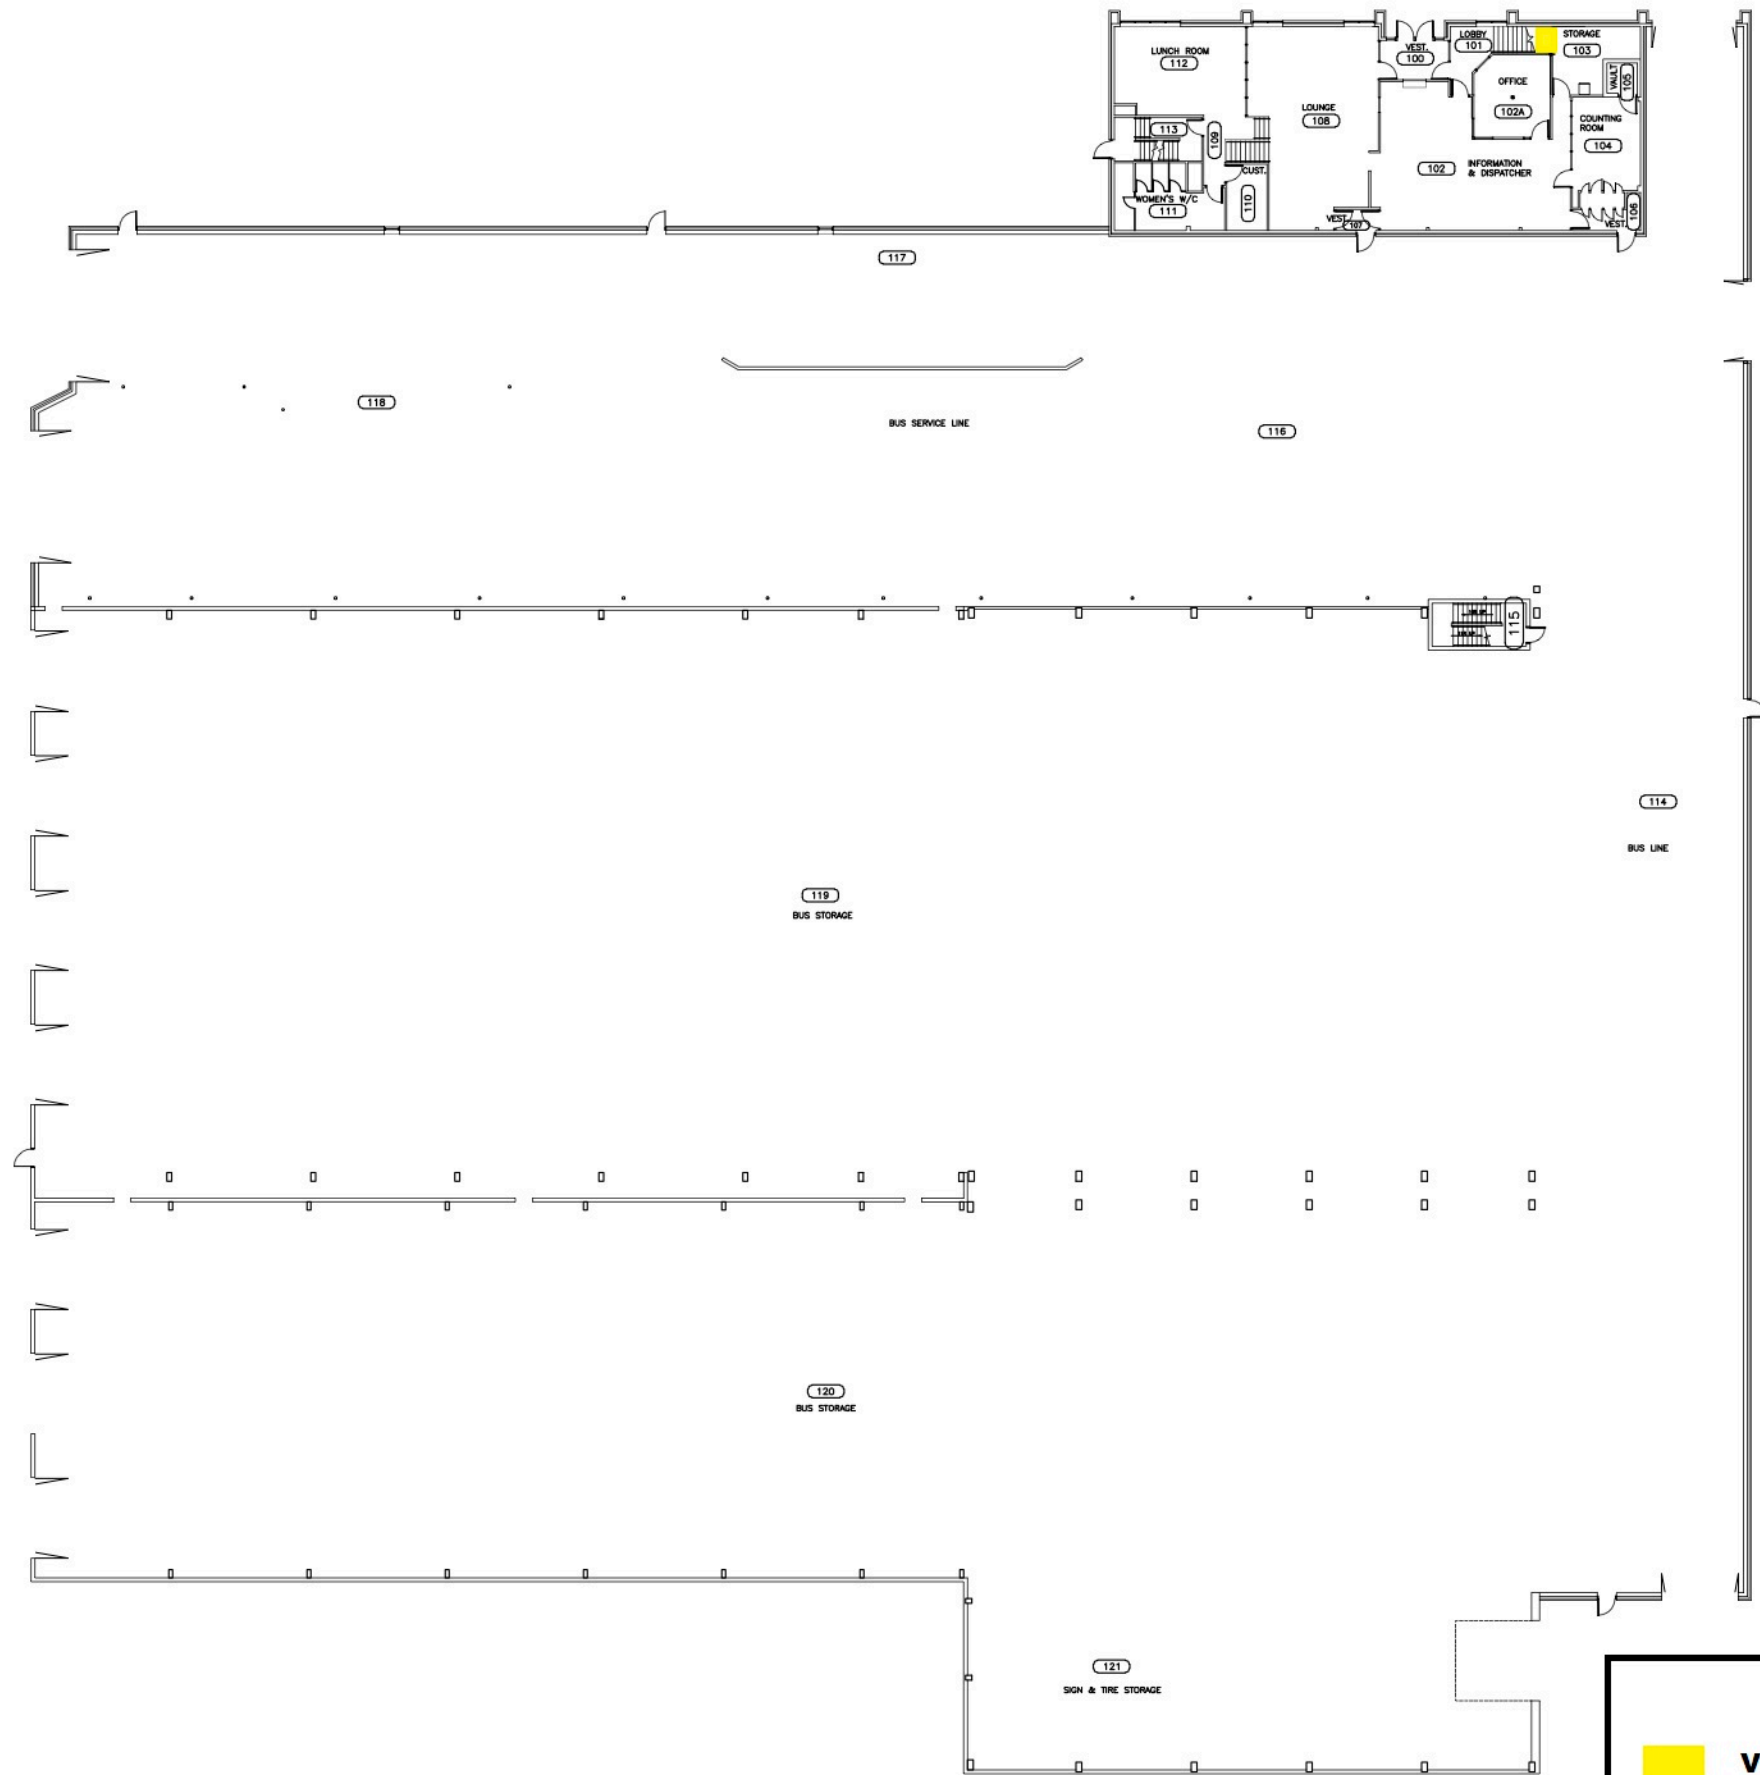
PROJECT TITLE  
**852  
Transit Admin  
Building**

- **Vinyl Asbestos Floor Tile** is located within 244 and 103 Storage Rooms. The Asbestos Floor Tile has been identified on the **Floor Plans** included in **Appendix II** of this report.

**KEY**  
Vinyl Asbestos Floor Tile
