## CITY OF SASKATOON

# Asbestos-Containing Building Materials Assessment Report - Transit Body Shop

**Report Number: 1667963**

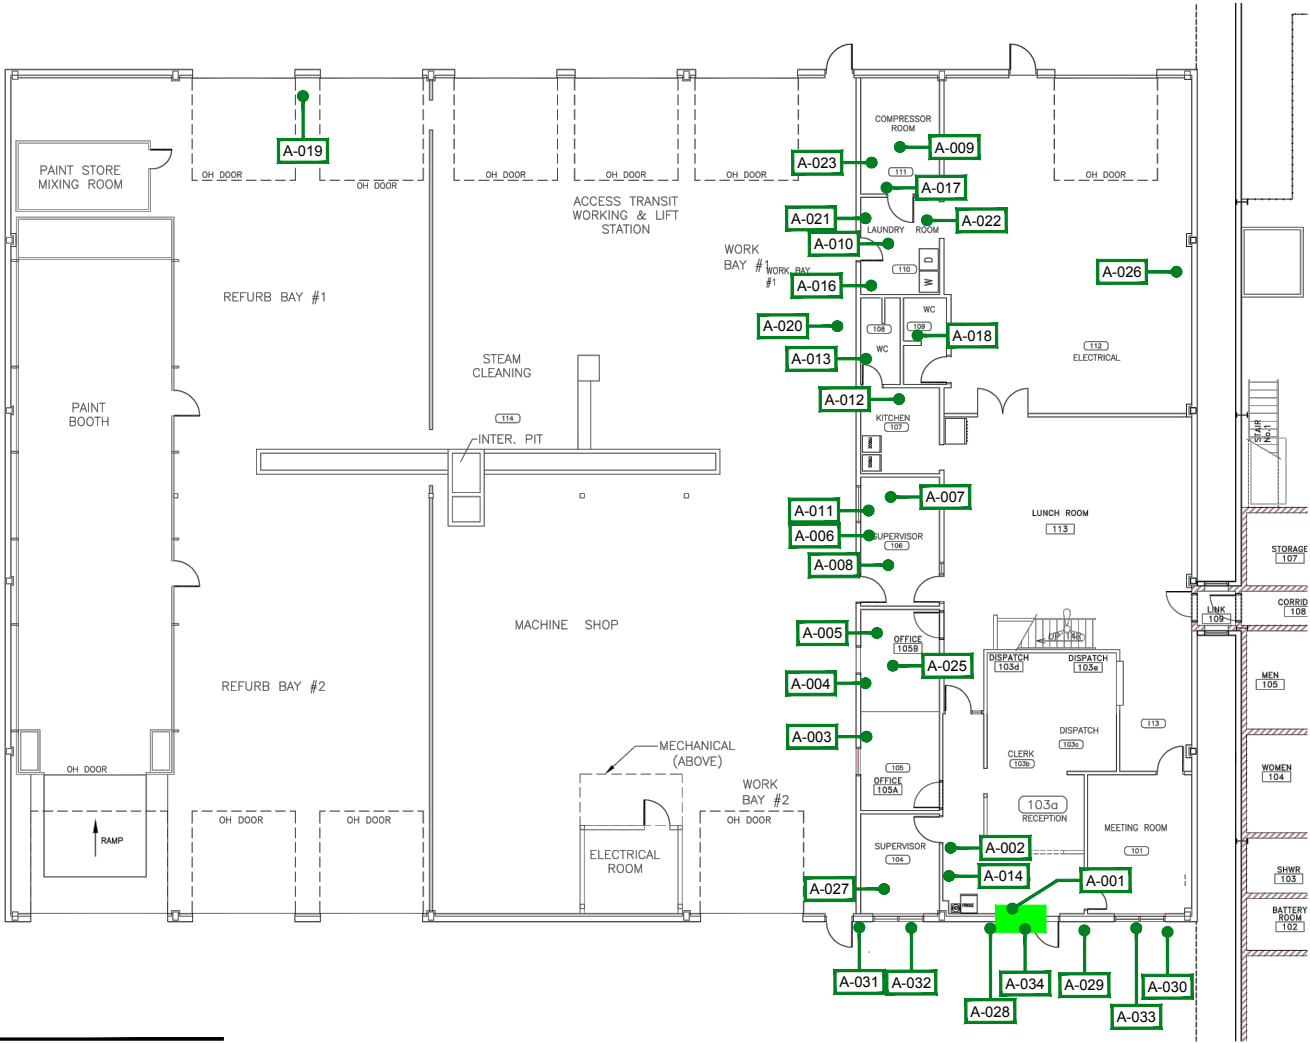
## **Floor Plans**

One (1) sample of black window caulking was collected during the assessment. The sample collected was found to contain 5.6% Chrysotile asbestos. Asbestos-containing black window caulking (see Photograph 1 in Appendix B) was observed in the following locations:

- # ASBESTOS SAMPLE LOCATION
- ASBESTOS - CONTAINING WINDOW CAULKING

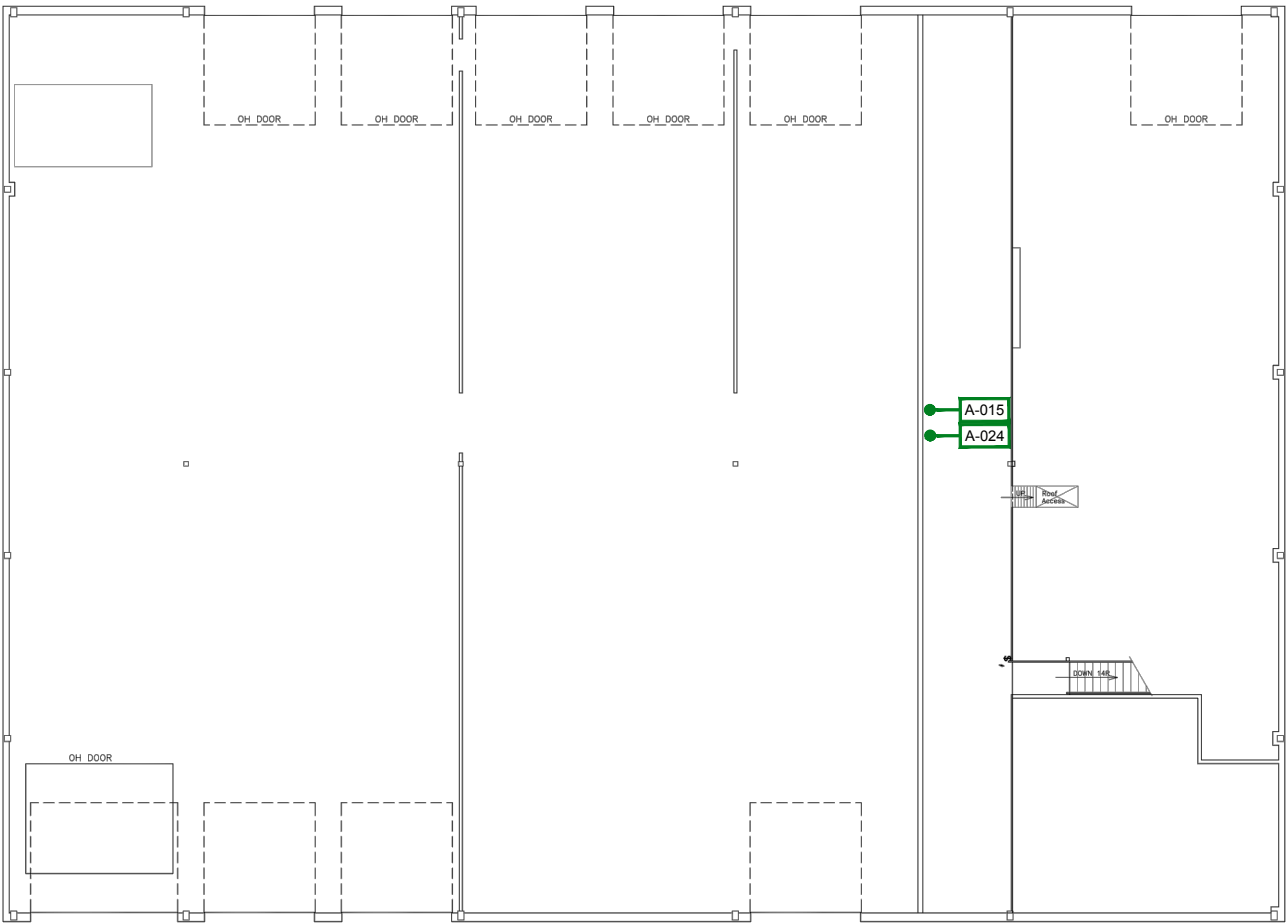
● # ASBESTOS SAMPLE LOCATION
