## CITY OF SASKATOON

# Asbestos-Containing Building Materials Assessment Report - Water Meter Shop

**Report Number: 1667963**

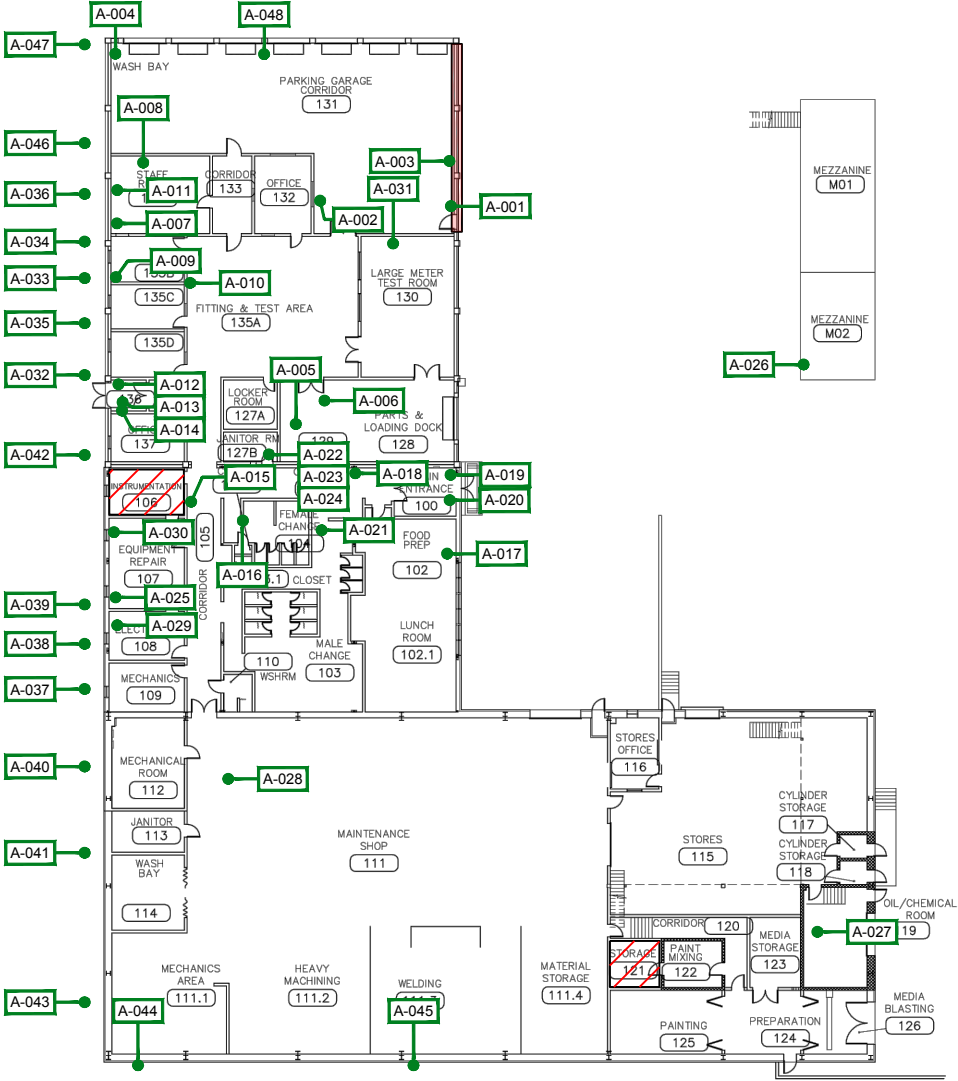
## **Floor Plan**

One (1) sample of loose-fill vermiculite insulation was collected during the assessment. The sample collected was found to contain trace amount of Actinolite asbestos. Asbestos-containing loose-fill vermiculite insulation (see Photograph 1 in Appendix B) was observed to have leaked from the wall cavity in Room 131. The loose vermiculite was subsequently cleaned by the Client following its identification.

Removal work should be completed by workers that are adequately trained in the hazards and proper methods of working with asbestos. Throughout the abatement activities, appropriate air monitoring and inspections should be conducted by a competent person to document that contamination is contained and that ACM are disposed of appropriately. Ensure asbestos waste is disposed of in accordance with the requirements of the Government of Saskatchewan.
