## CITY OF SASKATOON

# Asbestos-Containing Building Materials Assessment Report - Waste Water Sodium Hypochlorite Building

**Report Number: 1667963**

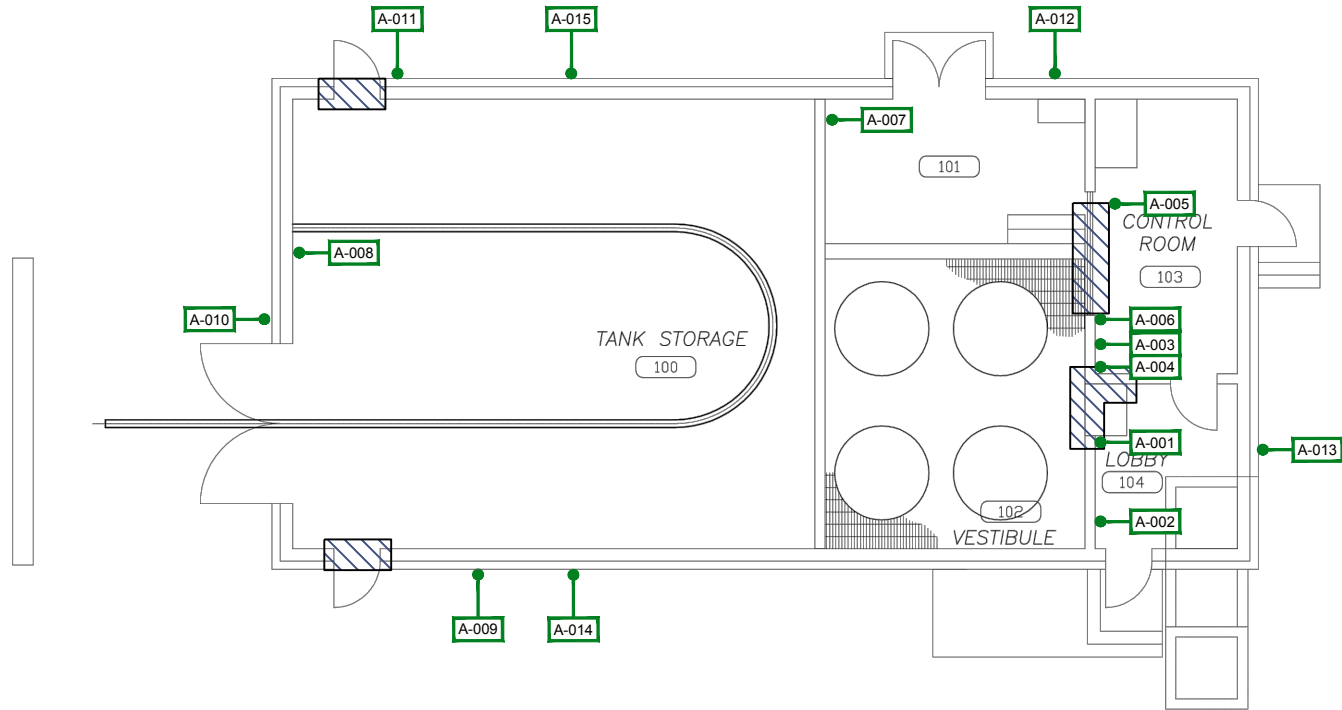
## **Floor Plan**

One (1) sample of black window glazing was collected during the assessment. The sample collected was found to contain 10% Chrysotile asbestos. Asbestos-containing black window glazing (see Photograph 1 in Appendix B) was observed in the following locations:
